CLASHINDARROCH II

WIND FARM

Technical Appendix 11.3

This Technical Appendix presents information with regard to existing and proposed new watercourse crossings.

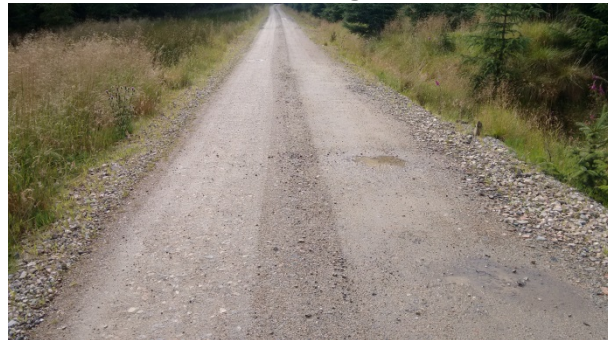
Watercourse Crossing Details	Photography	Location
<p>Watercourse Crossing 1 Existing</p> <p>NGR: NJ 46024 36073</p> <p>Watercourse: Burn of Corshalloch</p> <p>Notes: 0.6 m diameter plastic circular culvert, no flow noted</p>	<p style="text-align: center;">Crossing</p>

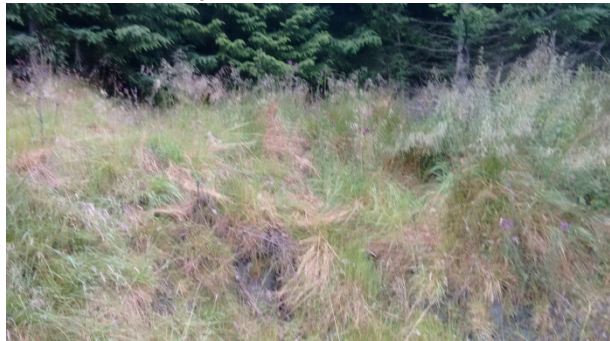
Watercourse Crossing Details	Photography		Location
Watercourse Crossing 2 Existing NGR: NJ 45698 36063 Watercourse: Unnamed Tributary of Burn of Corshalloch Notes: 0.6 m diameter plastic circular culvert, negligible flow from natural catchment, majority of inflow from track drainage.	Upstream Catchment

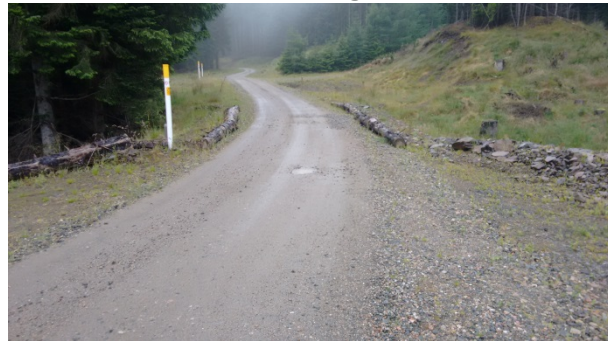
Watercourse Crossing Details	Photography		Location
<p>Watercourse Crossing 3 Existing</p> <p>NGR: NJ 45311 35895</p> <p>Watercourse: Black Burn</p> <p>Notes: 1.2 m diameter plastic circular culvert with slight warping under track.</p>	<p>Crossing</p>

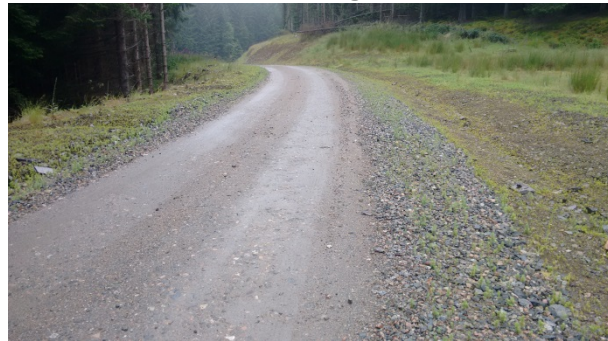
Watercourse Crossing Details	Photography		Location
<p>Watercourse Crossing 4 Existing</p> <p>NGR: NJ 45221 35773</p> <p>Watercourse: Dry Burn</p> <p>Notes: 0.6 m diameter plastic circular culvert upstream discharging to a 0.9 m diameter plastic circular culvert downstream, lots of growth at entrance.</p>	<p>Crossing</p>

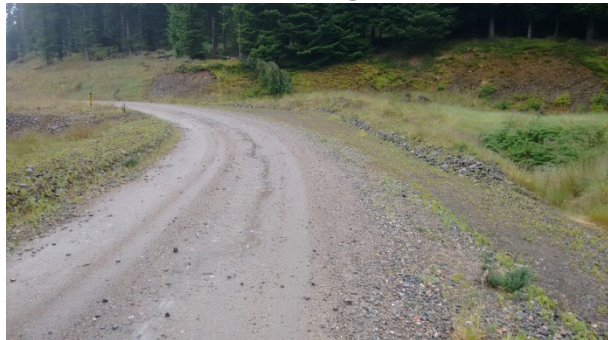
Watercourse Crossing Details	Photography		Location
<p>Watercourse Crossing 5 Existing</p> <p>NGR: NJ 45188 35609</p> <p>Watercourse: Long Slouch</p> <p>Notes: 0.9 m diameter plastic circular culvert, old culvert immediately upstream.</p>	<p>Crossing</p>

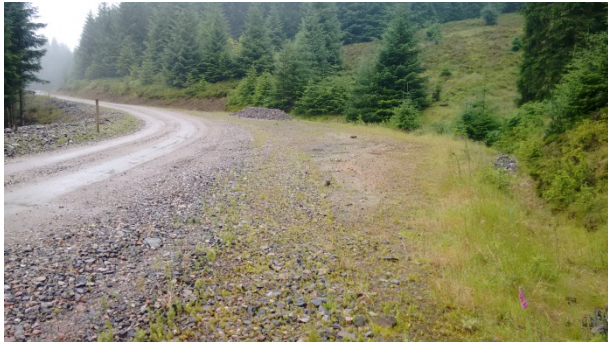
Watercourse Crossing Details	Photography		Location
<p>Watercourse Crossing 6 Existing</p> <p>NGR: NJ 45326 35480</p> <p>Watercourse: Green Slouch</p> <p>Notes: 0.8 m diameter plastic circular culvert, no flow observed, debris build up at culvert exit.</p>	<p style="text-align: center;">Crossing</p>

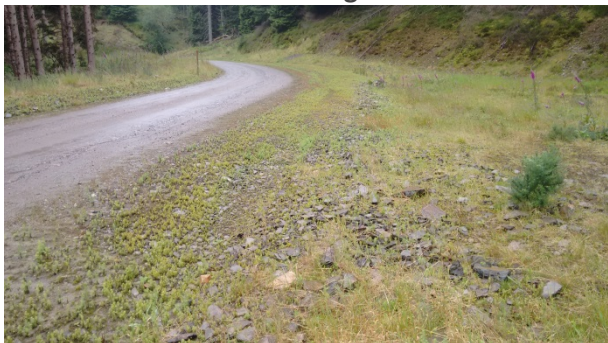
Watercourse Crossing Details	Photography		Location
<p>Watercourse Crossing 7 Existing requiring upgrade</p> <p>NGR: NJ 45486 35147</p> <p>Watercourse: Headwater of The Grains</p> <p>Notes: 0.6 m diameter plastic circular culvert, no flow observed.</p>	<p style="text-align: center;">Crossing</p>

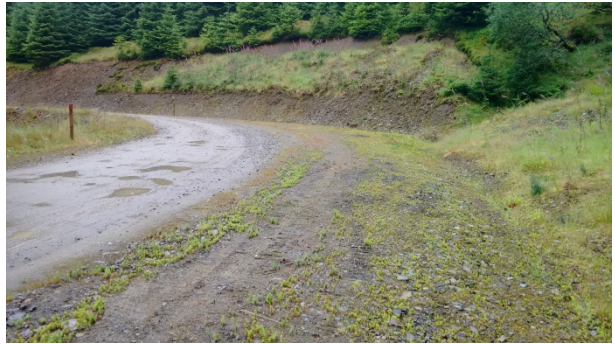
Watercourse Crossing Details	Photography	Location
<p>Watercourse Crossing 8 Existing requiring upgrade</p> <p>NGR: NJ 45473 35091</p> <p>Watercourse: Headwater of The Grains</p> <p>Notes: 0.6 m diameter plastic circular culvert, roadside drainage is directed vial two pipes to the culvert discharge location</p>	<div data-bbox="622 331 1234 707"> <p>Crossing</p>

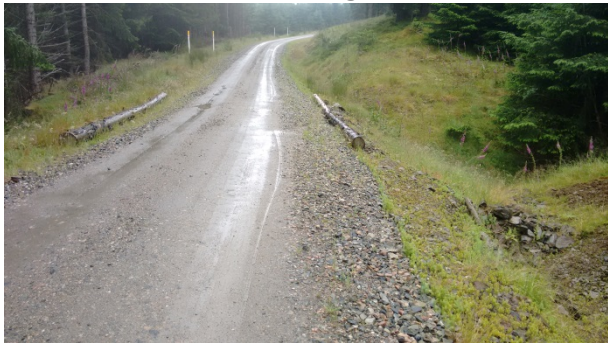
Watercourse Crossing Details	Photography	Location
<p>Watercourse Crossing 9 Existing</p> <p>NGR: NJ 45614 35035</p> <p>Watercourse: Headwater of The Grains</p> <p>Notes: 0.9 m diameter plastic circular culvert, no flow noted.</p>	<p style="text-align: center;">Crossing</p>

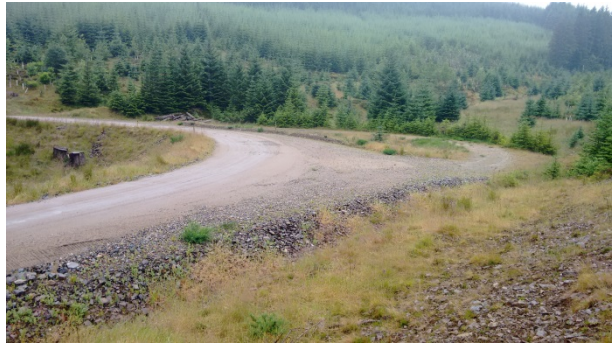
Watercourse Crossing Details	Photography	Location
<p>Watercourse Crossing 10 Existing requiring upgrade</p> <p>NGR: NJ 45175 34317</p> <p>Watercourse: Killin Burn</p> <p>Notes: 1.2 m diameter plastic circular culvert, older culvert immediately upstream.</p>	<div data-bbox="622 331 1234 708"> <p>Crossing</p>

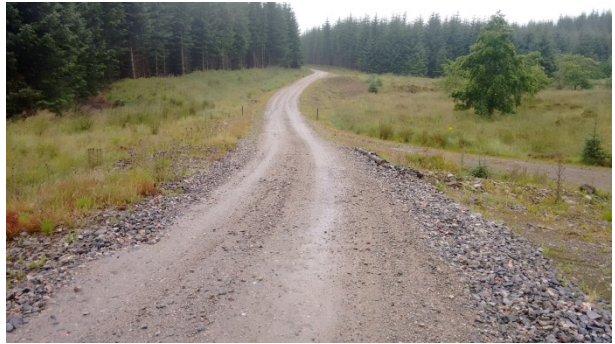
Watercourse Crossing Details	Photography	Location
<p>Watercourse Crossing 11 Existing</p> <p>NGR: NJ 44647 33666</p> <p>Watercourse: Burn of Bedlaithen</p> <p>Notes: 1.2 m diameter plastic circular culvert, an older crossing exists immediately upstream.</p>	<div data-bbox="622 331 1234 707"> <p>Crossing</p>

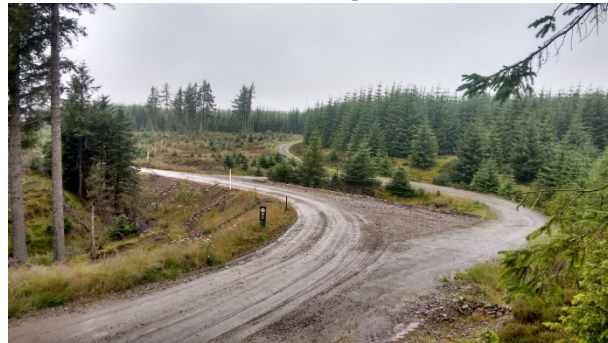
Watercourse Crossing Details	Photography		Location
<p>Watercourse Crossing 13 Existing requiring upgrade</p> <p>NGR: NJ 43255 32623</p> <p>Watercourse: Badilauchter Burn</p> <p>Notes: 1.2 m diameter plastic circular culvert, an older culvert exists immediately upstream.</p>	<p style="text-align: center;">Crossing</p>

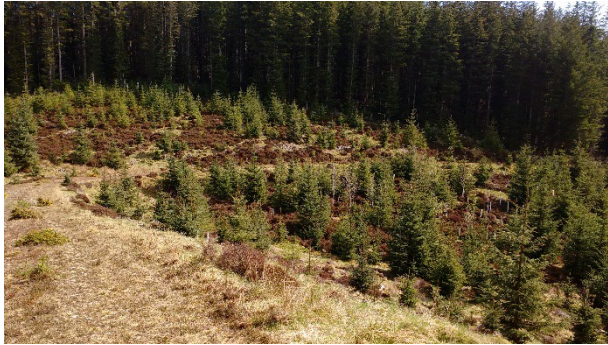
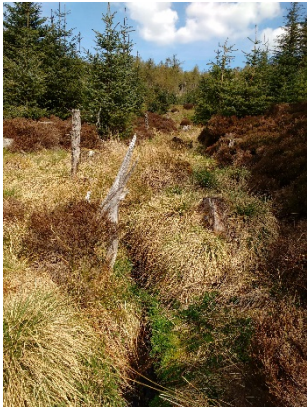
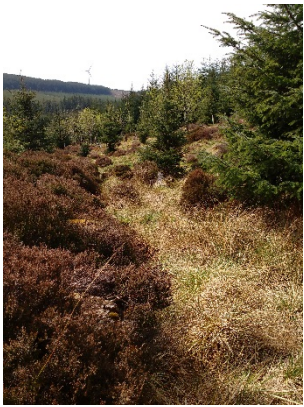
Watercourse Crossing Details	Photography	Location
<p>Watercourse Crossing 14 New</p> <p>NGR: NJ 43721 31770</p> <p>Watercourse: Headwater of Ealaiche Burn</p> <p>Notes: 0.4 m wide very shallow minor watercourse with clean fine to medium gravel base.</p>	<p style="text-align: center;">Crossing</p>

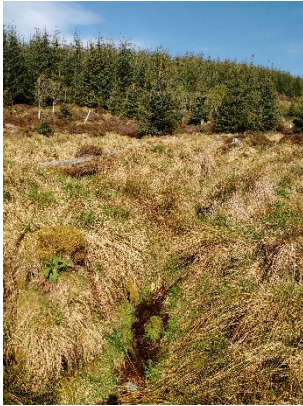
Watercourse Crossing Details	Photography	Location
<p>Watercourse Crossing 15 New</p> <p>NGR: NJ 43742 31592</p> <p>Watercourse: Headwater of Ealaiche Burn</p> <p>Notes: 0.3 m wide shallow watercourse with clean medium gravel base.</p>	<p>Upstream</p>
