# South Kyle II Wind Farm

## Technical Appendix 8.3: Watercourse Crossing Assessment

**Vattenfall Wind Power Ltd**

1357601/B

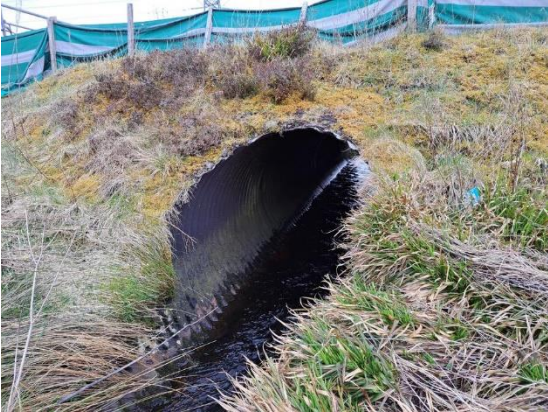
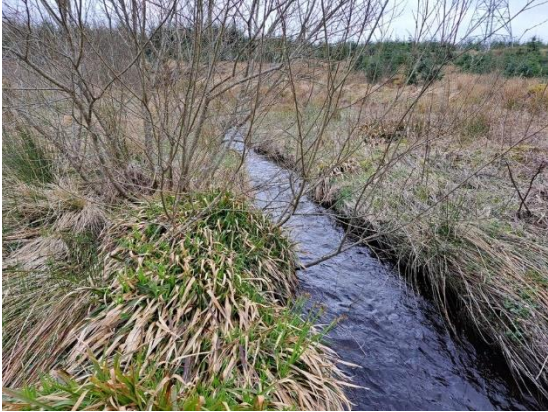
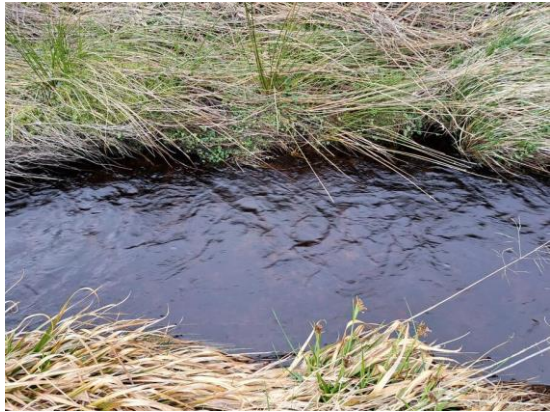
WX1 (252179, 607841)		
Crossing Location	Crossing Description	
<div>

<p>© Crown Copyright 2025. All rights reserved. Ordnance Survey Licence 0100031673.</p></div>	<ul style="list-style-type: none"><li>• <b>Existing Crossing:</b> Yes</li><li>• <b>Crossing Type (existing):</b> Circular Culvert</li><li>• <b>Crossing Material (existing):</b> Plastic</li><li>• <b>Crossing Condition (existing):</b> Good</li><li>• <b>Channel Type:</b> Artificial drainage channel, artificially modified watercourse</li><li>• <b>Gradient:</b> Gentle</li><li>• <b>Valley form:</b> Shallow vee</li><li>• <b>Bank condition:</b> Stable</li><li>• <b>Bed material:</b> Rounded pebbles</li><li>• <b>Riparian corridor:</b> Commercial Forestry, Moorland</li><li>• <b>Flow condition:</b> Fast</li></ul>	<ul style="list-style-type: none"><li>• <b>Culvert Dimensions (m):</b> 1.5</li><li>• <b>Water width (m):</b> 1.0</li><li>• <b>Water depth (m):</b> 0.2</li><li>• <b>Bankfull width (m):</b> 1.2</li><li>• <b>Bankfull height (m):</b> 0.4</li><li>• <b>Banktop height (m):</b> 0.6</li><li>• <b>Flooded Bankfull width (m):</b> 1.2</li><li>• <b>Flooded Bankfull height:</b> 0.6</li></ul> <p><b>Note:</b> None</p>

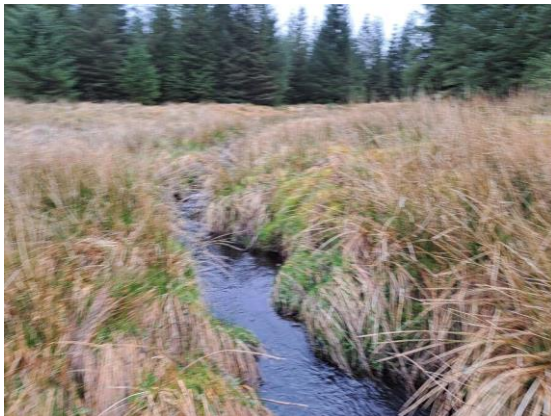
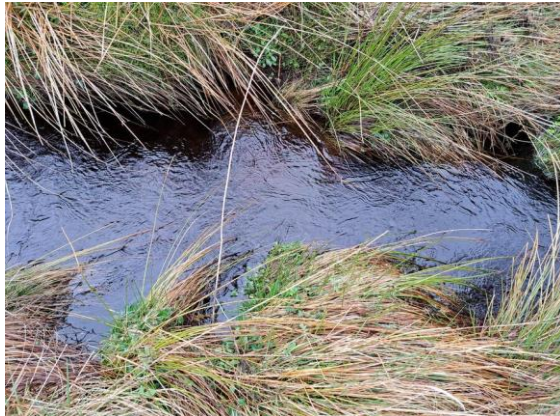
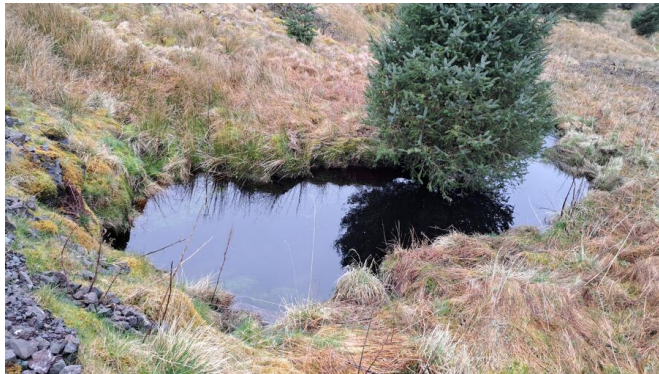
WX2 (252846, 607065)			
Crossing Location		Crossing Description	
<div>

<p>© Crown Copyright 2024. All rights reserved. Ordnance Survey Licence 0100031673.</p></div>		<div><ul style="list-style-type: none"><li>• <b>Existing Crossing:</b> Yes</li><li>• <b>Crossing Type (existing):</b> Circular culvert</li><li>• <b>Crossing Material (existing):</b> Plastic</li><li>• <b>Crossing Condition (existing):</b> Good</li><li>• <b>Channel Type:</b> Artificial drainage channel</li><li>• <b>Gradient:</b> Gentle</li><li>• <b>Valley form:</b> Shallow vee</li><li>• <b>Bank condition:</b> Stable</li><li>• <b>Bed material:</b> Bedrock</li><li>• <b>Riparian corridor:</b> Commercial Forestry, Moorland</li><li>• <b>Flow condition:</b> Moderate</li></ul></div> <div><ul style="list-style-type: none"><li>• <b>Culvert Dimensions (m):</b> 0.5</li><li>• <b>Water width (m):</b> 1.0</li><li>• <b>Water depth (m):</b> 0.30</li><li>• <b>Bankfull width (m):</b> 1.3</li><li>• <b>Bankfull height (m):</b> 0.70</li><li>• <b>Banktop height (m):</b> 1.0</li><li>• <b>Flooded Bankfull width (m):</b> 1.5</li><li>• <b>Flooded Bankfull height:</b> 1.0</li></ul></div> <div><p><b>Note:</b> Crossed by hardstanding track in good state, it creates a pool on the other side of the track and there returns to the same width see (picture 2).</p></div>

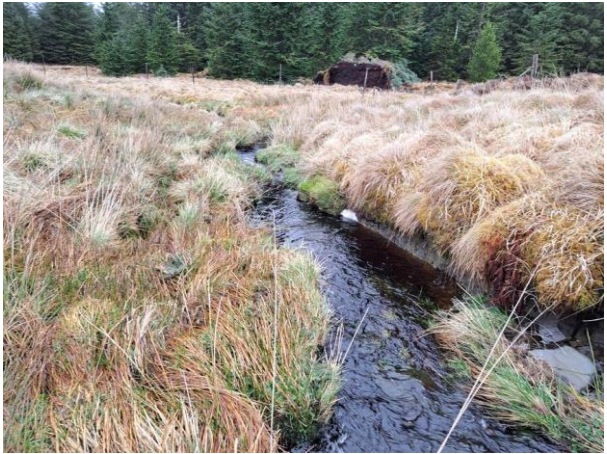
WX3 (252888, 606660)

- **Existing Crossing:** Yes
- **Crossing Type (existing):** Circular culvert
- **Crossing Material (existing):** Plastic
- **Crossing Condition (existing):** Good
- **Channel Type:** Artificially modified watercourse
- **Gradient:** Gentle
- **Valley form:** Shallow vee
- **Bank condition:** Stable
- **Bed material:** Bedrock, Vegetation
- **Riparian corridor:** Commercial Forestry
- **Flow condition:** Moderate

**Note:** Hardstanding track crosses this watercourse , in good condition, upstream ( see picture 2 for other side of the stream), believe it is an artificially modified stream.

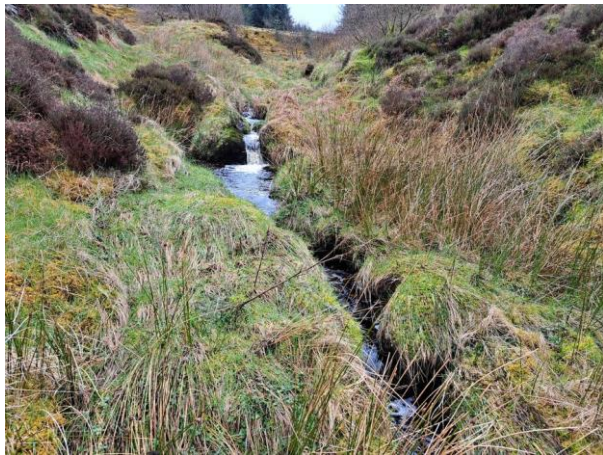
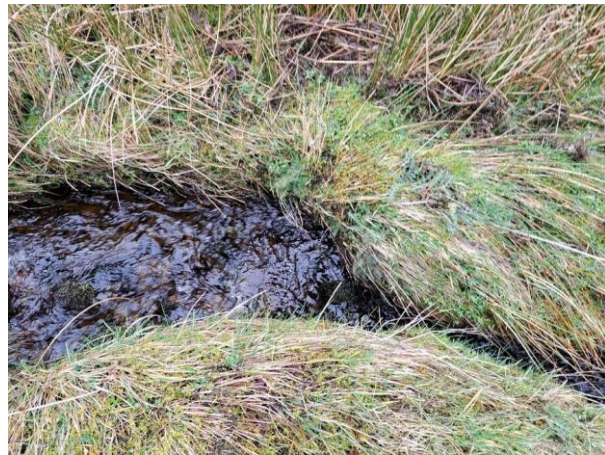
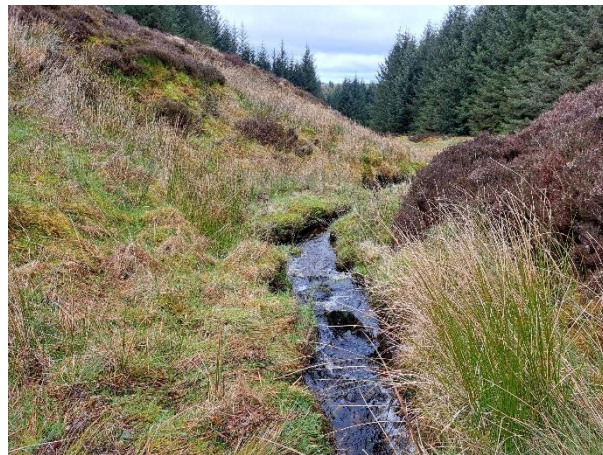
WX5 (252783, 606196)		
Crossing Location	Crossing Description	
<div>

<p>© Crown Copyright 2024. All rights reserved. Ordnance Survey Licence 0100031673.</p></div>	<div><ul style="list-style-type: none"><li>• <b>Existing Crossing:</b> No</li><li>• <b>Channel Type:</b> Meandering</li><li>• <b>Gradient:</b> Gentle</li><li>• <b>Valley form:</b> Shallow vee</li><li>• <b>Bank condition:</b> Stable</li><li>• <b>Bed material:</b> Rounded pebbles</li><li>• <b>Riparian corridor:</b> Moorland, Commercial Forestry</li><li>• <b>Flow condition:</b> Fast</li></ul><div><ul style="list-style-type: none"><li>• <b>Water width (m):</b> 0.5</li><li>• <b>Water depth (m):</b> 0.1</li><li>• <b>Bankfull width (m):</b> 0.7</li><li>• <b>Bankfull height (m):</b> 0.5</li><li>• <b>Banktop height (m):</b> 0.7</li><li>• <b>Flooded Bankfull width (m):</b> 0.7</li><li>• <b>Flooded Bankfull height:</b> 0.7</li></ul></div><p><b>Note:</b> None</p></div>

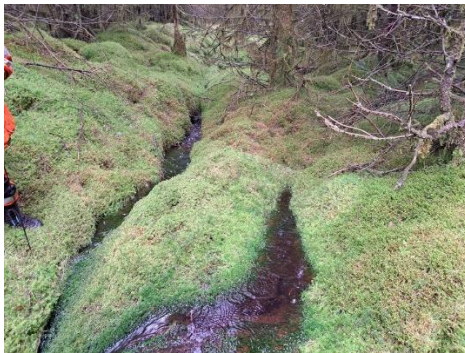
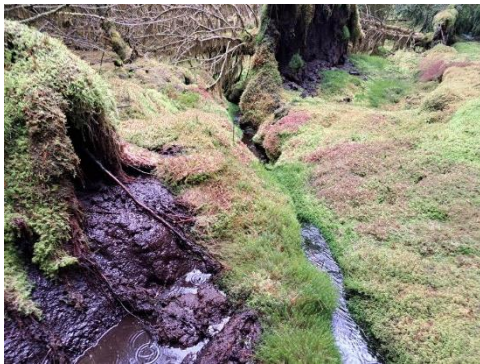
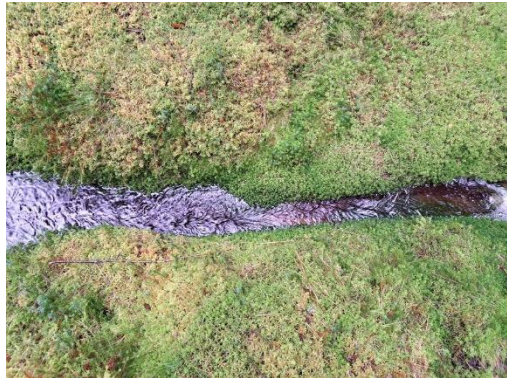
WX6 (253577, 605824)		
Crossing Location	Crossing Description	
<div>

</div> <p>© Crown Copyright 2024. All rights reserved. Ordnance Survey Licence 0100031673.</p>	<ul style="list-style-type: none"><li>• <b>Existing Crossing:</b> No</li><li>• <b>Channel Type:</b> Incised</li><li>• <b>Gradient:</b> Gentle</li><li>• <b>Valley form:</b> Shallow vee</li><li>• <b>Bank condition:</b> Stable</li><li>• <b>Bed material:</b> Vegetation, Soil</li><li>• <b>Riparian corridor:</b> Commercial Forestry</li><li>• <b>Flow condition:</b> Moderate</li></ul> <ul style="list-style-type: none"><li>• <b>Water width (m):</b> 0.3</li><li>• <b>Water depth (m):</b> 0.5</li><li>• <b>Bankfull width (m):</b> 0.4</li><li>• <b>Bankfull height (m):</b> 0.6</li><li>• <b>Banktop height (m):</b> 0.9</li><li>• <b>Flooded Bankfull width (m):</b> 1.1</li><li>• <b>Flooded Bankfull height:</b> 1.0</li></ul> <p><b>Note:</b> None</p>

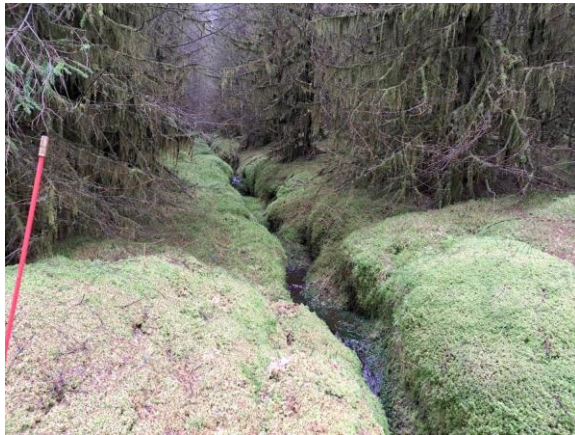
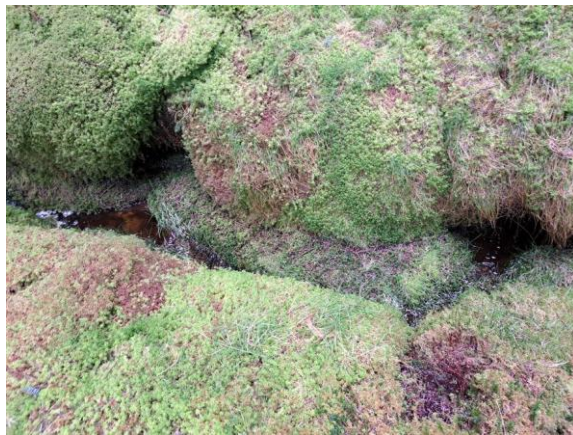
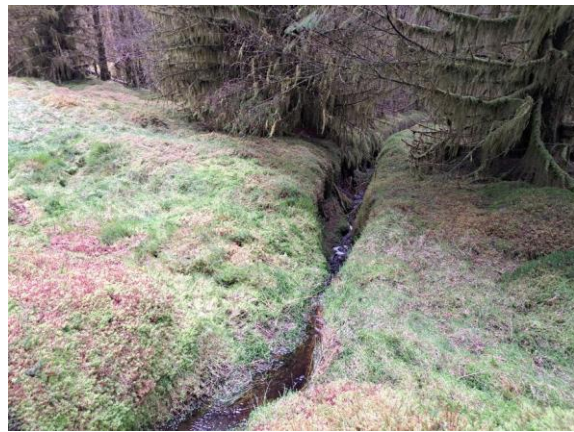
WX7 (253924, 605409)			
Crossing Location		Crossing Description	
<div>

<p>© Crown Copyright 2024. All rights reserved. Ordnance Survey Licence 0100031673.</p></div>		<div><ul style="list-style-type: none"><li>Existing Crossing: No</li><li>Channel Type: Incised</li><li>Gradient: Gentle</li><li>Valley form: Shallow vee</li><li>Bank condition: Stable</li><li>Bed material: Vegetation, Soil</li><li>Riparian corridor: Commercial Forestry</li><li>Flow condition: Moderate</li></ul></div> <div><ul style="list-style-type: none"><li>Water width (m): 0.4</li><li>Water depth (m): 0.4</li><li>Bankfull width (m): 0.7</li><li>Bankfull height (m): 1.0</li><li>Banktop height (m): 1.5</li><li>Flooded Bankfull width (m): 0.8</li><li>Flooded Bankfull height: 1.5</li></ul></div> <div><p>Note: None</p></div>	
Crossing Photographs			
Upstream	Across	Downstream

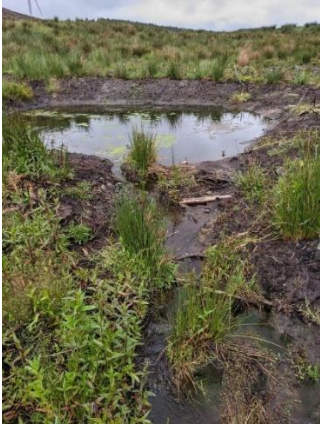
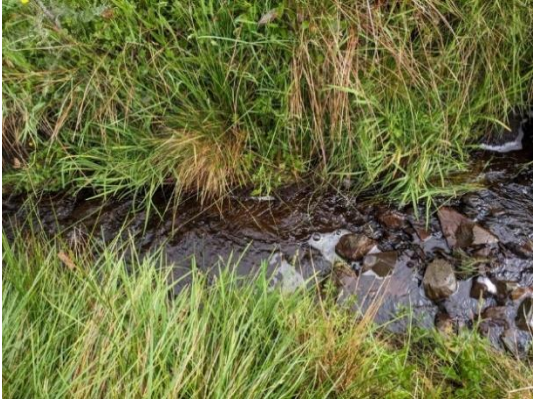
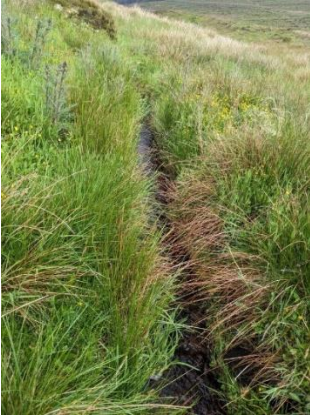
WX8 (255076, 606228)		
Crossing Photographs		
Upstream	Across	Downstream

<p>© Crown Copyright 2024. All rights reserved. Ordnance Survey Licence 0100031673.</p>	<ul style="list-style-type: none"><li>• <b>Existing Crossing:</b> Yes</li><li>• <b>Crossing Type (existing):</b> Circular Culvert</li><li>• <b>Crossing Material (existing):</b> Plastic</li><li>• <b>Crossing Condition (existing):</b> Good</li><li>• <b>Channel Type:</b> Poorly defined, Incised</li><li>• <b>Gradient:</b> Gentle</li><li>• <b>Valley form:</b> No obvious valley sides, Shallow vee</li><li>• <b>Bank condition:</b> Stable</li><li>• <b>Bed material:</b> Coarse gravel, Boulders, Rounded pebbles</li><li>• <b>Riparian corridor:</b> Moorland</li><li>• <b>Flow condition:</b> Moderate</li></ul>	
	<ul style="list-style-type: none"><li>• <b>Culvert Dimensions (m):</b> 0.8</li><li>• <b>Water width (m):</b> 0.5</li><li>• <b>Water depth (m):</b> 0.10</li><li>• <b>Bankfull width (m):</b> 0.7</li><li>• <b>Bankfull height (m):</b> 0.5</li><li>• <b>Flooded Bankfull width (m):</b> 1.5</li><li>• <b>Flooded Bankfull height:</b> 0.6-0.7</li></ul> <p><b>Note:</b> Kept in for consideration given proximity to existing track and at source of Nith location. This is a different culvert system, it has a landscaped feature of two pools and artificial channel above the upstream culvert, which is approximately 20m from the road and steep sided slope. It also has two watercourses entering the culvert, the other looks like a drainage ditch. The culvert doesn't cross the road perpendicularly but at an angle of 45 degrees, emerging on the downstream side approx. 50m from the upstream culvert. The downstream watercourse is more natural and dimensions and descriptions are from the downstream watercourse.</p>

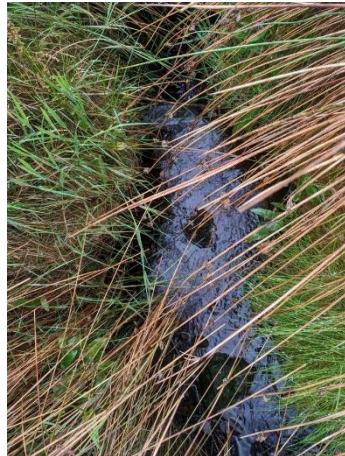
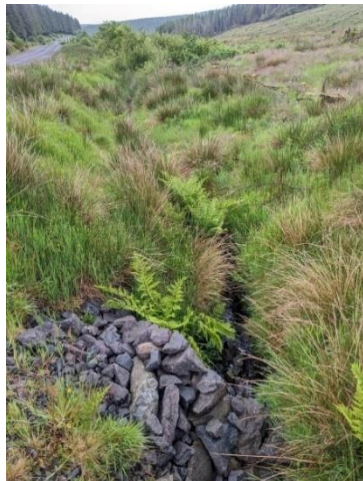
WX9 (254729, 606500)		
Crossing Location	Crossing Description

<p>© Crown Copyright 2024. All rights reserved. Ordnance Survey Licence 0100031673.</p>	<ul style="list-style-type: none"><li>• <b>Existing Crossing:</b> Yes</li><li>• <b>Crossing Type (existing):</b> Circular Culvert</li><li>• <b>Crossing Material (existing):</b> Plastic</li><li>• <b>Crossing Condition (existing):</b> Good</li><li>• <b>Channel Type:</b> Poorly defined</li><li>• <b>Gradient:</b> Moderate</li><li>• <b>Valley form:</b> Shallow vee</li><li>• <b>Bank condition:</b> Stable</li><li>• <b>Bed material:</b> Rounded pebbles, Coarse gravel, Boulders</li><li>• <b>Riparian corridor:</b> Commercial Forestry</li><li>• <b>Flow condition:</b> Moderate</li></ul> <ul style="list-style-type: none"><li>• <b>Culvert Dimensions (m):</b> 1.1</li><li>• <b>Water width (m):</b> 0.4</li><li>• <b>Water depth (m):</b> 0.1</li><li>• <b>Bankfull width (m):</b> 0.6</li><li>• <b>Bankfull height (m):</b> 0.7</li><li>• <b>Flooded Bankfull width (m):</b> 1.5</li><li>• <b>Flooded Bankfull height:</b> 0.8-1.0</li></ul> <p><b>Note:</b> The upstream culvert has another 'culvert pipe' diverting the roadside drainage ditch water flow over this culvert and continues draining on the other side of the culvert (see photo).</p>

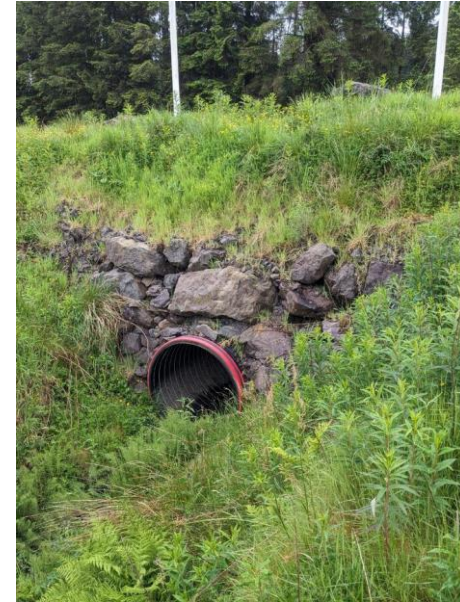
Culvert view (downstream of crossing)

WX10 (254547, 606804)		
Crossing Location	Crossing Description	
  <p>© Crown Copyright 2024. All rights reserved. Ordnance Survey Licence 0100031673.</p>	<ul style="list-style-type: none"><li>• <b>Existing Crossing:</b> Yes</li><li>• <b>Crossing Type (existing):</b> Circular Culvert</li><li>• <b>Crossing Material (existing):</b> Plastic</li><li>• <b>Crossing Condition (existing):</b> Good</li><li>• <b>Channel Type:</b> Incised</li><li>• <b>Gradient:</b> Moderate</li><li>• <b>Valley form:</b> Shallow vee</li><li>• <b>Bank condition:</b> Stable</li><li>• <b>Bed material:</b> Coarse gravel, Boulders</li><li>• <b>Riparian corridor:</b> Commercial Forestry</li><li>• <b>Flow condition:</b> Moderate</li><li>• <b>Culvert Dimensions (m):</b> 1.2</li><li>• <b>Water width (m):</b> 0.3</li><li>• <b>Water depth (m):</b> 0.1</li><li>• <b>Bankfull width (m):</b> 0.5</li><li>• <b>Bankfull height (m):</b> 0.35</li><li>• <b>Flooded Bankfull width (m):</b> 1.5-2.0</li><li>• <b>Flooded Bankfull height:</b> 0.8</li></ul> <p><b>Note:</b> Upstream gradient steeper than downstream. Downstream has incised valley.</p>

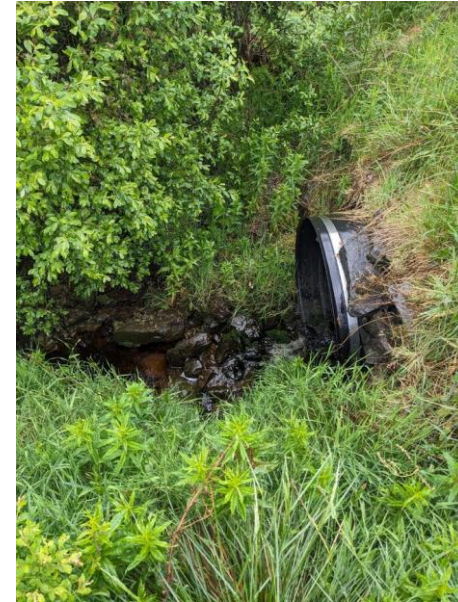
Culvert view (downstream of crossing)

- Existing Crossing: Yes
- Crossing Type (existing): Circular Culvert
- Crossing Material (existing): Plastic
- Crossing Condition (existing):
- Channel Type: Incised
- Gradient: Moderate
- Valley form: Shallow vee
- Bank condition: Stable
- Bed material: Fine sand/silt, Rounded pebbles, Coarse gravel, Boulders
- Riparian corridor: Commercial Forestry
- Flow condition: Moderate
- Culvert Dimensions (m): 1.0
- Water width (m): 0.3
- Water depth (m): 0.15
- Bankfull width (m): 0.4
- Bankfull height (m): 0.35
- Flooded Bankfull width (m): 0.5-0.7
- Flooded Bankfull height: 0.6

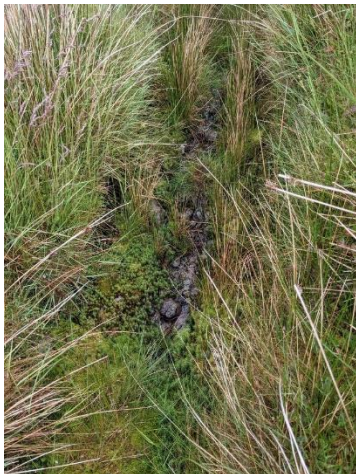
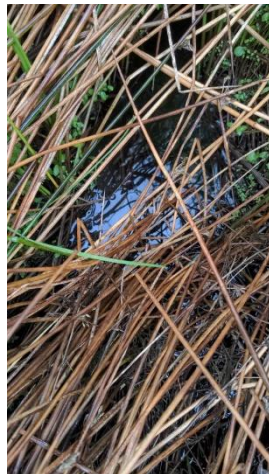
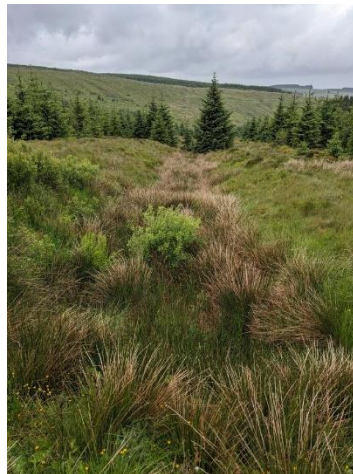
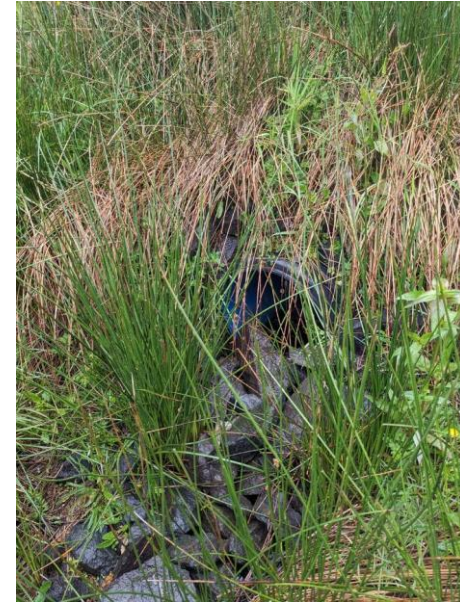
WX12 (253935, 607440)			
Crossing Location		Crossing Description	
<div>

<p>© Crown Copyright 2024. All rights reserved. Ordnance Survey Licence 0100031673.</p></div>		<ul style="list-style-type: none"><li>• <b>Existing Crossing:</b> Yes</li><li>• <b>Crossing Type (existing):</b> Circular Culvert</li><li>• <b>Crossing Material (existing):</b> Plastic</li><li>• <b>Crossing Condition (existing):</b> Good</li><li>• <b>Channel Type:</b> Incised, Artificial drainage channel, Artificially modified watercourse</li><li>• <b>Gradient:</b> Moderate</li><li>• <b>Valley form:</b> Shallow vee</li><li>• <b>Bank condition:</b> Stable</li><li>• <b>Bed material:</b> Coarse gravel, Boulders</li><li>• <b>Riparian corridor:</b></li><li>• <b>Flow condition:</b></li></ul> <ul style="list-style-type: none"><li>• <b>Water width (m):</b> 0.2</li><li>• <b>Water depth (m):</b> 0.1</li><li>• <b>Bankfull width (m):</b> 0.4</li><li>• <b>Bankfull height (m):</b> 0.3</li><li>• <b>Flooded Bankfull width (m):</b> 1.0</li><li>• <b>Flooded Bankfull height:</b> 0.5</li></ul> <p><b>Note:</b> Water channel upstream was dry. Watercourse downstream was almost dry (must be water draining into from roadside), but it has signs of erosion, so water has been present.</p>

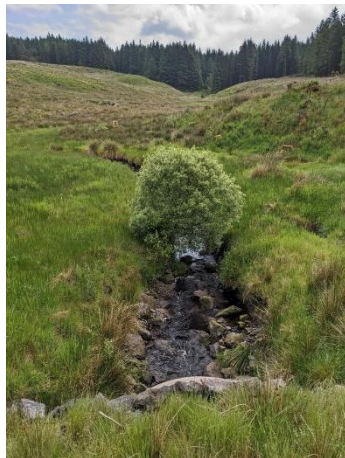
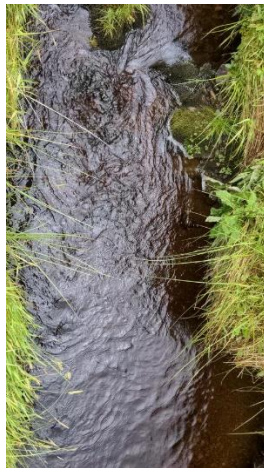
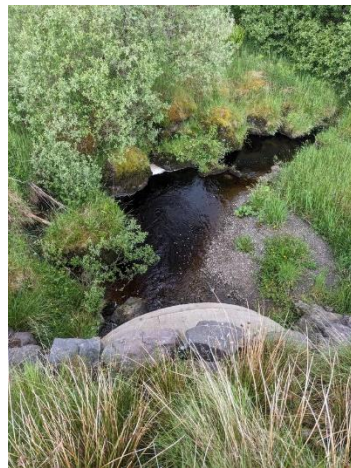
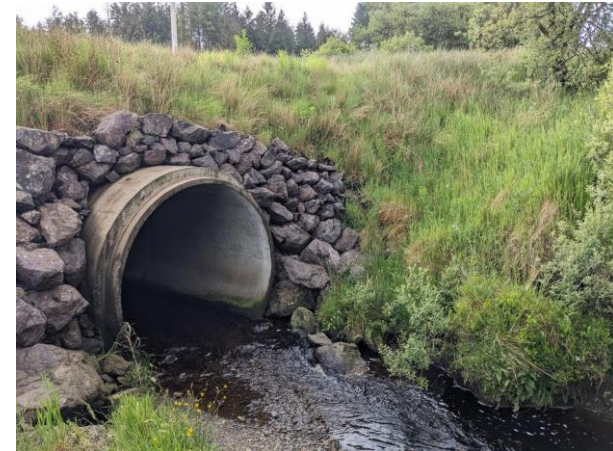
WX13 (253463, 607065)		
Crossing Location	Crossing Description

<p>© Crown Copyright 2024. All rights reserved. Ordnance Survey Licence 0100031673.</p>	<ul style="list-style-type: none"><li>• <b>Existing Crossing:</b> Yes</li><li>• <b>Crossing Type (existing):</b> Circular Culvert</li><li>• <b>Crossing Material (existing):</b> Concrete</li><li>• <b>Crossing Condition (existing):</b> Excellent</li><li>• <b>Channel Type:</b> Incised</li><li>• <b>Gradient:</b> Moderate</li><li>• <b>Valley form:</b> Shallow vee</li><li>• <b>Bank condition:</b> Stable</li><li>• <b>Bed material:</b> Fine sand/silt, Rounded pebbles, Coarse gravel, Boulders</li><li>• <b>Riparian corridor:</b> Commercial Forestry</li><li>• <b>Flow condition:</b> Moderate</li></ul> <ul style="list-style-type: none"><li>• <b>Culvert Dimensions (m):</b> 2.2</li><li>• <b>Water width (m):</b> 1.0</li><li>• <b>Water depth (m):</b> 0.3</li><li>• <b>Bankfull width (m):</b> 1.5</li><li>• <b>Bankfull height (m):</b> 0.9</li><li>• <b>Flooded Bankfull width (m):</b> 1.5-2.0</li><li>• <b>Flooded Bankfull height:</b> 0.9-1.0</li></ul> <p><b>Note:</b> None</p>

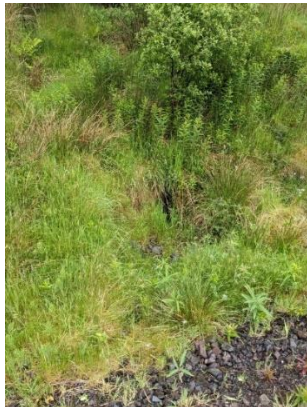
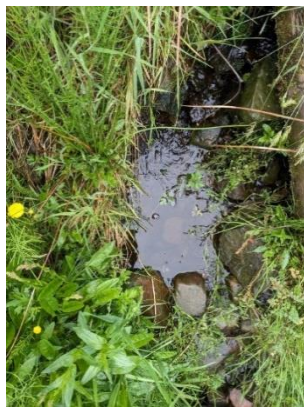
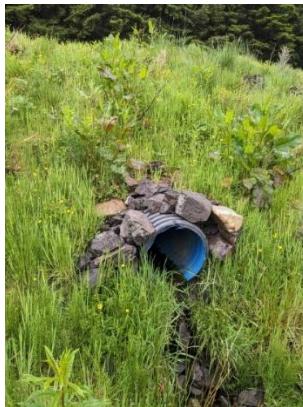
WX16 (254478, 606927)		
Crossing Location	Crossing Description

<p>© Crown Copyright 2024. All rights reserved. Ordnance Survey Licence 0100031673.</p>	<ul style="list-style-type: none"><li>Existing Crossing: Yes</li><li>Crossing Type (existing): Circular Culvert</li><li>Crossing Material (existing): Plastic</li><li>Crossing Condition (existing): Average</li><li>Channel Type: Poorly defined, Incised</li><li>Gradient: Moderate</li><li>Valley form: Shallow vee</li><li>Bank condition: Stable</li><li>Bed material: Coarse gravel, Boulders</li><li>Riparian corridor: Commercial Forestry</li><li>Flow condition: Moderate</li></ul> <ul style="list-style-type: none"><li>Culvert Dimensions (m): 0.45</li><li>Water width (m): 0.2</li><li>Water depth (m): 0.07</li><li>Bankfull width (m): 0.5</li><li>Bankfull height (m): 0.26</li><li>Flooded Bankfull width (m): 1.0</li><li>Flooded Bankfull height: 0.5</li></ul> <p>Note: None.</p>

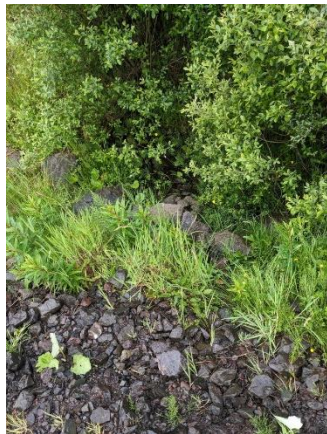
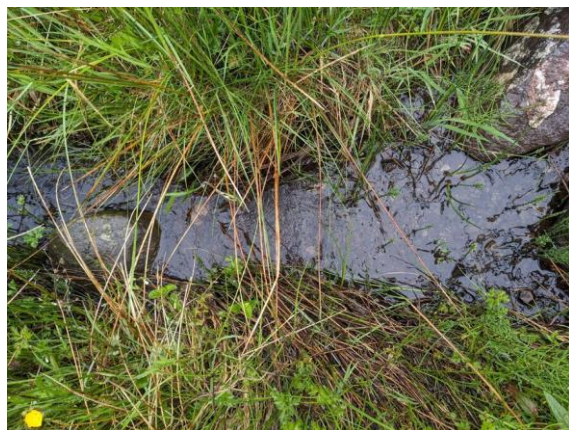
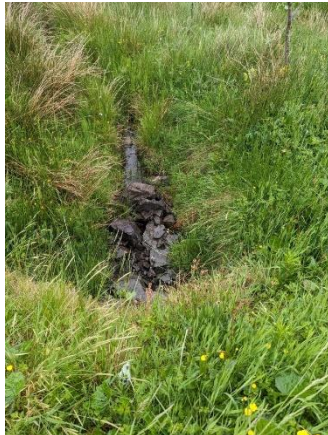
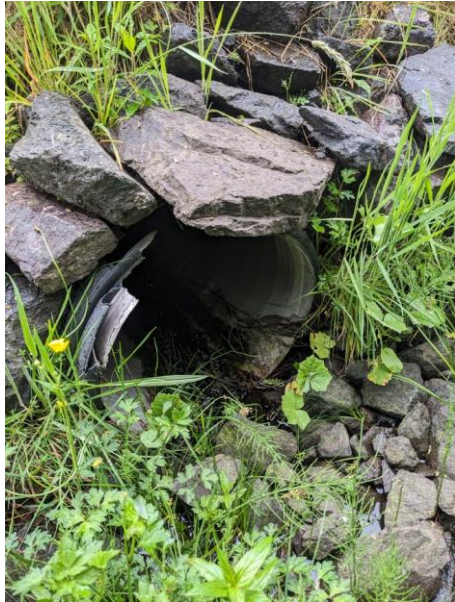
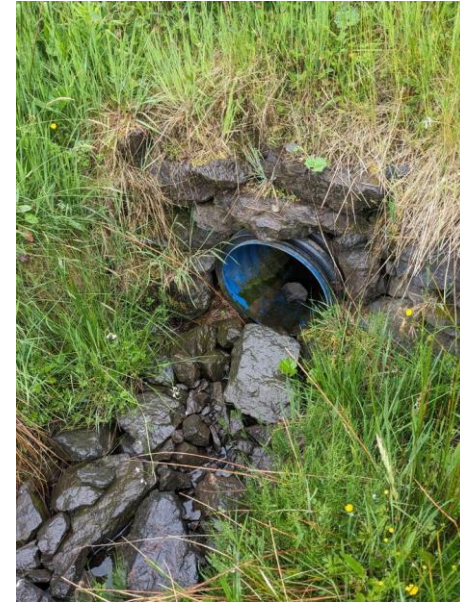
WX17 (254391, 607172)			
Crossing Location		Crossing Description	
<div>

<p>© Crown Copyright 2024. All rights reserved. Ordnance Survey Licence 0100031673.</p></div>		<div><ul style="list-style-type: none"><li>• <b>Existing Crossing:</b> Yes</li><li>• <b>Crossing Type (existing):</b> Circular Culvert</li><li>• <b>Crossing Material (existing):</b> Plastic</li><li>• <b>Crossing Condition (existing):</b> Average</li><li>• <b>Channel Type:</b> Poorly defined, Incised</li><li>• <b>Gradient:</b> Moderate</li><li>• <b>Valley form:</b> Shallow vee</li><li>• <b>Bank condition:</b> Stable</li><li>• <b>Bed material:</b> Coarse gravel, Boulders</li><li>• <b>Riparian corridor:</b> Commercial Forestry</li><li>• <b>Flow condition:</b> Slow</li></ul><div><b>Note:</b> None</div></div>	
Crossing Photographs			
Upstream	Across	Downstream

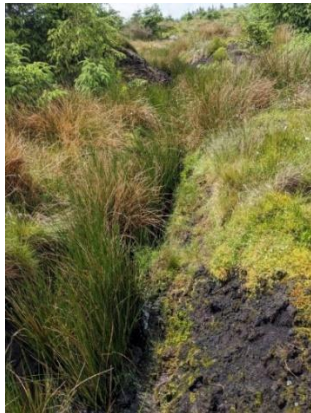
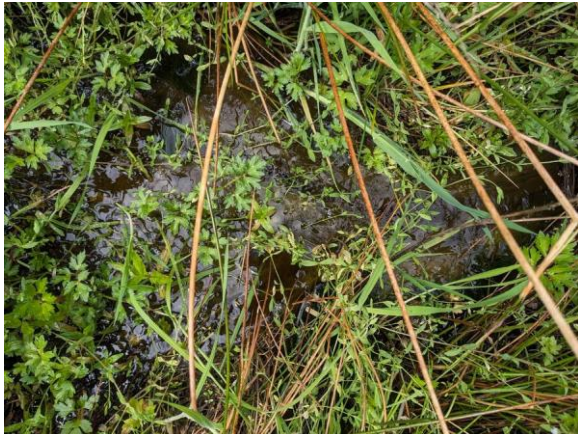
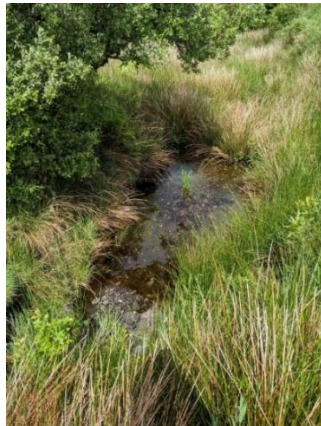
WX18 (253852, 607414)		
Crossing Location	Crossing Description	
<div>

<p>© Crown Copyright 2024. All rights reserved. Ordnance Survey Licence 0100031673.</p></div>	<ul style="list-style-type: none"><li>• <b>Existing Crossing:</b> Yes</li><li>• <b>Crossing Type (existing):</b> Circular Culvert</li><li>• <b>Crossing Material (existing):</b> Plastic</li><li>• <b>Crossing Condition (existing):</b> Good</li><li>• <b>Channel Type:</b> None evident, Poorly defined</li><li>• <b>Gradient:</b> Gentle</li><li>• <b>Valley form:</b> No obvious valley sides</li><li>• <b>Bank condition:</b> Stable</li><li>• <b>Bed material:</b> Vegetation, Peat</li><li>• <b>Riparian corridor:</b> Commercial Forestry</li><li>• <b>Flow condition:</b> Slow</li></ul> <ul style="list-style-type: none"><li>• <b>Culvert Dimensions (m):</b> 0.5</li><li>• <b>Water width (m):</b> 0.2</li><li>• <b>Water depth (m):</b> 0.05</li><li>• <b>Bankfull width (m):</b> 0.5</li><li>• <b>Bankfull height (m):</b> 0.15</li><li>• <b>Flooded Bankfull width (m):</b> 1-3</li><li>• <b>Flooded Bankfull height:</b> 0.5</li></ul> <p><b>Note:</b> Upstream from culvert is artificial drainage channel. Downstream the water is ponding with a small watercourse flowing from it.</p>

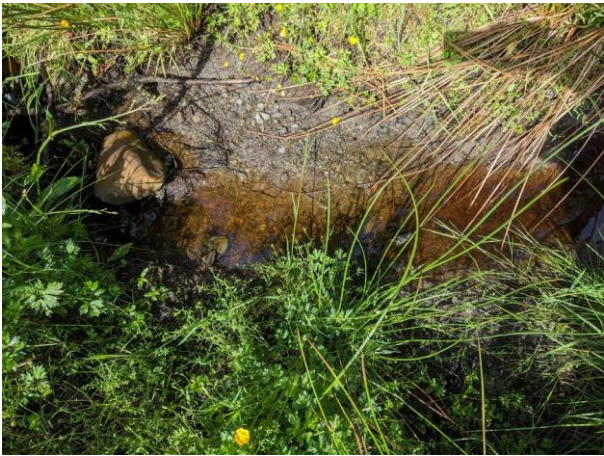
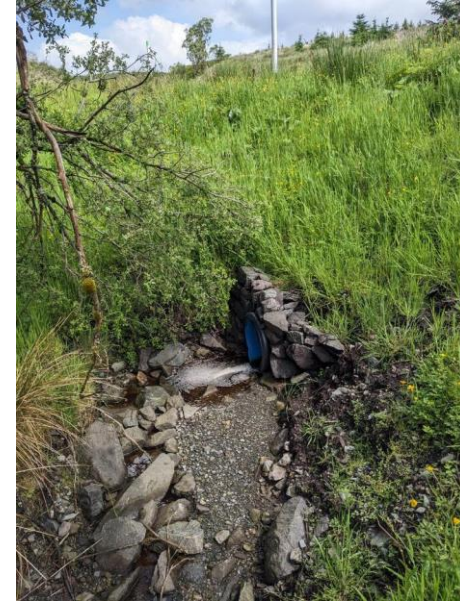
WX19 (253672, 607259)

- **Existing Crossing:** Yes
  - **Crossing Type (existing):** Circular Culvert
  - **Crossing Material (existing):** Plastic
  - **Crossing Condition (existing):** Good
  - **Channel Type:** Incised
  - **Gradient:** Moderate
  - **Valley form:** Shallow vee
  - **Bank condition:** Stable
  - **Bed material:** Fine sand/silt, Rounded pebbles, Coarse gravel, Boulders, Peat
  - **Riparian corridor:** Commercial Forestry
  - **Flow condition:** Slow
- **Culvert Dimensions (m):** 0.45
  - **Water width (m):** 0.4
  - **Water depth (m):** 0.06
  - **Bankfull width (m):** 1.0
  - **Bankfull height (m):** 0.35
  - **Flooded Bankfull width (m):** 2.0
  - **Flooded Bankfull height:** 0.5
