CLASHINDARROCH II

WIND FARM

Peat Assessment

Technical Appendix 11.1

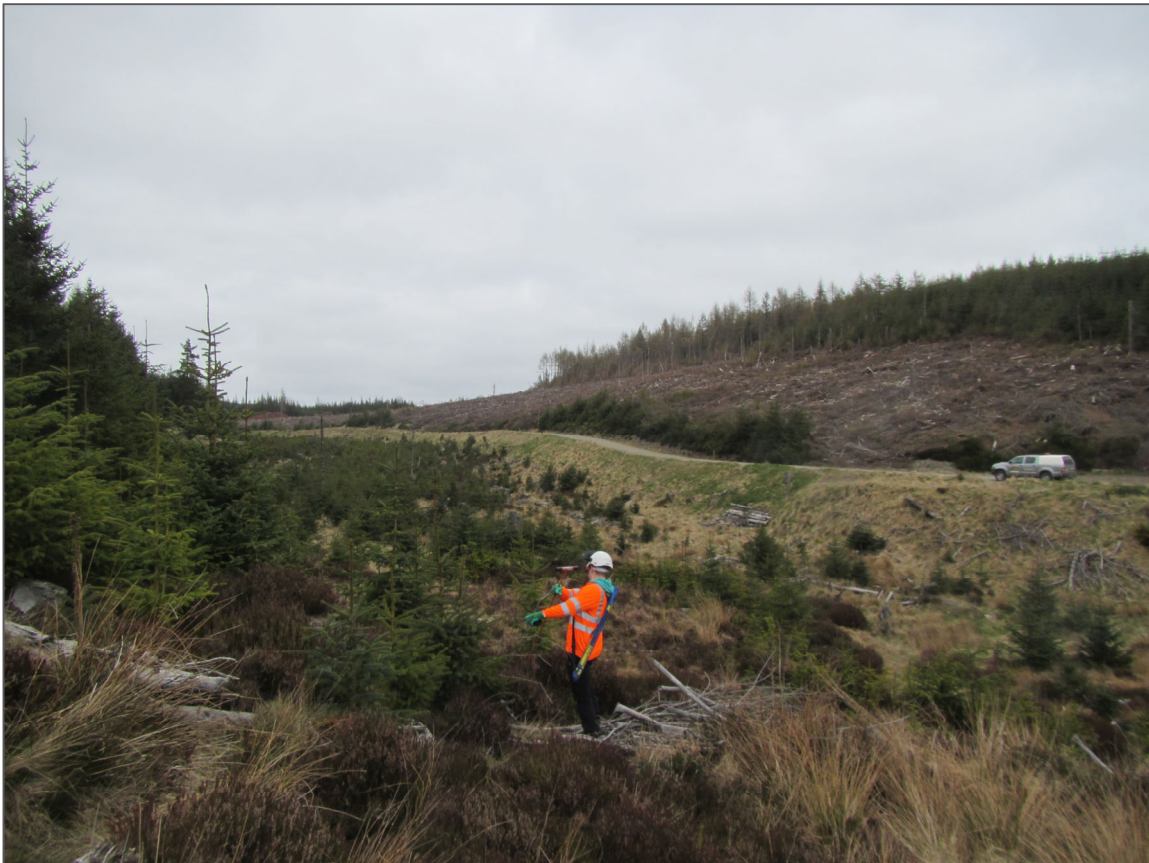
Photograph 1.1
General View of Ground Conditions near Turbine 10 (T10) (NGR 251290, 611747)

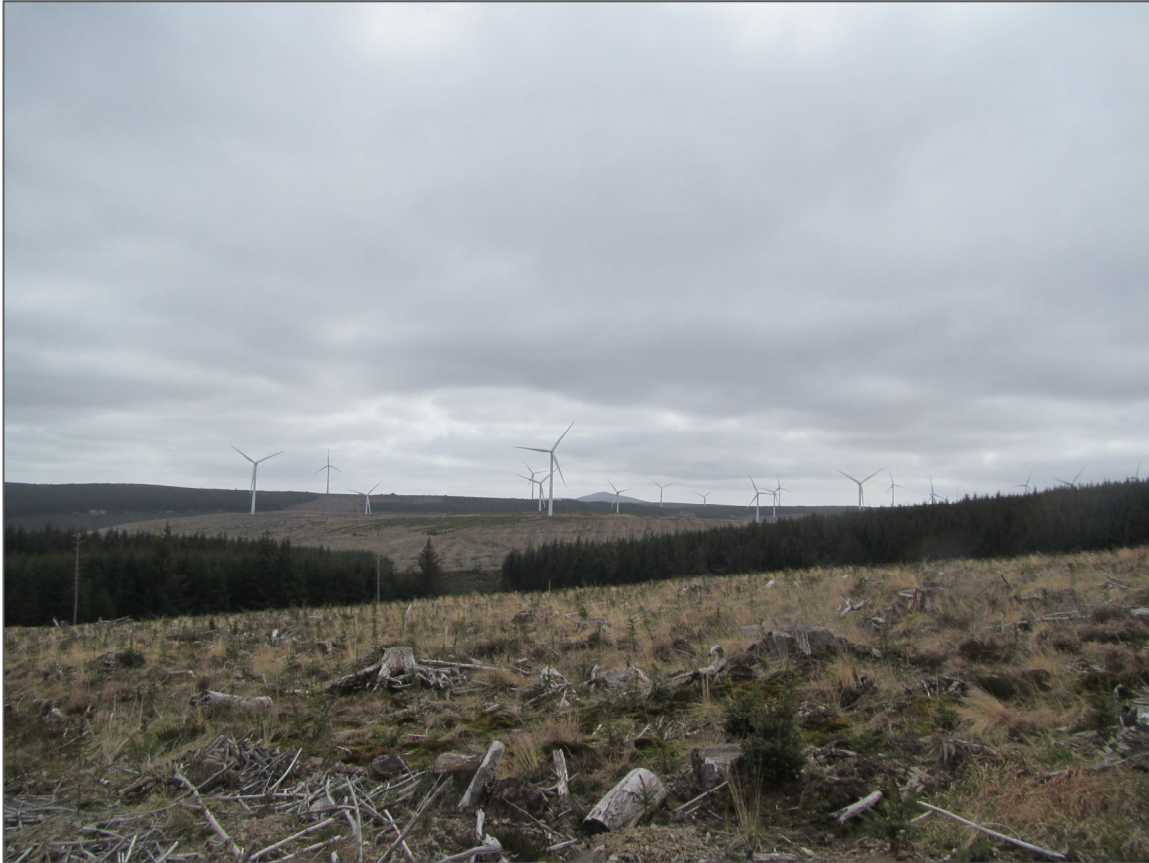
Photograph 1.2
General View of Ground Conditions Looking Towards Clashindarroch Wind Farm
(NGR 251290, 611747)

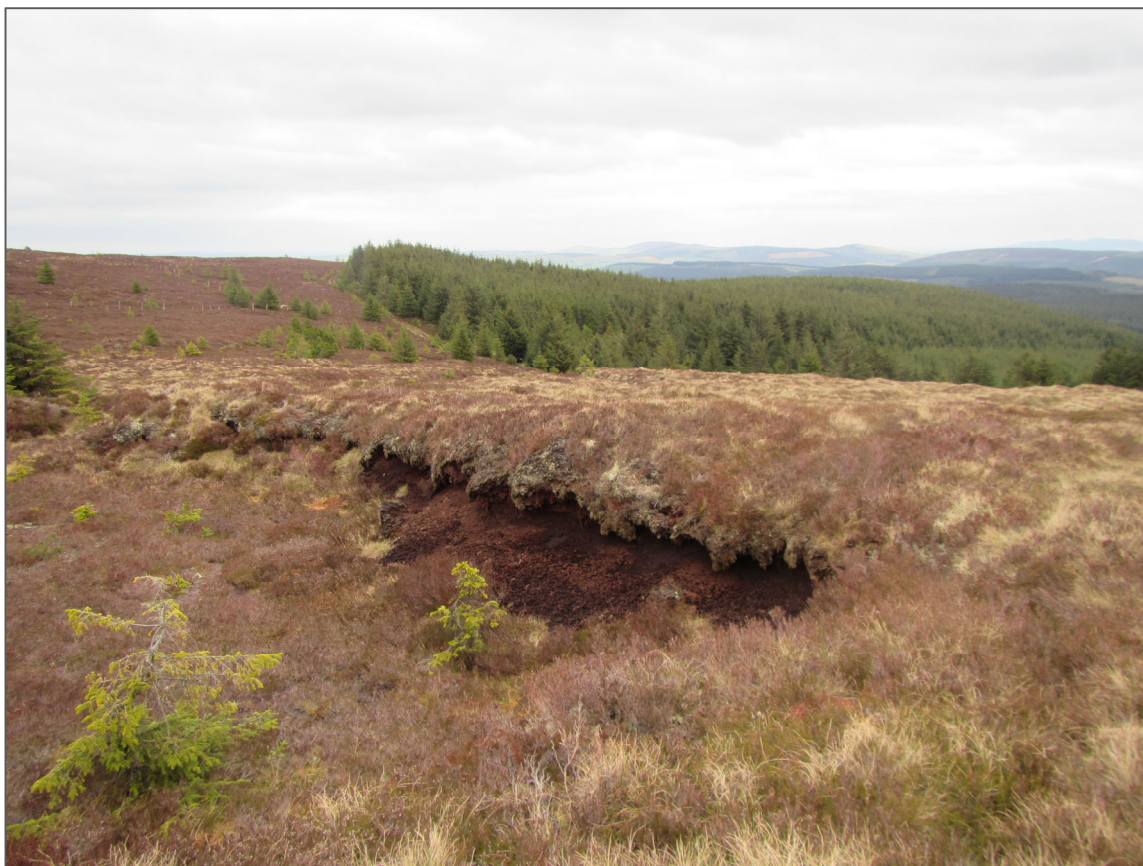
Photograph 4.3
Haggy Peat Deposits (NGR 251636, 611971)

- 85 The results of the probing survey are detailed within Figure 4 – Peat Depth Plan, with a summary of peat depths included within Table 4-1 below.
- 86 The peat was found to be very limited across the site in terms of thickness and coverage. The majority of probes (approximately 95%) identified peaty soils (<0.5m). Peat deposits are present to the western edge of the site boundary extending across a flat expanse, northwards from the summit of Red Hill, reaching thicknesses of 1.9m. This area of peat comprises haggy deposits, shown in Photograph 4.3. This area is very localised and outside of the proposed development area, and as such it has been discounted from the assessment as it is not in the development footprint and could not impact upon the proposed development.

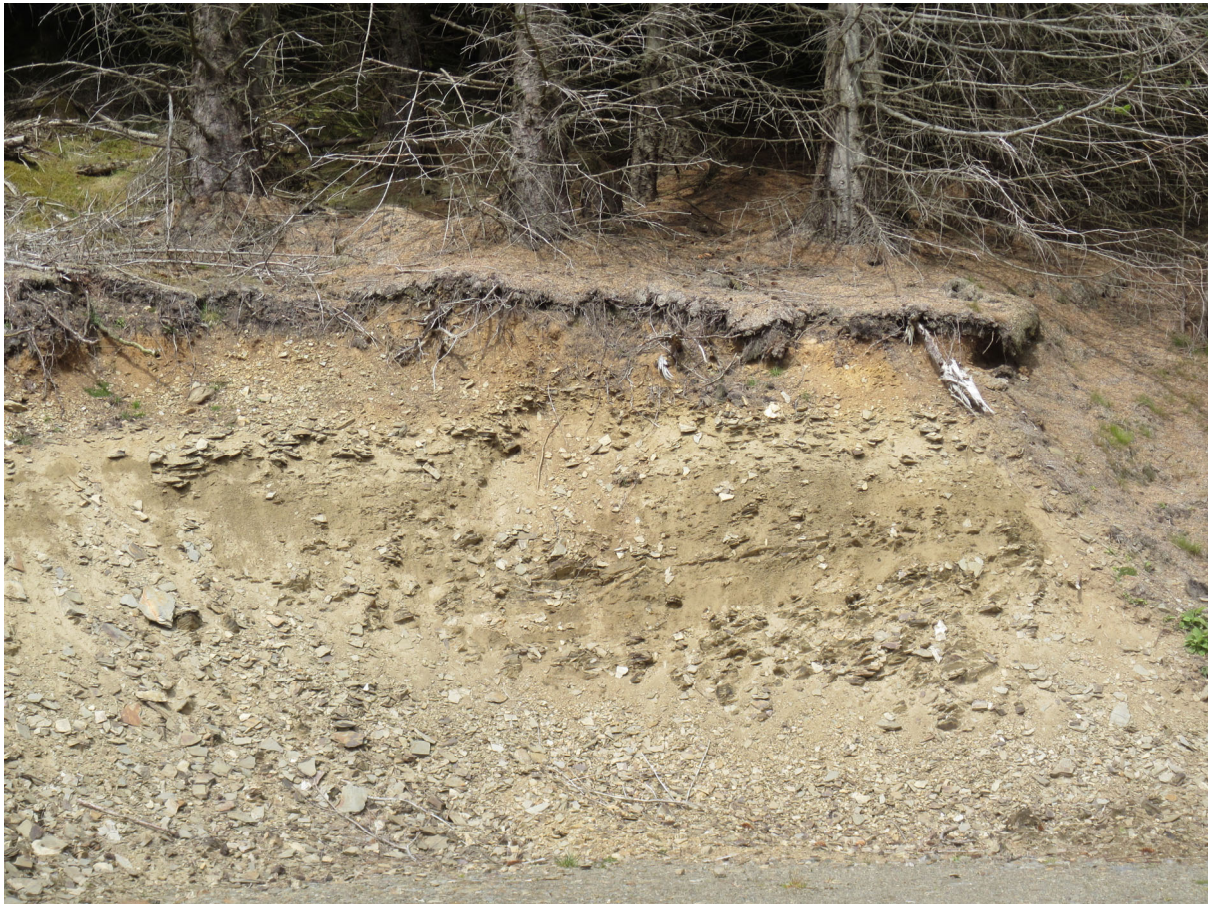
Photograph 4.4
Peat Overlying Glacial Soils (NGR 251607, 612845)

91 The assessment of the underlying substrate from the probing data was interpreted as predominately glacial soils and weathered bedrock. A typical stratigraphic section is shown in Photograph 1.4.
