Technical Appraisal 10.5: Borrow Pit Appraisal

Aultmore Wind Farm Redesign

Vattenfall Wind Power Ltd.

1 December 2023

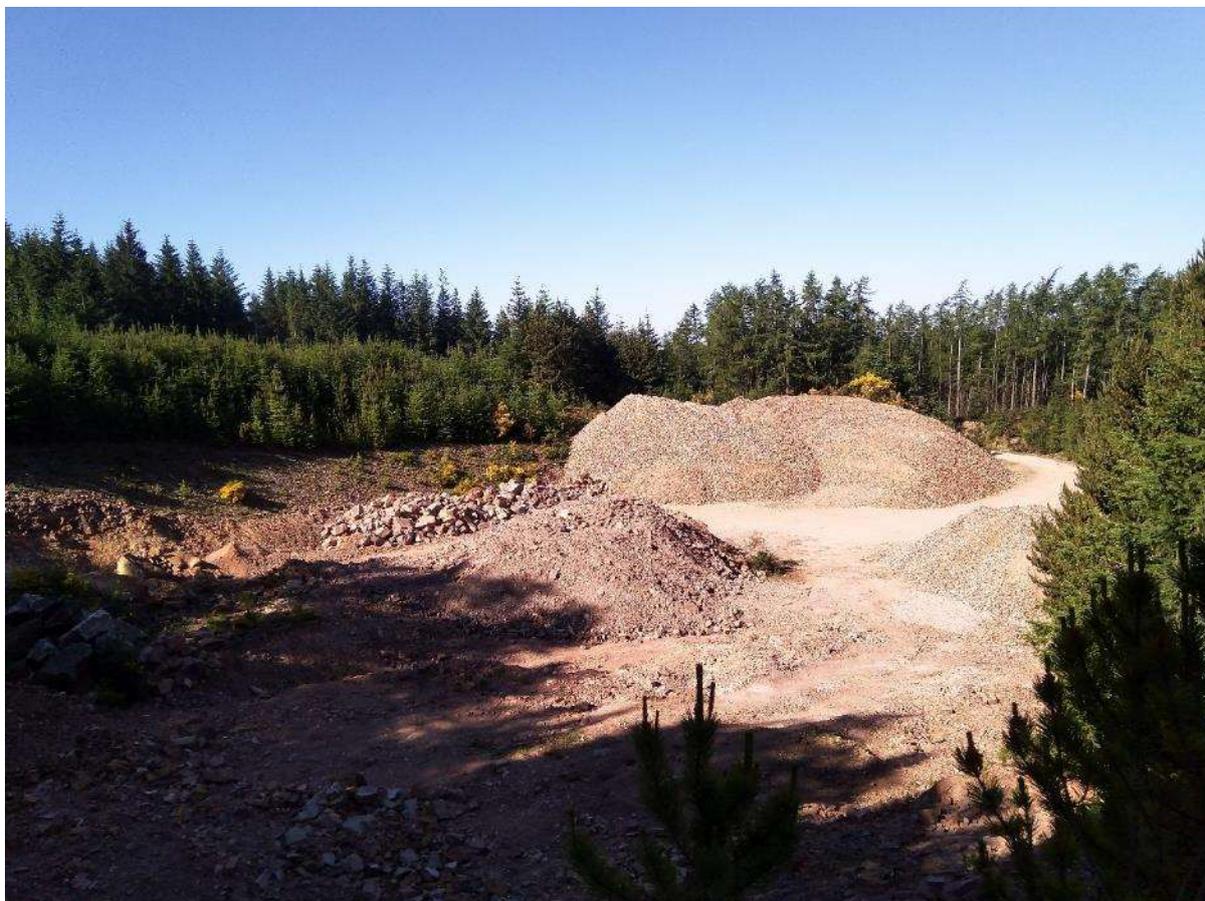
Photo 1: View looking south from NGR 341986, 858697 showing BP1

Borrow Pit 1 (BP1) is proposed in the northwest of the proposed development and forms part of an existing active borrow pit, at approximately NGR 341910 858600, shown on **Figure 10.5.1** with further details in **Table B**.

Borrow Pit 1	
Excavation Area	Approximately 50,000m ²
Height of Excavation	Approximately 10m
Gradient	Slope increasing steeply towards the east
Details of Likely Extraction	Combination of digging, drilling and blasting
Likely Overburden Type and Depth	Bedrock at or near surface. Minimal superficial coverage with an average thickness of approximately 0.1m
Extent of Aggregate Extraction	Approximately 38,714m ³
Aggregate Composition	Findlater Flag Formation – Psammite and Semipelite Findlater Flag Formation – Quartzite (north eastern edge only)

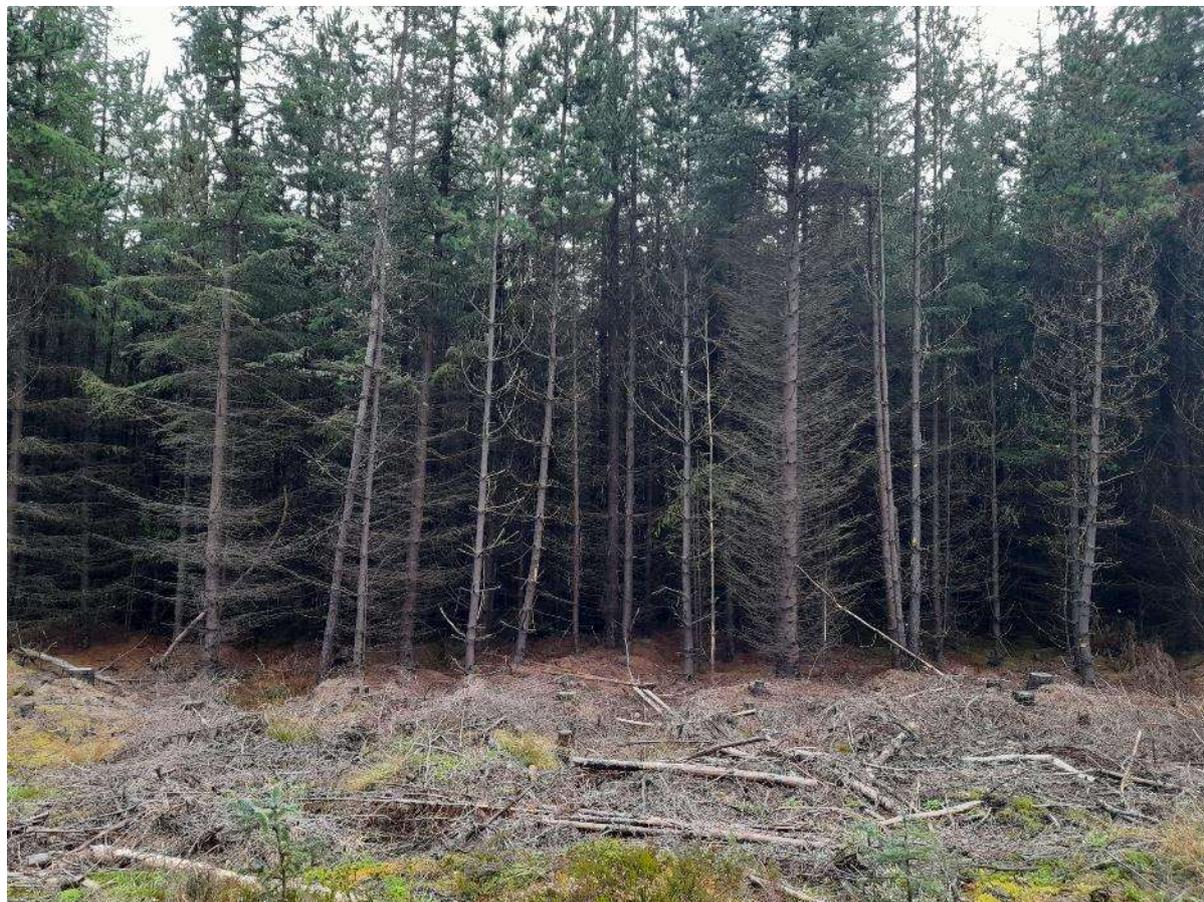
Photo 2: View looking north from NGR 343234, 858098 showing BP2

Borrow Pit 2 (BP2) is proposed in the centre of the proposed development, at approximately NGR 343219, 858135, shown on **Figure 10.5.1** with further details in **Table C**.

Borrow Pit 2	
Excavation Area	Approximately 18,000m ²
Height of Excavation	Approximately 12.5m
Gradient	Slope increasing steeply towards the north
Details of Likely Extraction	Combination of digging, drilling and blasting
Likely Overburden Type and Depth	Glacial till with an average thickness of approximately 0.5m.
Extent of Aggregate Extraction	Approximately 80,200m ³
Aggregate Composition	Findlater Flag Formation – Psammite and Semipelite

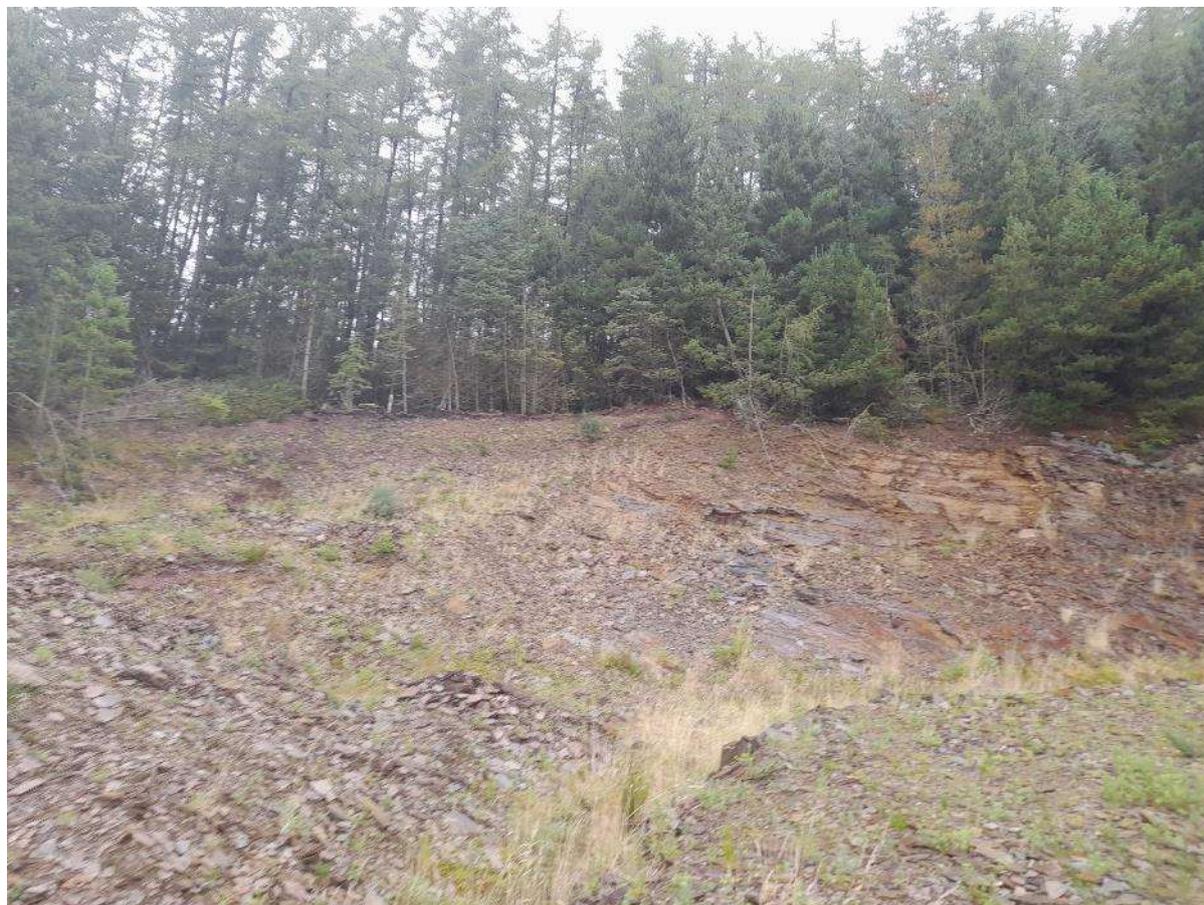
Photo 3: View looking north from NGR 347288, 857237 showing BP3

Borrow Pit 3 (BP3) is proposed in the southeast of the proposed development and forms part of a historic borrow pit, at approximately NGR 347294, 857241, shown on **Figure 10.5.1** with further details in **Table D**.

Borrow Pit 3	
Excavation Area	Approximately 5,700m ²
Height of Excavation	Approximately 7.5m
Gradient	Slope increasing steeply towards the north
Details of Likely Extraction	Combination of digging, drilling and blasting
Likely Overburden Type and Depth	Bedrock at or near surface. Minimal superficial coverage with an average thickness of approximately 0.1m
Extent of Aggregate Extraction	Approximately 16,875m ³
Aggregate Composition	Findlater Flag Formation –Semipelite

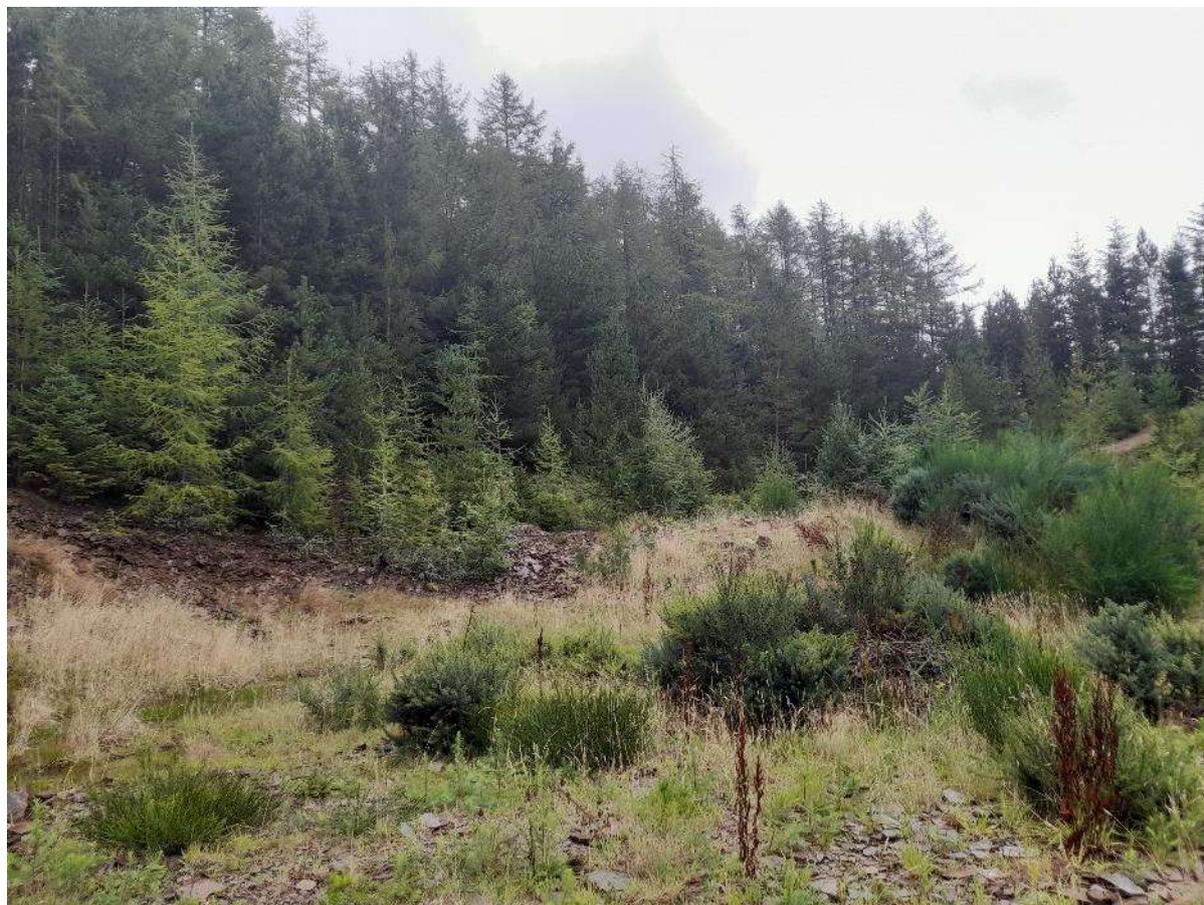
Photo 4: View looking east from NGR 347039, 860315 showing BP4

Borrow Pit 4 (BP4) is proposed in the northeast of the proposed development and forms part of a historic borrow pit, at approximately NGR 347044, 860225, shown on **Figure 10.5.1** with further details in **Table E**.

Borrow Pit 4	
Excavation Area	Approximately 22,000m ²
Height of Excavation	Approximately 10m
Gradient	Slope increasing steeply towards the east
Details of Likely Extraction	Combination of digging, drilling and blasting
Likely Overburden Type and Depth	Bedrock at or near surface. Minimal superficial coverage with an average thickness of approximately 0.1m
Extent of Aggregate Extraction	Approximately 53,500m ³
Aggregate Composition	Findlater Flag Formation –Psammite and Semipelite

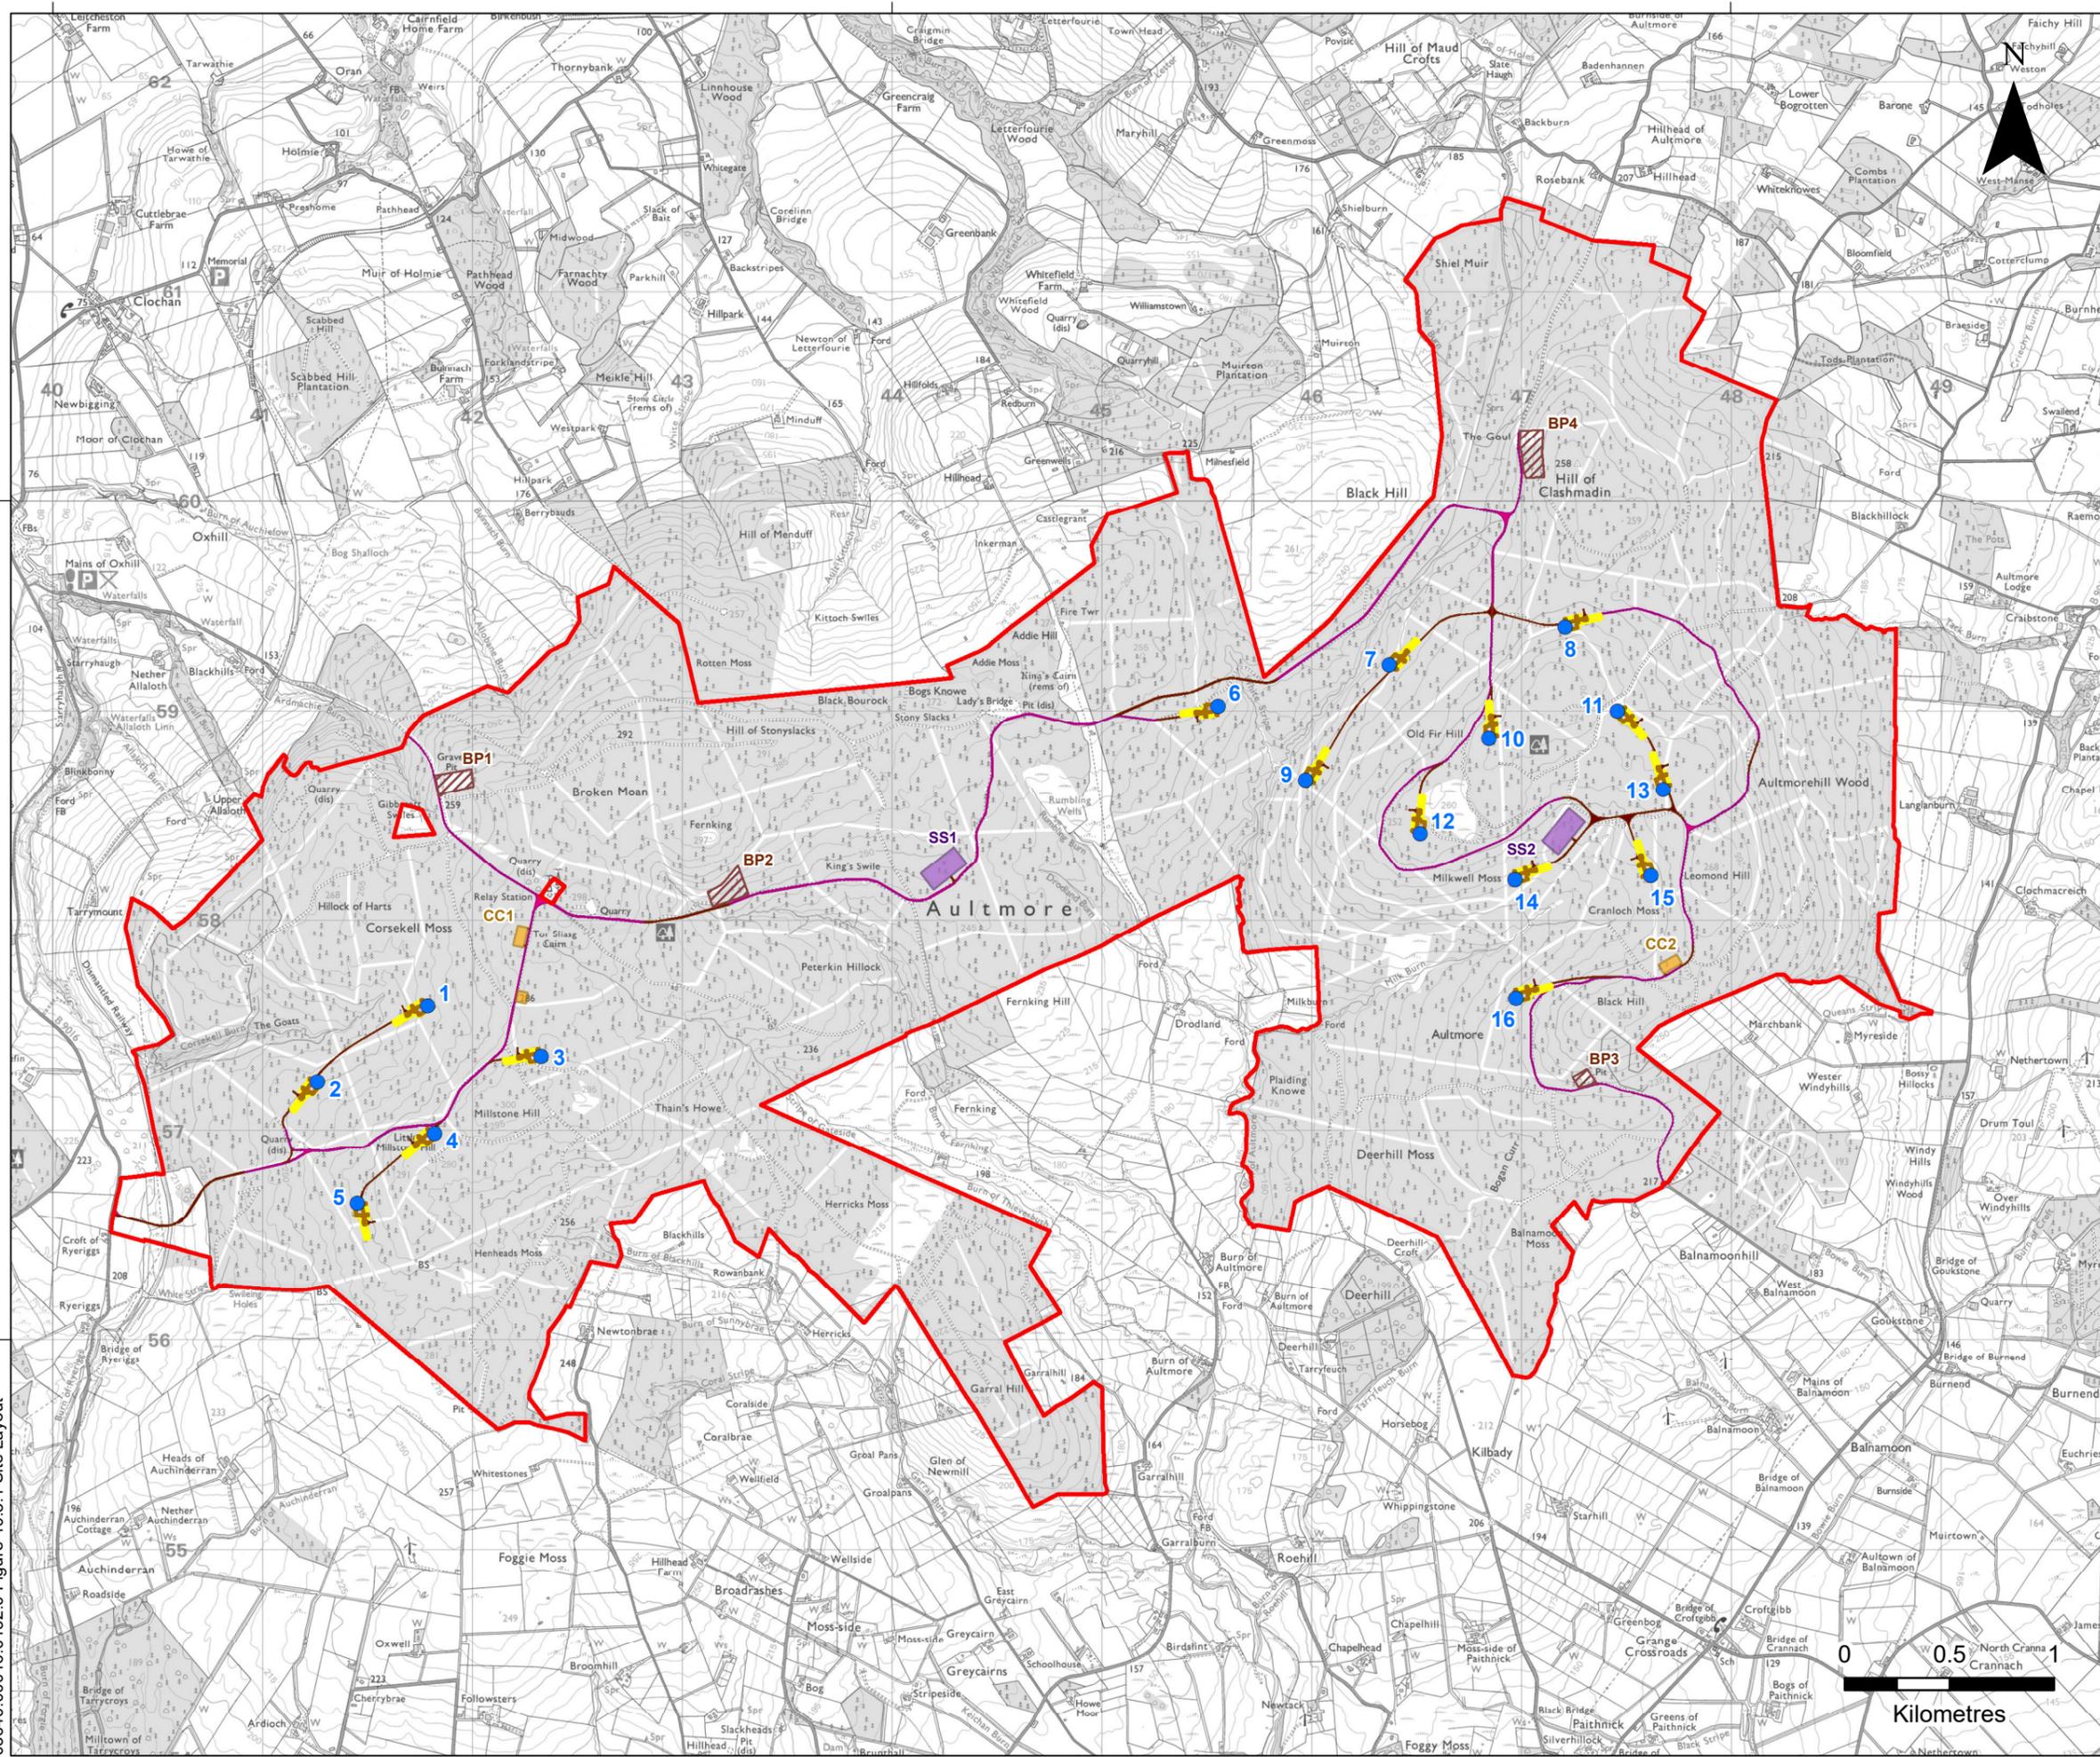
FIGURE 10.5.1

SITE LAYOUT

In exploring the four potential borrow pit locations, as defined on **Figure 10.5.1**, consideration has been given to the practical aspects of each borrow pit. The main aspects to consider are as follows:

A total of four search areas were selected as possible borrow pit locations, shown on **Figure 10.5.1**. Each location is reviewed in the sections below. Potential search areas have been highlighted with indicative excavation areas identified at each borrow pit location.

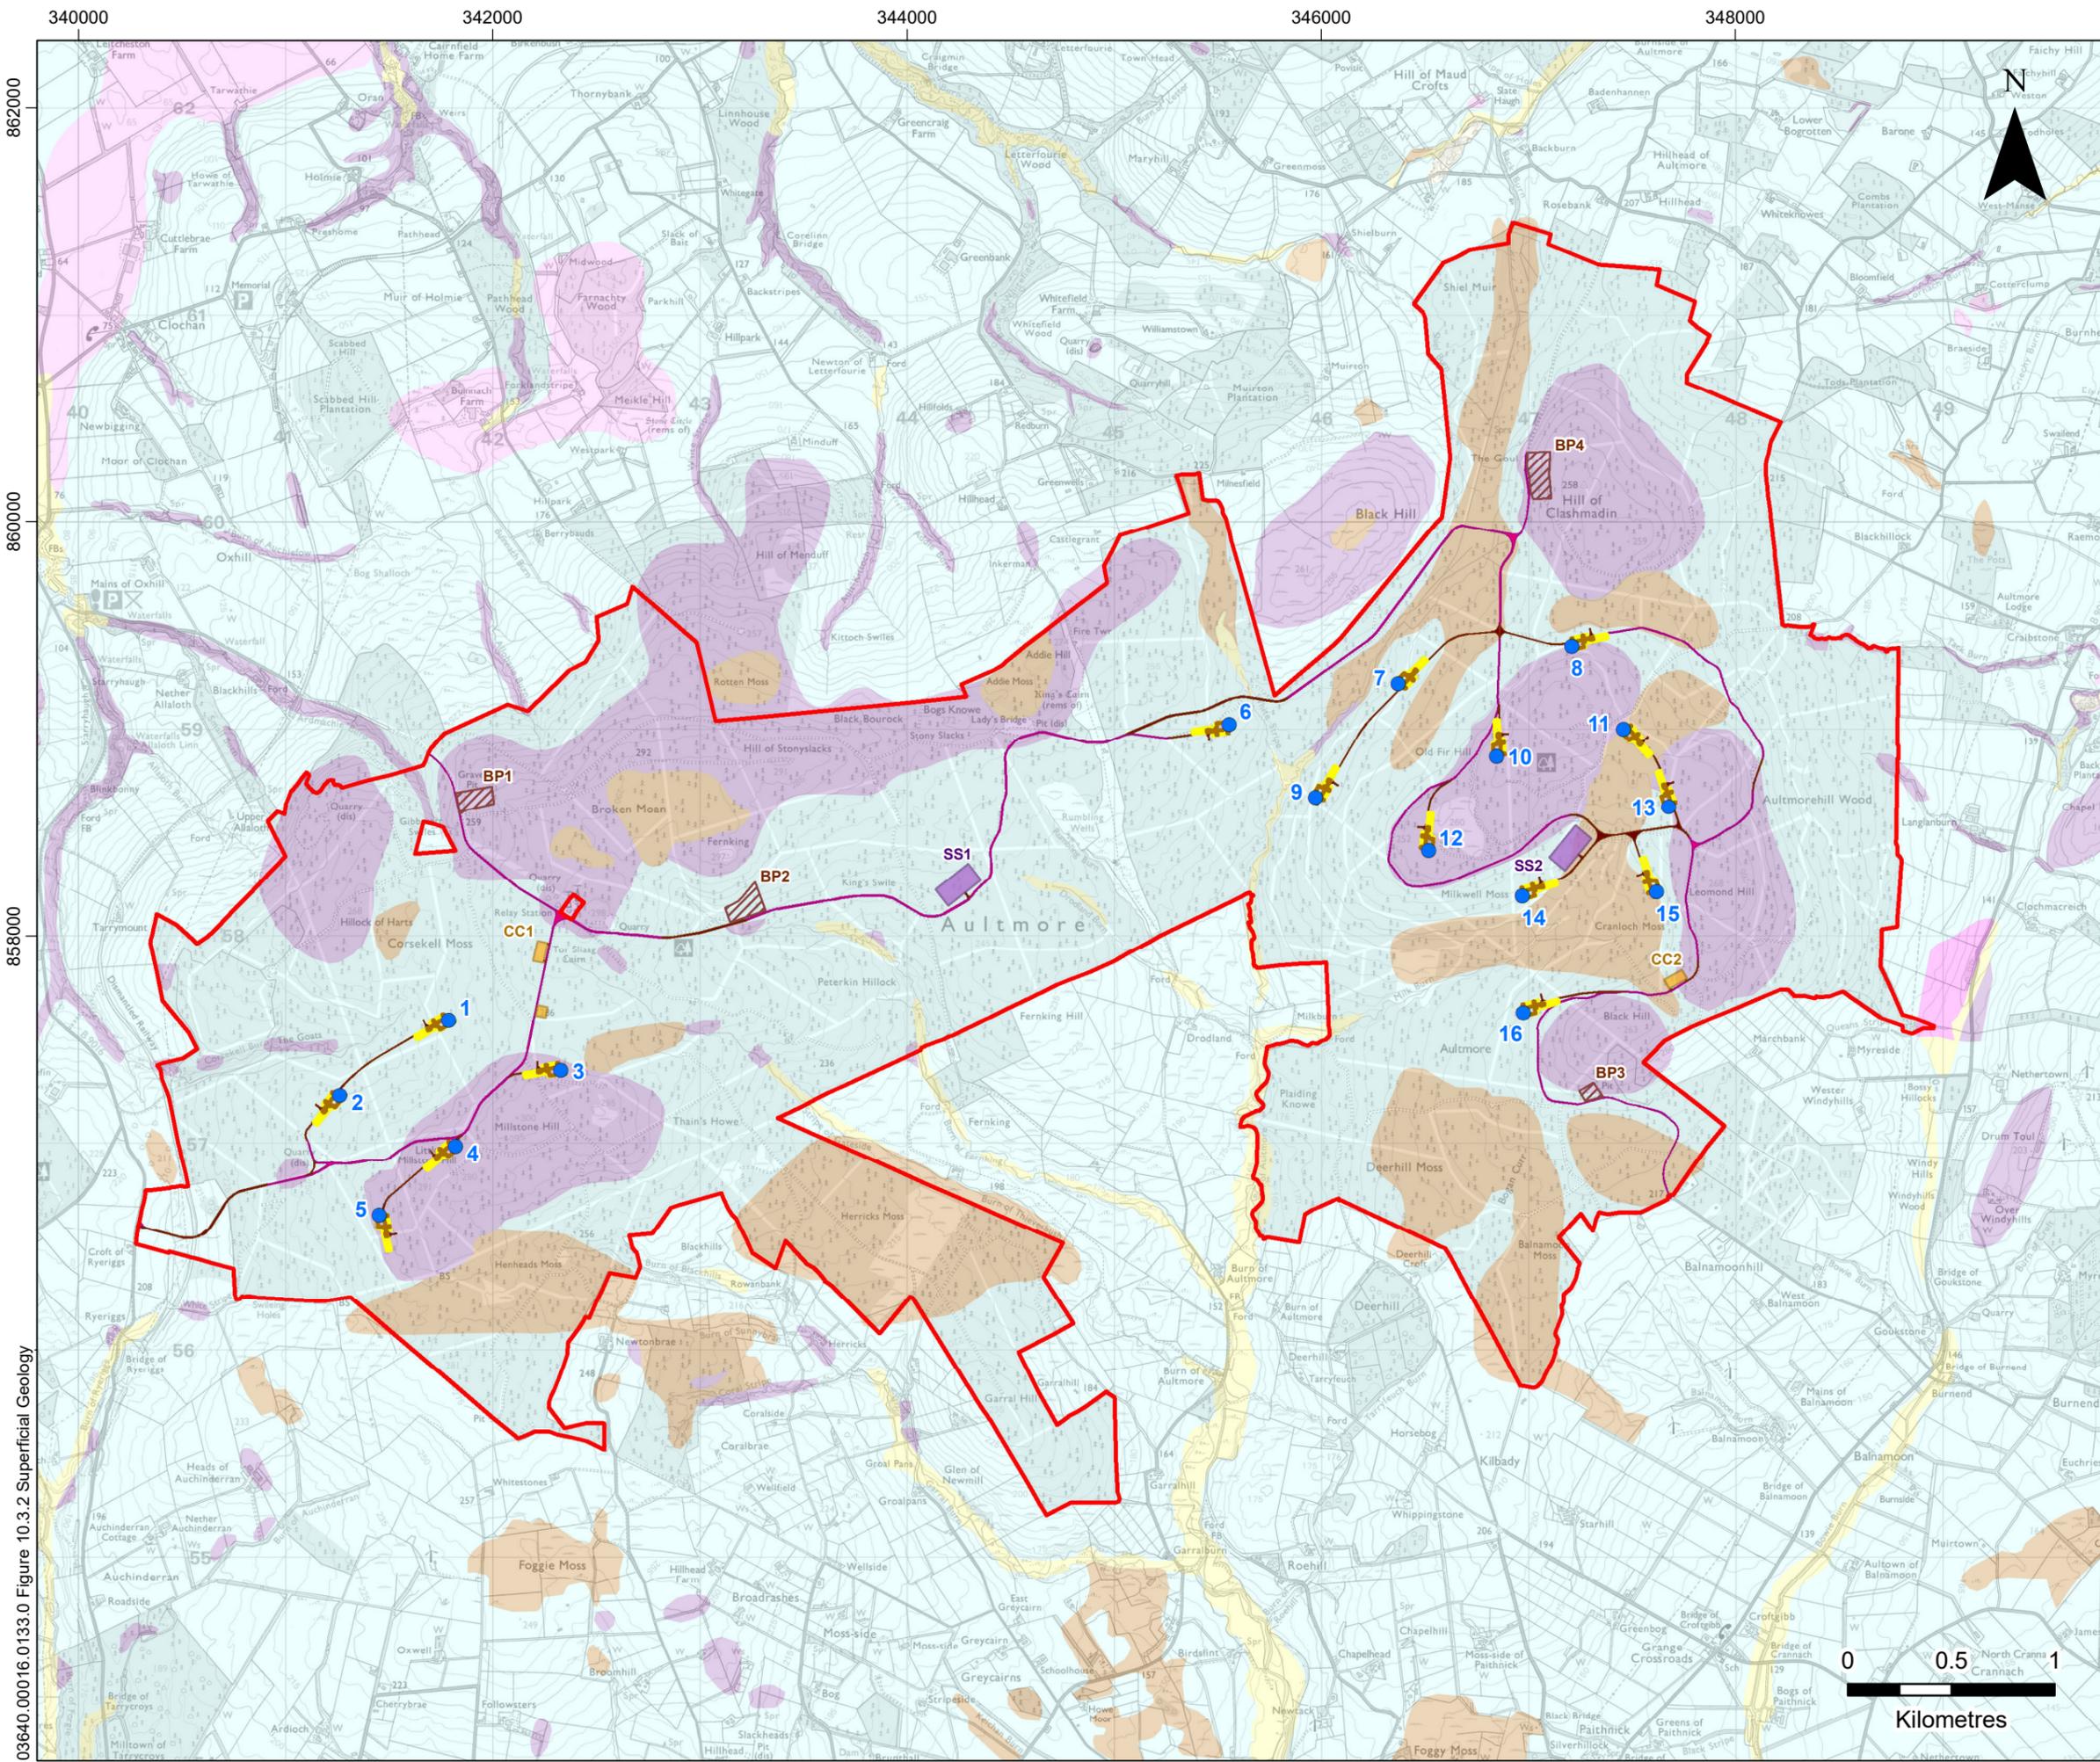
FIGURE 10.5.2

Figure 10.5.2 contained within this report details the superficial geology BGS mapping overlaid across the proposed development.

SUPERFICIAL GEOLOGY

BGS mapping indicates that peat and glacial till are the most common superficial deposits within the proposed development. Till (Devensian) is present throughout the majority of the site. Localised peat deposits are present throughout the site, predominantly in the east, southeast, southwest and areas of the north. Alluvium is located adjacent to watercourses in the south and east of the site. Areas of the north and west of the south are absent from mapped superficial deposits which may be indicative of shallow or exposed bedrock.

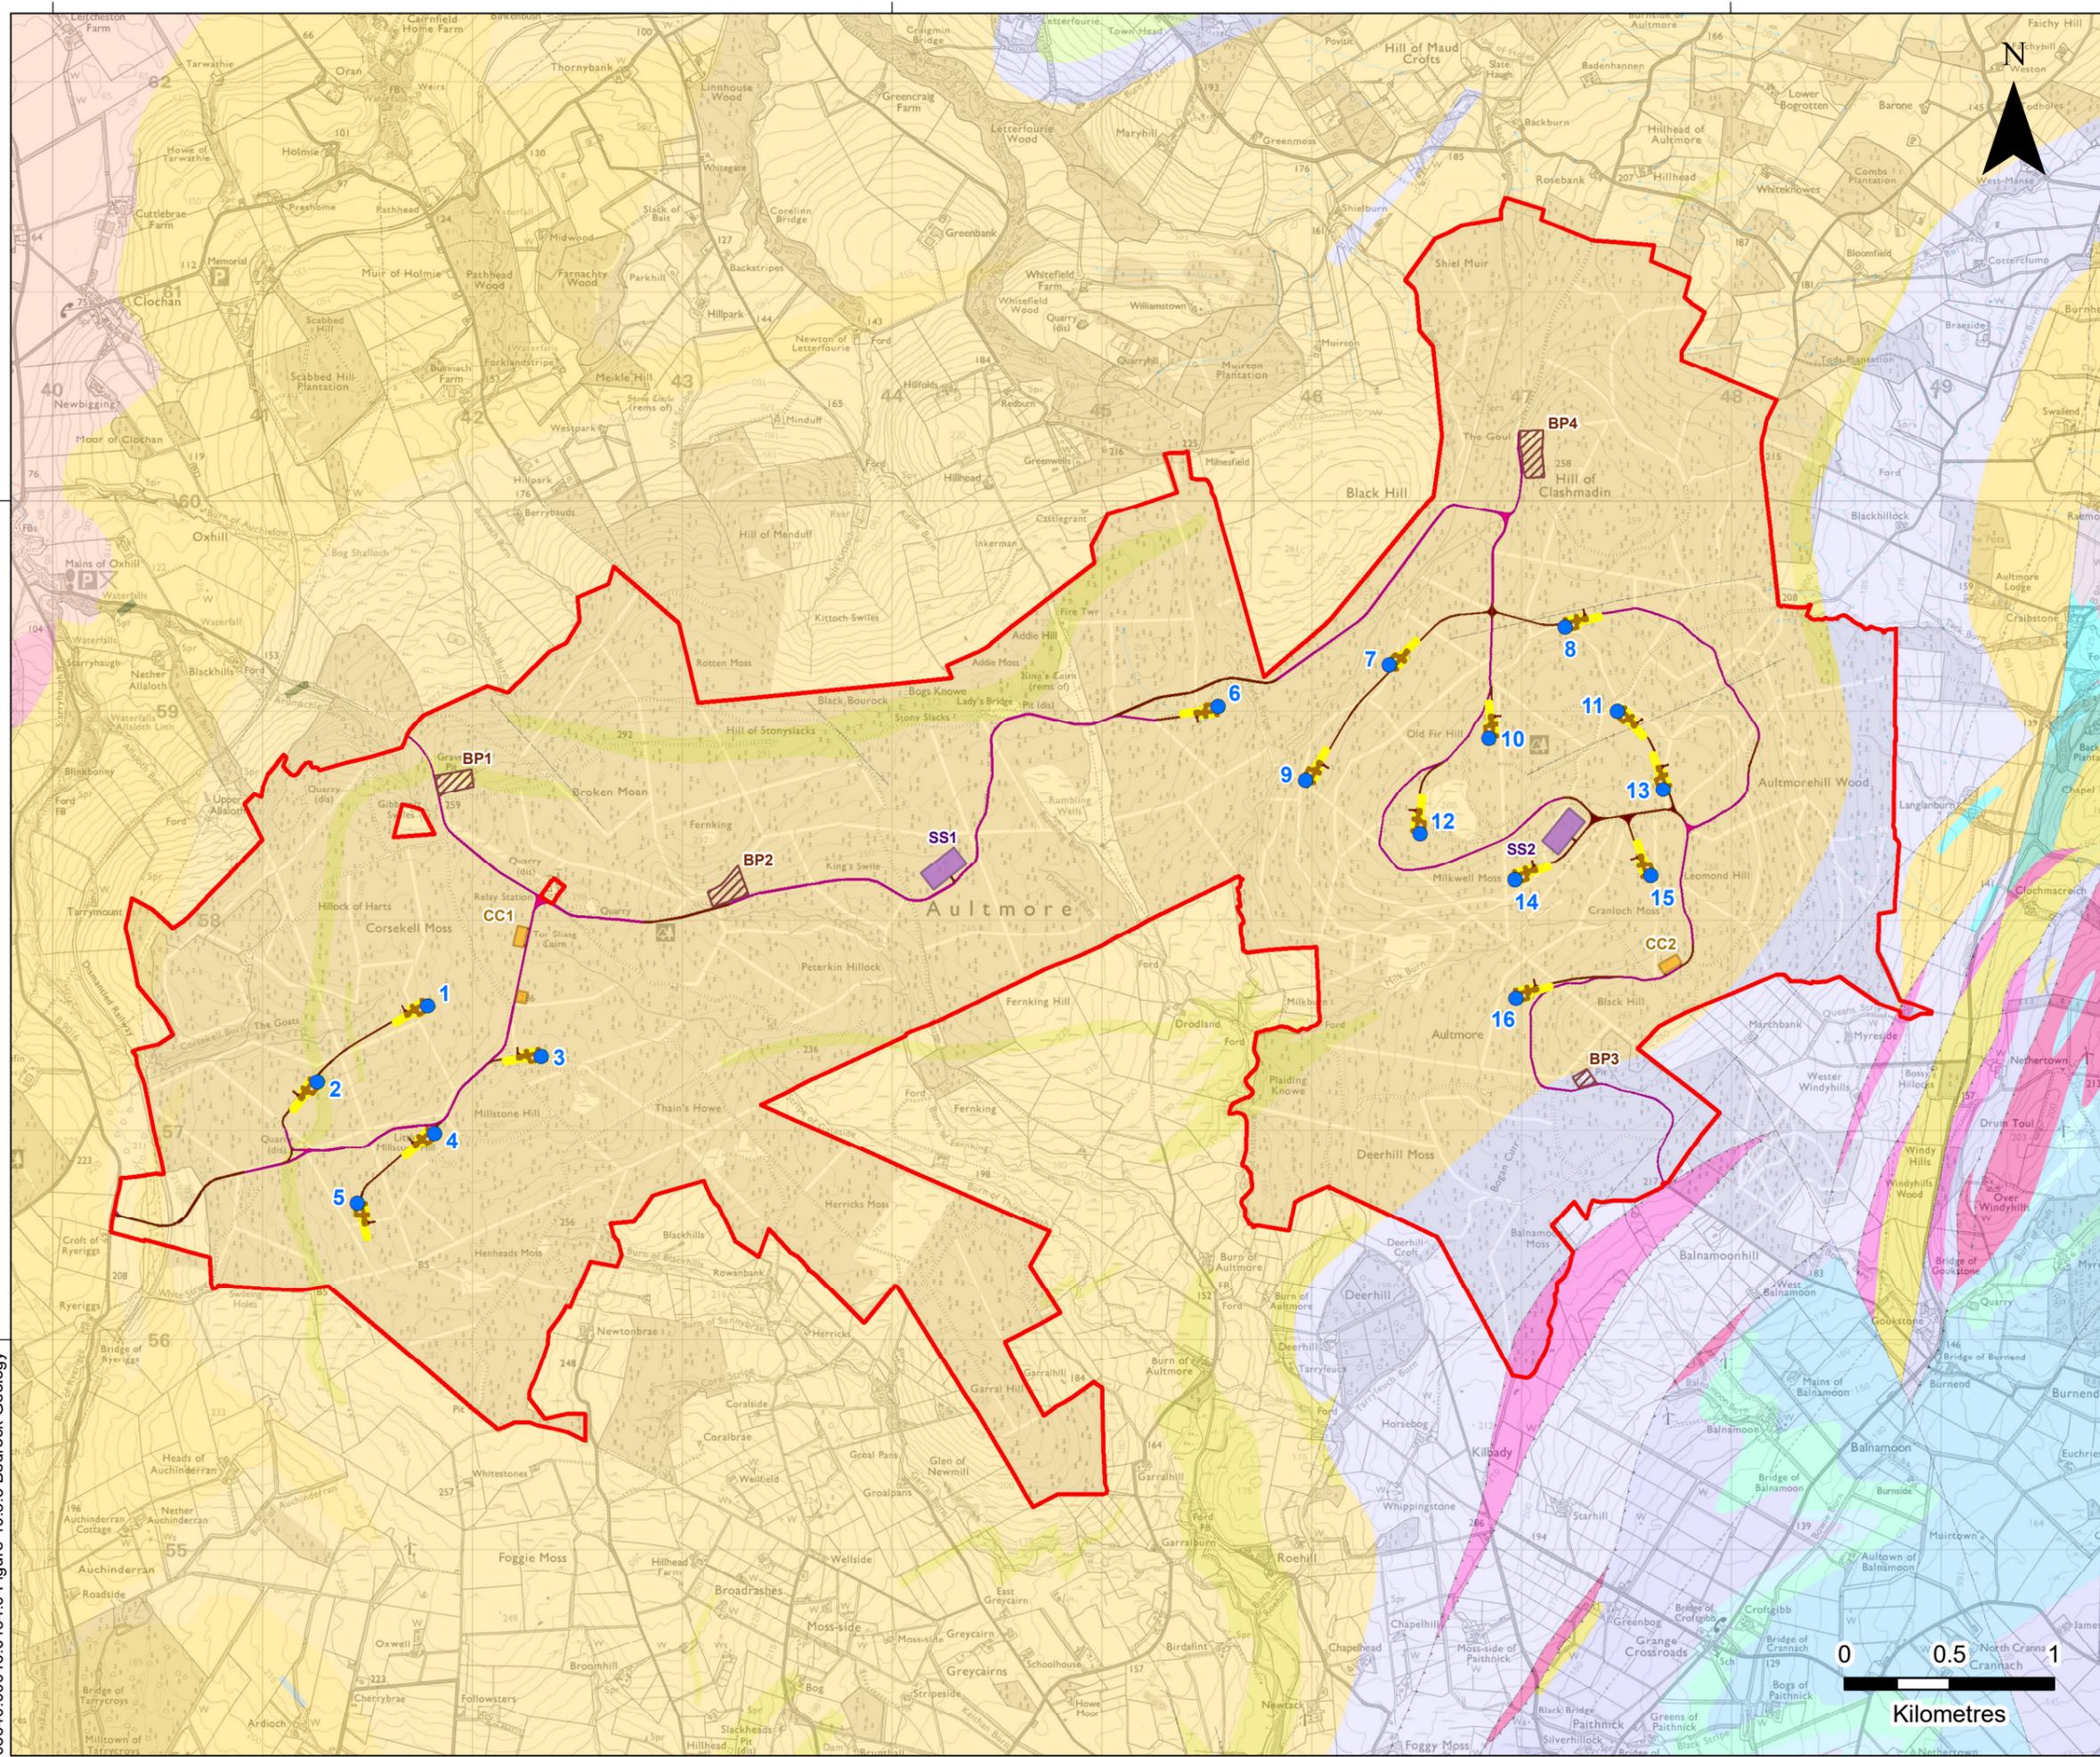
FIGURE 10.5.3

Figure 10.5.3 contained within this report details the bedrock geology BGS mapping overlaid across the Proposed Development.

BEDROCK GEOLOGY

BGS mapping indicates that the Findlater Flag Formation (Neoproterozoic) is underlying the proposed development. This unit is predominantly comprised of metamorphic rocks, psammite and semipelite. Quartzite units in this formation are present in areas of the north, east and south of the proposed development.
