CLASHINDARROCH II

WIND FARM

Technical Appendix 11.3

This Technical Appendix presents information with regard to existing and proposed new watercourse crossings.

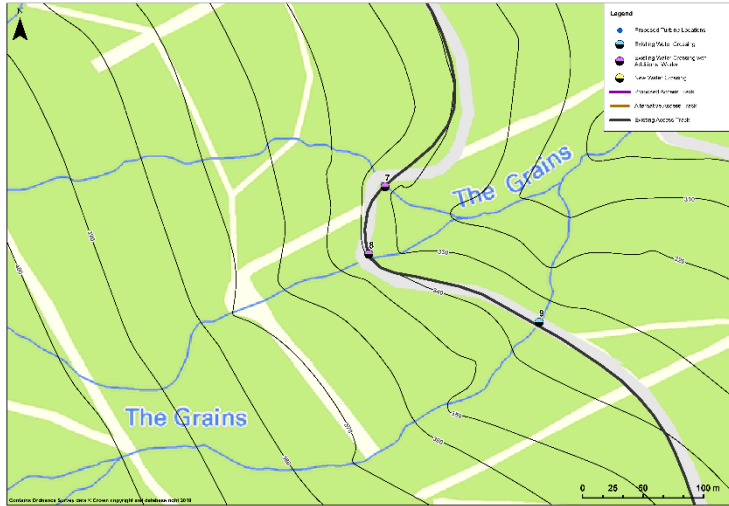
Watercourse Crossing Details	Photography	Location
<p>Watercourse Crossing 8 Existing requiring upgrade</p> <p>NGR: NJ 45473 35091</p> <p>Watercourse: Headwater of The Grains</p> <p>Notes: 0.6 m diameter plastic circular culvert, roadside drainage is directed vial two pipes to the culvert discharge location</p>	<div data-bbox="622 331 1234 707"> <p>Crossing</p>

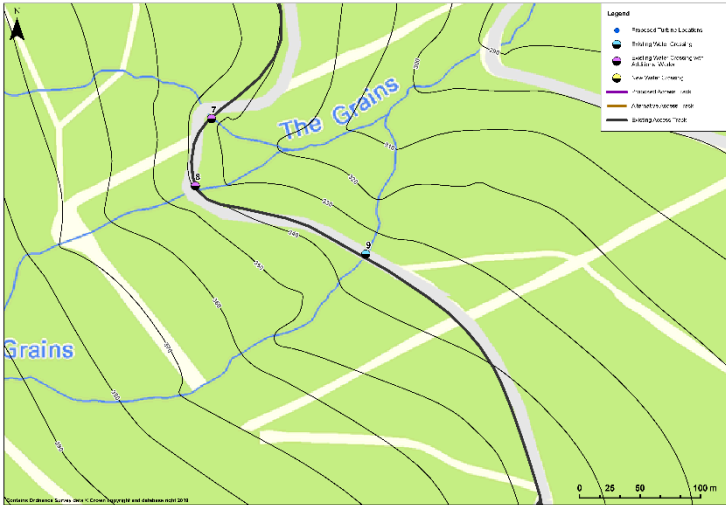
Watercourse Crossing Details	Photography	Location
<p>Watercourse Crossing 9 Existing</p> <p>NGR: NJ 45614 35035</p> <p>Watercourse: Headwater of The Grains</p> <p>Notes: 0.9 m diameter plastic circular culvert, no flow noted.</p>	<p style="text-align: center;">Crossing</p>

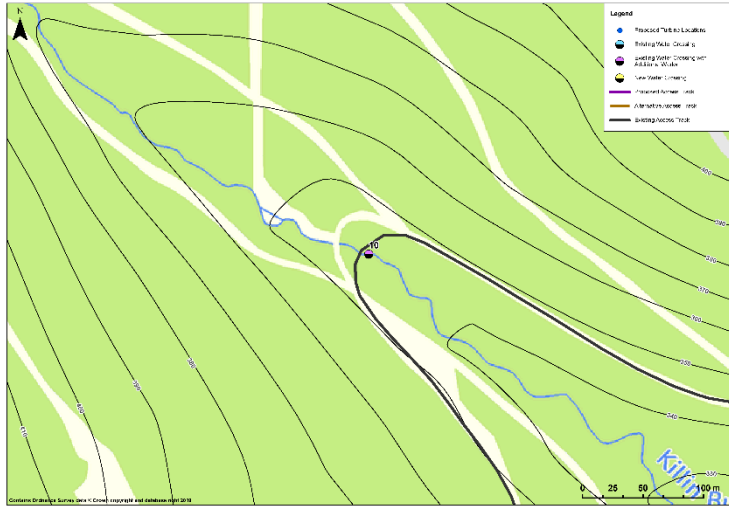
Watercourse Crossing Details	Photography	Location
<p>Watercourse Crossing 10 Existing requiring upgrade</p> <p>NGR: NJ 45175 34317</p> <p>Watercourse: Killin Burn</p> <p>Notes: 1.2 m diameter plastic circular culvert, older culvert immediately upstream.</p>	<div data-bbox="622 331 1234 708"> <p>Crossing</p>

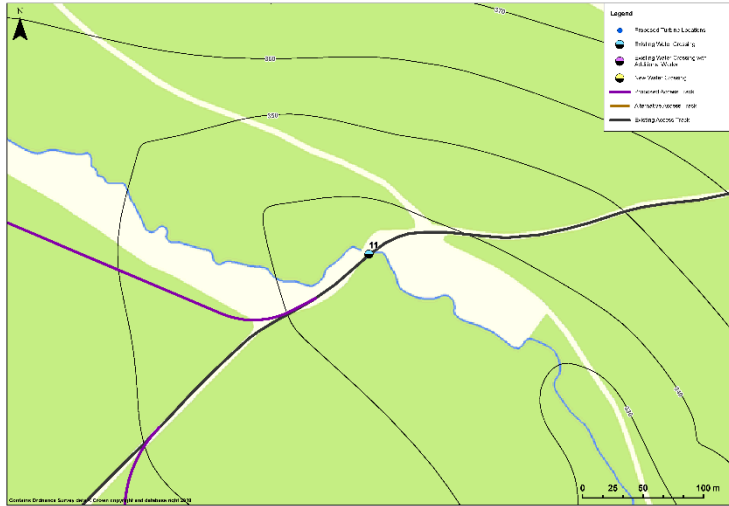
Watercourse Crossing Details	Photography	Location
<p>Watercourse Crossing 11 Existing</p> <p>NGR: NJ 44647 33666</p> <p>Watercourse: Burn of Bedlaithen</p> <p>Notes: 1.2 m diameter plastic circular culvert, an older crossing exists immediately upstream.</p>	<div data-bbox="622 331 1234 707"> <p>Crossing</p>
