# South Kyle II Wind Farm

## Technical Appendix 8.3: Watercourse Crossing Assessment

**Vattenfall Wind Power Ltd**

1357601/B

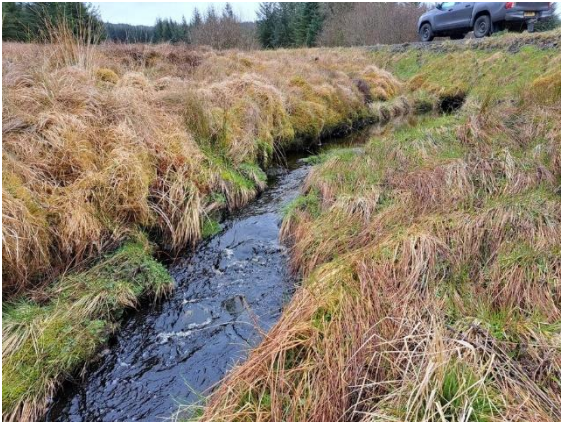
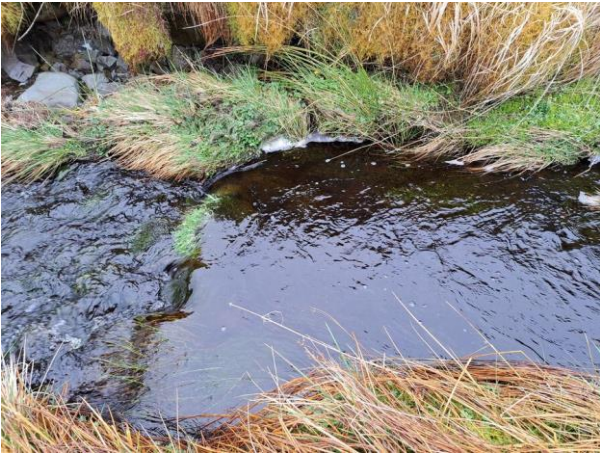
WX3 (252888, 606660)

- **Existing Crossing:** Yes
- **Crossing Type (existing):** Circular culvert
- **Crossing Material (existing):** Plastic
- **Crossing Condition (existing):** Good
- **Channel Type:** Artificially modified watercourse
- **Gradient:** Gentle
- **Valley form:** Shallow vee
- **Bank condition:** Stable
- **Bed material:** Bedrock, Vegetation
- **Riparian corridor:** Commercial Forestry
- **Flow condition:** Moderate

**Note:** Hardstanding track crosses this watercourse , in good condition, upstream ( see picture 2 for other side of the stream), believe it is an artificially modified stream.

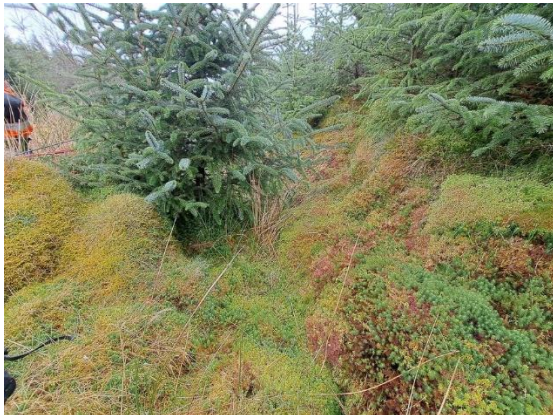
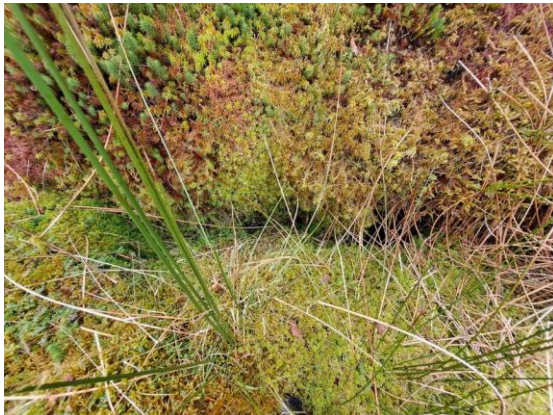
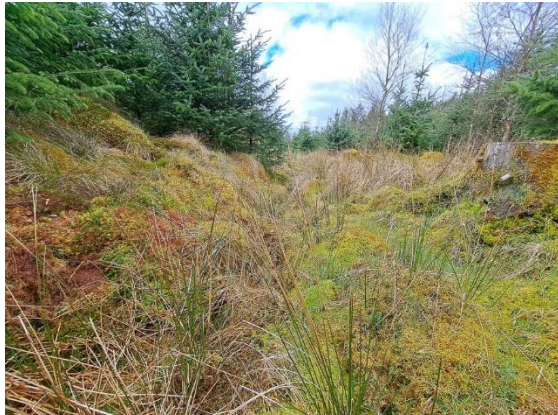
WX4 (251954, 606639)			
Crossing Location		Crossing Description	
<div>

<p>© Crown Copyright 2024. All rights reserved. Ordnance Survey Licence 0100031673.</p></div>		<div><ul style="list-style-type: none"><li>• <b>Existing Crossing:</b> No</li><li>• <b>Channel Type:</b> Incised</li><li>• <b>Gradient:</b> Gentle</li><li>• <b>Valley form:</b> Shallow vee</li><li>• <b>Bank condition:</b> Stable</li><li>• <b>Bed material:</b> Vegetation</li><li>• <b>Riparian corridor:</b> Commercial Forestry</li><li>• <b>Flow condition:</b> Slow</li></ul><ul style="list-style-type: none"><li>• <b>Water width (m):</b> 0.2</li><li>• <b>Water depth (m):</b> 0.25</li><li>• <b>Bankfull width (m):</b> 0.3</li><li>• <b>Bankfull height (m):</b> 0.5</li><li>• <b>Banktop height (m):</b> 0.6</li><li>• <b>Flooded Bankfull width (m):</b> 0.5</li><li>• <b>Flooded Bankfull height:</b> 0.6</li></ul><p><b>Note:</b> None</p></div>

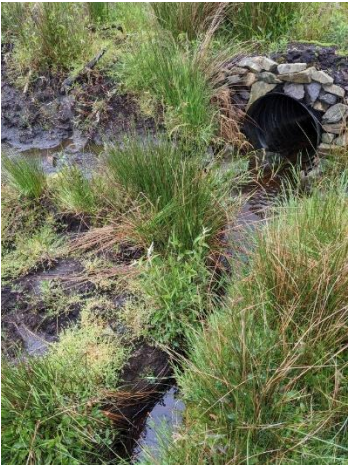
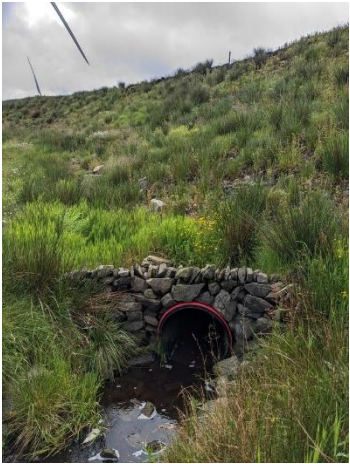
Culvert view (upstream of crossing)		Culvert view (downstream of crossing)

<p>© Crown Copyright 2024. All rights reserved. Ordnance Survey Licence 0100031673.</p>	<ul style="list-style-type: none"><li>• <b>Existing Crossing:</b> Yes</li><li>• <b>Crossing Type (existing):</b> Circular Culvert</li><li>• <b>Crossing Material (existing):</b> Plastic</li><li>• <b>Crossing Condition (existing):</b> Good</li><li>• <b>Channel Type:</b> Poorly defined, Incised</li><li>• <b>Gradient:</b> Gentle</li><li>• <b>Valley form:</b> No obvious valley sides, Shallow vee</li><li>• <b>Bank condition:</b> Stable</li><li>• <b>Bed material:</b> Coarse gravel, Boulders, Rounded pebbles</li><li>• <b>Riparian corridor:</b> Moorland</li><li>• <b>Flow condition:</b> Moderate</li></ul>	
	<ul style="list-style-type: none"><li>• <b>Culvert Dimensions (m):</b> 0.8</li><li>• <b>Water width (m):</b> 0.5</li><li>• <b>Water depth (m):</b> 0.10</li><li>• <b>Bankfull width (m):</b> 0.7</li><li>• <b>Bankfull height (m):</b> 0.5</li><li>• <b>Flooded Bankfull width (m):</b> 1.5</li><li>• <b>Flooded Bankfull height:</b> 0.6-0.7</li></ul> <p><b>Note:</b> Kept in for consideration given proximity to existing track and at source of Nith location. This is a different culvert system, it has a landscaped feature of two pools and artificial channel above the upstream culvert, which is approximately 20m from the road and steep sided slope. It also has two watercourses entering the culvert, the other looks like a drainage ditch. The culvert doesn't cross the road perpendicularly but at an angle of 45 degrees, emerging on the downstream side approx. 50m from the upstream culvert. The downstream watercourse is more natural and dimensions and descriptions are from the downstream watercourse.</p>

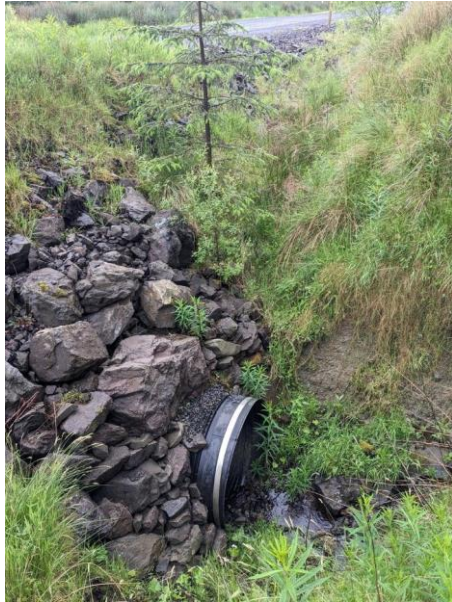
Culvert view (upstream of crossing)

WX10 (254547, 606804)		
Crossing Location	Crossing Description	
  <p>© Crown Copyright 2024. All rights reserved. Ordnance Survey Licence 0100031673.</p>	<ul style="list-style-type: none"><li>• <b>Existing Crossing:</b> Yes</li><li>• <b>Crossing Type (existing):</b> Circular Culvert</li><li>• <b>Crossing Material (existing):</b> Plastic</li><li>• <b>Crossing Condition (existing):</b> Good</li><li>• <b>Channel Type:</b> Incised</li><li>• <b>Gradient:</b> Moderate</li><li>• <b>Valley form:</b> Shallow vee</li><li>• <b>Bank condition:</b> Stable</li><li>• <b>Bed material:</b> Coarse gravel, Boulders</li><li>• <b>Riparian corridor:</b> Commercial Forestry</li><li>• <b>Flow condition:</b> Moderate</li><li>• <b>Culvert Dimensions (m):</b> 1.2</li><li>• <b>Water width (m):</b> 0.3</li><li>• <b>Water depth (m):</b> 0.1</li><li>• <b>Bankfull width (m):</b> 0.5</li><li>• <b>Bankfull height (m):</b> 0.35</li><li>• <b>Flooded Bankfull width (m):</b> 1.5-2.0</li><li>• <b>Flooded Bankfull height:</b> 0.8</li></ul> <p><b>Note:</b> Upstream gradient steeper than downstream. Downstream has incised valley.</p>

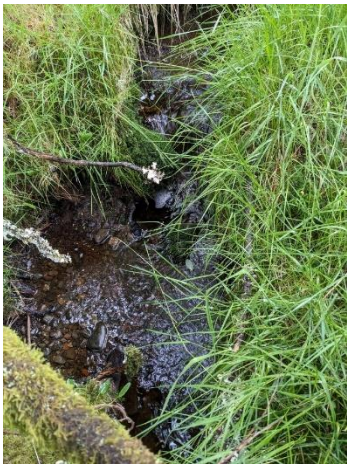
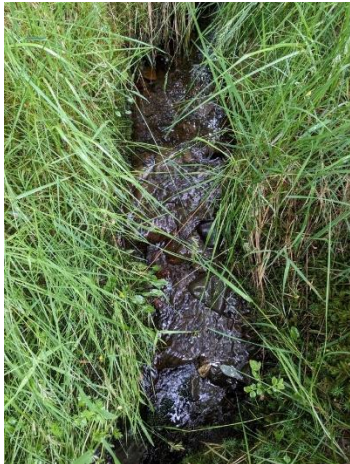
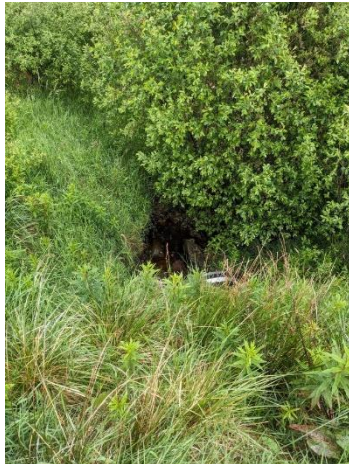
WX11 (254218, 607359)

- Existing Crossing: Yes
- Crossing Type (existing): Circular Culvert
- Crossing Material (existing): Plastic
- Crossing Condition (existing):
- Channel Type: Incised
- Gradient: Moderate
- Valley form: Shallow vee
- Bank condition: Stable
- Bed material: Fine sand/silt, Rounded pebbles, Coarse gravel, Boulders
- Riparian corridor: Commercial Forestry
- Flow condition: Moderate
- Culvert Dimensions (m): 1.0
- Water width (m): 0.3
- Water depth (m): 0.15
- Bankfull width (m): 0.4
- Bankfull height (m): 0.35
- Flooded Bankfull width (m): 0.5-0.7
- Flooded Bankfull height: 0.6

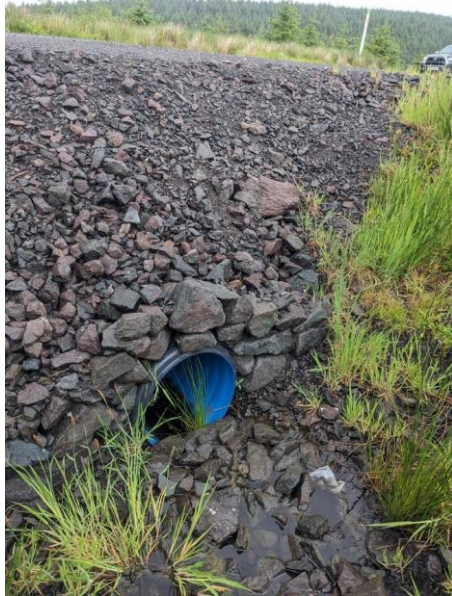
Culvert view (upstream of crossing)

<p>© Crown Copyright 2024. All rights reserved. Ordnance Survey Licence 0100031673.</p></div>		<ul style="list-style-type: none"><li>• <b>Existing Crossing:</b> Yes</li><li>• <b>Crossing Type (existing):</b> Circular Culvert</li><li>• <b>Crossing Material (existing):</b> Plastic</li><li>• <b>Crossing Condition (existing):</b> Good</li><li>• <b>Channel Type:</b> Incised, Artificial drainage channel, Artificially modified watercourse</li><li>• <b>Gradient:</b> Moderate</li><li>• <b>Valley form:</b> Shallow vee</li><li>• <b>Bank condition:</b> Stable</li><li>• <b>Bed material:</b> Coarse gravel, Boulders</li><li>• <b>Riparian corridor:</b></li><li>• <b>Flow condition:</b></li></ul> <ul style="list-style-type: none"><li>• <b>Water width (m):</b> 0.2</li><li>• <b>Water depth (m):</b> 0.1</li><li>• <b>Bankfull width (m):</b> 0.4</li><li>• <b>Bankfull height (m):</b> 0.3</li><li>• <b>Flooded Bankfull width (m):</b> 1.0</li><li>• <b>Flooded Bankfull height:</b> 0.5</li></ul> <p><b>Note:</b> Water channel upstream was dry. Watercourse downstream was almost dry (must be water draining into from roadside), but it has signs of erosion, so water has been present.</p>

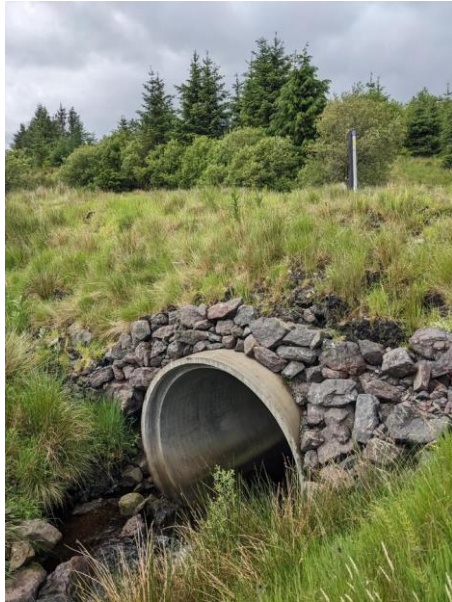
Culvert view (upstream of crossing)

<p>© Crown Copyright 2024. All rights reserved. Ordnance Survey Licence 0100031673.</p>	<ul style="list-style-type: none"><li>• <b>Existing Crossing:</b> Yes</li><li>• <b>Crossing Type (existing):</b> Circular Culvert</li><li>• <b>Crossing Material (existing):</b> Concrete</li><li>• <b>Crossing Condition (existing):</b> Excellent</li><li>• <b>Channel Type:</b> Incised</li><li>• <b>Gradient:</b> Moderate</li><li>• <b>Valley form:</b> Shallow vee</li><li>• <b>Bank condition:</b> Stable</li><li>• <b>Bed material:</b> Fine sand/silt, Rounded pebbles, Coarse gravel, Boulders</li><li>• <b>Riparian corridor:</b> Commercial Forestry</li><li>• <b>Flow condition:</b> Moderate</li></ul> <ul style="list-style-type: none"><li>• <b>Culvert Dimensions (m):</b> 2.2</li><li>• <b>Water width (m):</b> 1.0</li><li>• <b>Water depth (m):</b> 0.3</li><li>• <b>Bankfull width (m):</b> 1.5</li><li>• <b>Bankfull height (m):</b> 0.9</li><li>• <b>Flooded Bankfull width (m):</b> 1.5-2.0</li><li>• <b>Flooded Bankfull height:</b> 0.9-1.0</li></ul> <p><b>Note:</b> None</p>

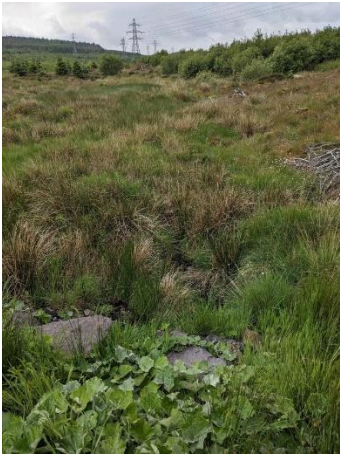
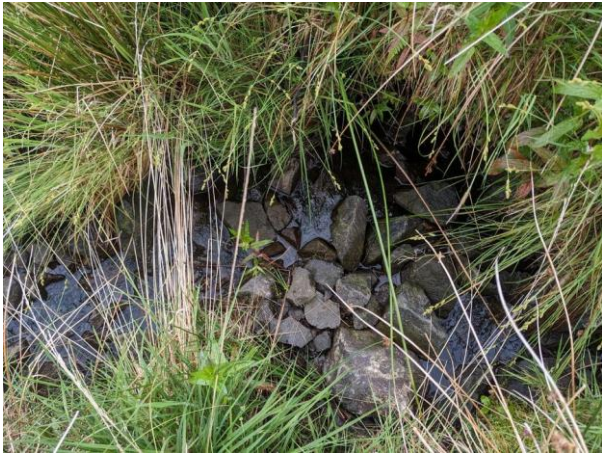
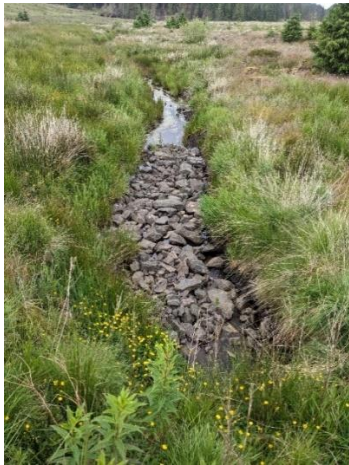
- **Existing Crossing:** Yes
- **Crossing Type (existing):** Circular Culvert
- **Crossing Material (existing):** Plastic
- **Crossing Condition (existing):** Good
- **Channel Type:** Poorly defined
- **Gradient:** Gentle
- **Valley form:** No obvious valley sides
- **Bank condition:** Stable
- **Bed material:** Boulders, Coarse gravel, Vegetation
- **Riparian corridor:** Commercial Forestry
- **Flow condition:** Slow

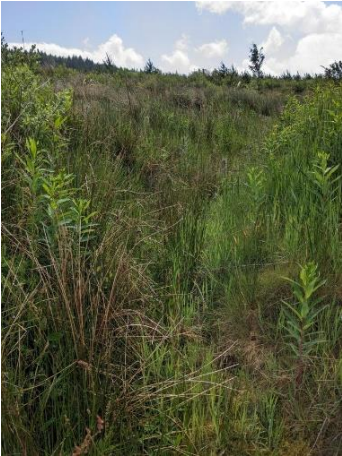
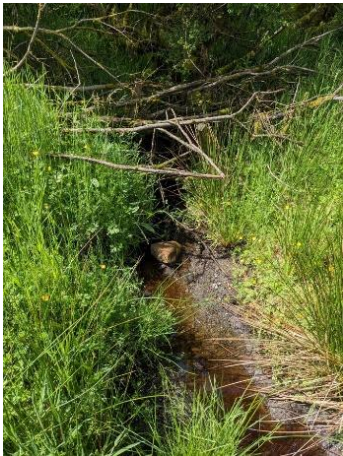
- **Existing Crossing:** Yes
  - **Crossing Type (existing):** Circular Culvert
  - **Crossing Material (existing):** Plastic
  - **Crossing Condition (existing):** Good
  - **Channel Type:** Incised
  - **Gradient:** Moderate
  - **Valley form:** Shallow vee
  - **Bank condition:** Stable
  - **Bed material:** Fine sand/silt, Rounded pebbles, Coarse gravel, Boulders, Peat
  - **Riparian corridor:** Commercial Forestry
  - **Flow condition:** Slow
- **Culvert Dimensions (m):** 0.45
  - **Water width (m):** 0.4
  - **Water depth (m):** 0.06
  - **Bankfull width (m):** 1.0
  - **Bankfull height (m):** 0.35
  - **Flooded Bankfull width (m):** 2.0
  - **Flooded Bankfull height:** 0.5
