# Aultmore Wind Farm Redesign

## Technical Appendix 10.4: Water Course Crossing Assessment

### Vattenfall Wind Power Ltd

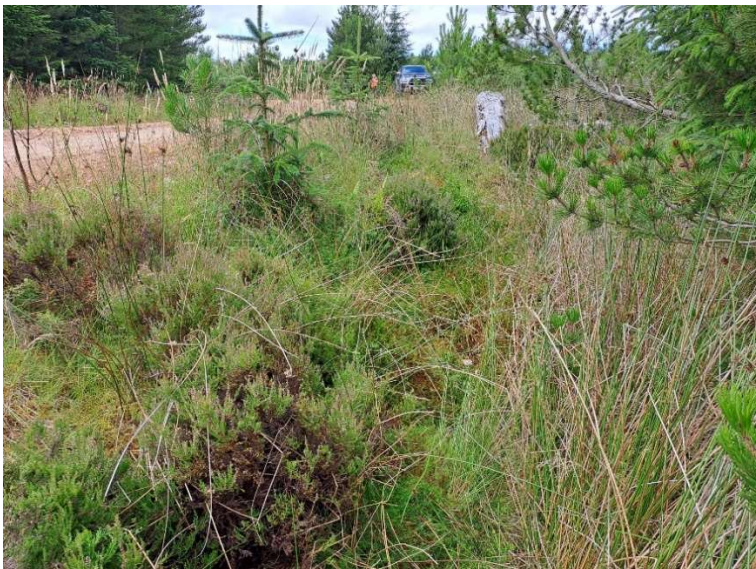
| Watercourse Crossing ID | WX01 |
|--|---|
| Photograph Looking at Culvert Entrance from Upstream | |

| Watercourse Crossing ID | WX01 |
|--|---|
| Watercourse Crossing Details | <p><b>E/N:</b> E346693, N859976</p> <p><b>Status:</b> Existing</p> <p><b>Culvert Diameter:</b> 0.3m</p> <p><b>Culvert Construction Type:</b> Plastic circular culvert</p> <p><b>Watercourse Width:</b> up to 0.5m</p> <p><b>Watercourse Depth:</b> 0.01m</p> <p><b>Notes:</b> Stagnant water with no clear channel upstream. Culvert is heavily vegetated and is noted to be 0.5m below the road surface. Unable to find culvert entrance upstream due to vegetation.</p> |

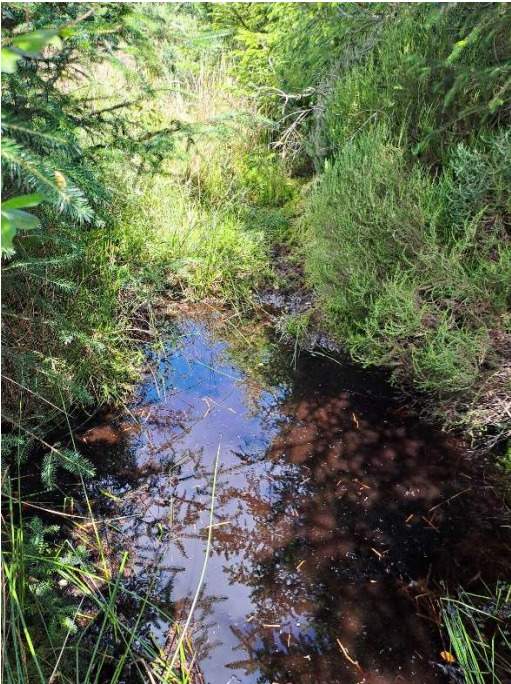
| Watercourse Crossing ID | WX02 |
|--|--|
| Photograph Looking at Culvert Entrance from Upstream | |

| Watercourse Crossing ID | WX02 |
|--|--|
| Watercourse Crossing Details | <p><b>E/N:</b> E346920, N859901</p> <p><b>Status:</b> Existing</p> <p><b>Culvert Diameter:</b> 0.5m</p> <p><b>Culvert Construction Type:</b> Concrete circular culvert</p> <p><b>Watercourse Width:</b> up to 1m</p> <p><b>Watercourse Depth:</b> 0.4m</p> <p><b>Notes:</b> No clear channel upstream, water has ponded from road drainage. Heavily vegetated.</p> |

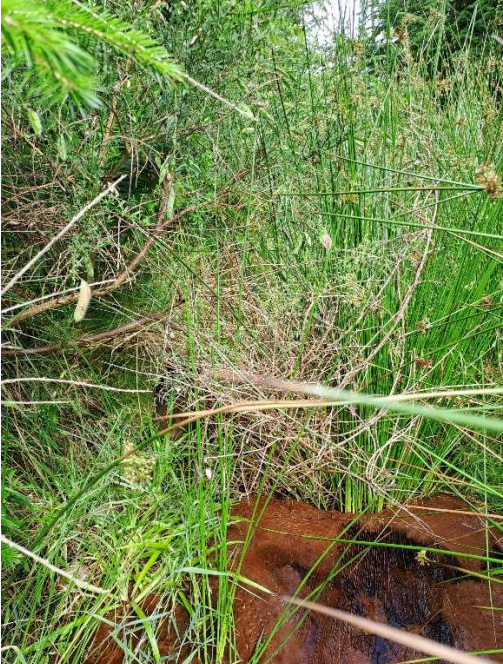
| Watercourse Crossing ID | WX03 |
|--|---|
| Photograph Looking at Culvert Entrance from Upstream | |

| Watercourse Crossing ID | WX03 |
|--|---|
| Watercourse Crossing Details | <p><b>E/N:</b> E346867, N859782</p> <p><b>Status:</b> Existing</p> <p><b>Culvert Diameter:</b> 0.5m</p> <p><b>Culvert Construction Type:</b> Concrete circular culvert</p> <p><b>Watercourse Width:</b> 0.2m</p> <p><b>Watercourse Depth:</b> 0.4m</p> <p><b>Notes:</b> Culvert up to 2m below road level. Stagnant water with evidence of ponding containing peaty sediments. Heavily vegetated.</p> |

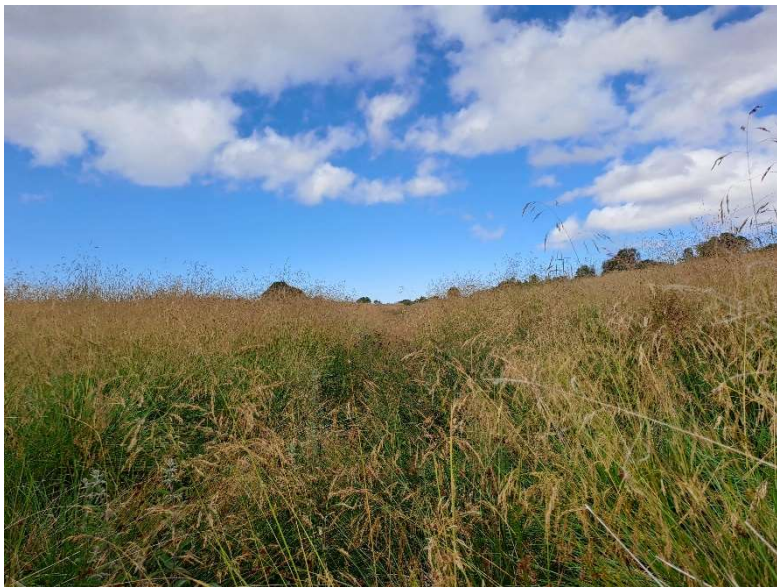
| Watercourse Crossing ID | WX05 |
|--|---|
| Photograph Looking Upstream | |

| Watercourse Crossing ID | WX05 |
|--|---|
| Watercourse Crossing Details | <p><b>E/N:</b> E340458, N856555</p> <p><b>Status:</b> New</p> <p><b>Watercourse Width:</b> 0.2m</p> <p><b>Watercourse Depth:</b> 0.1m</p> <p><b>Notes:</b> Located within a deeper channel measuring 0.8m wide.</p> |

| Watercourse Crossing ID | WX05 |
|--|---|
| Potential Crossing Type<br>Likely Required CAR Authorisation | Culvert<br>Registration |
