South Kyle II Wind Farm

FEI Technical Appendix E - Peat Slide Risk Assessment

Vattenfall

June 2026

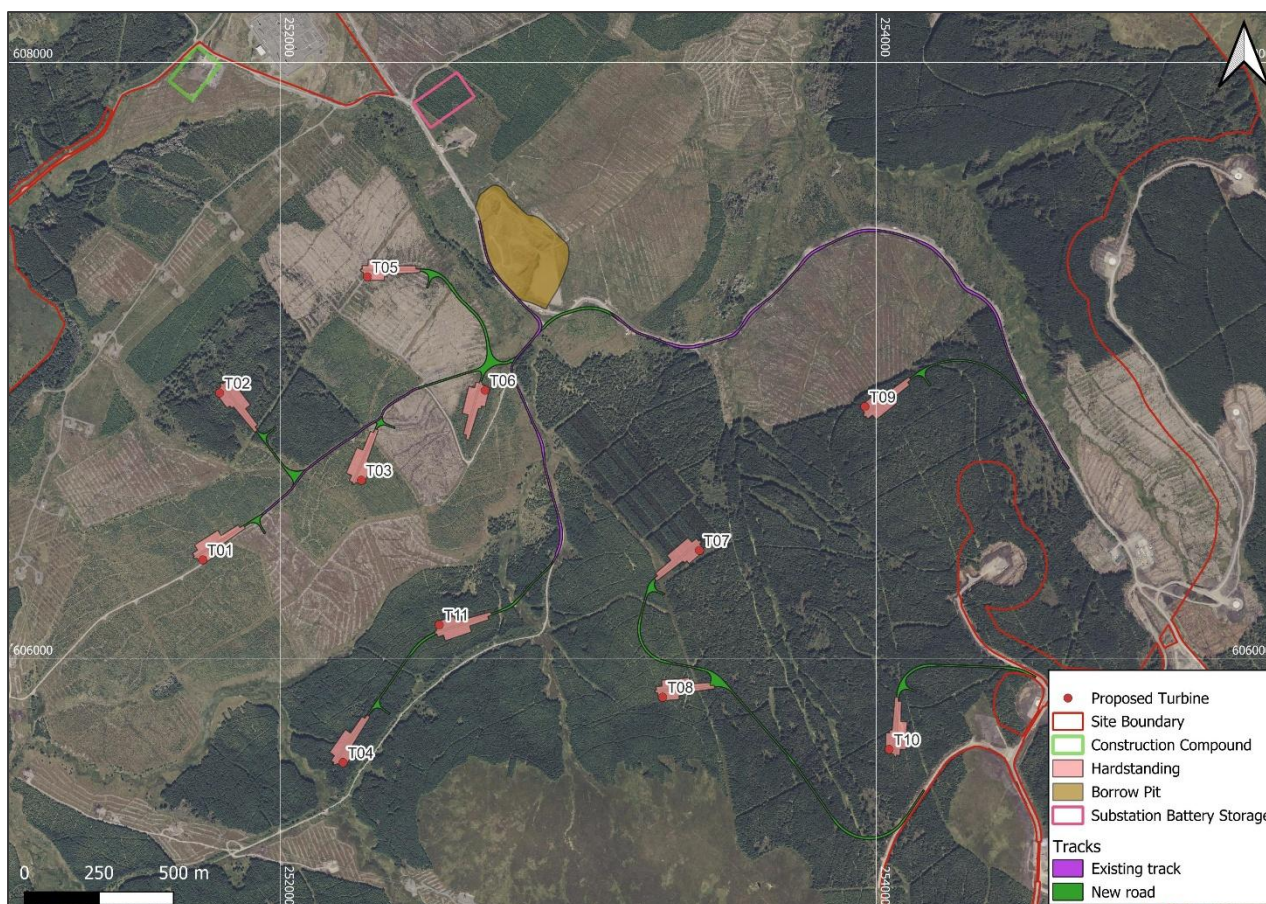
Figure 1.2: Amended Site layout with approximate Turbine Locations and associated infrastructure

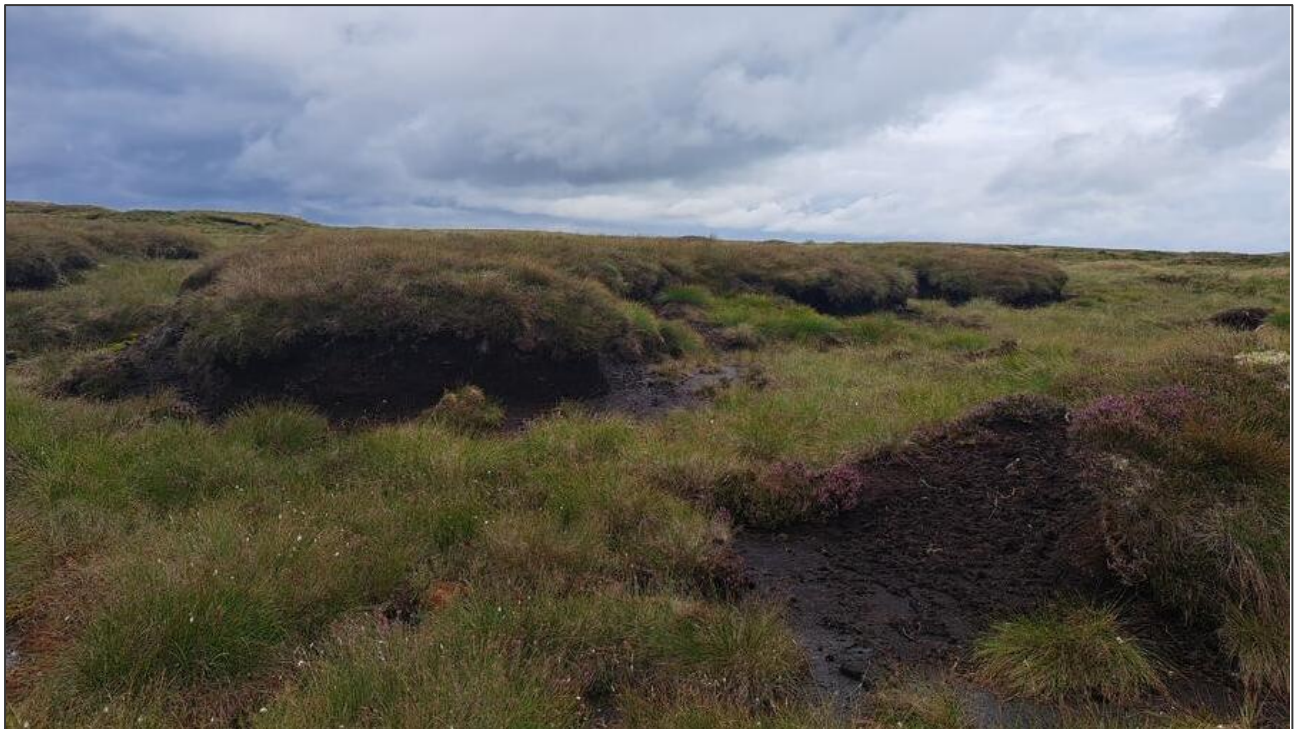
Figure 1.3: Peat hags observed in the open moorland on the eastern peripheries of the Site Boundary

No evidence of cracking, compression features of peat creep was identified during the site walkover. As described and illustrated in Section 1.5 and 1.6, evidence of damaged peat in the form of peat hag collapse were identified on the Amended Proposed Development. Although these features are not typically associated with major peat instability, they can increase weathering rates and influence water flow pathways.

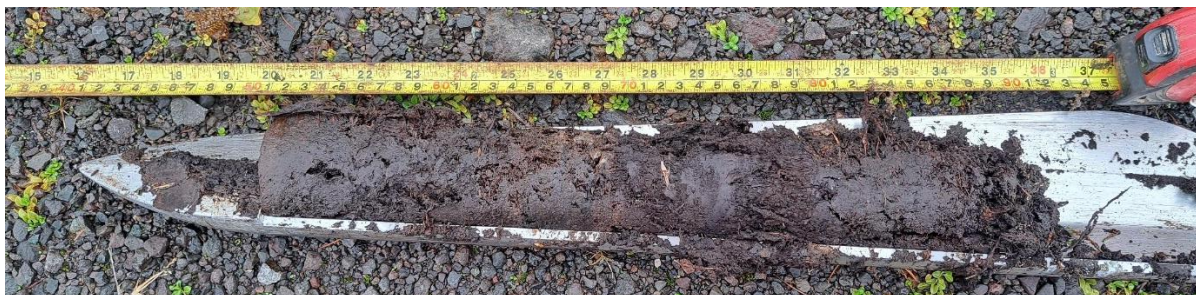
Figure 3.1: Photo of peat core undertaken at T01 m depth 0-0.90m)

Each core is photographed, given a general description, water content estimate (B) and Von Post rating (H) (Table 3.2). Peat deposit characteristics vary across the site. The core generally refused at the base of the peat. All Peat Cores and photographs are displayed in Appendix B.2 of this report. Examples of peat core are shown below in Figure 3.1.

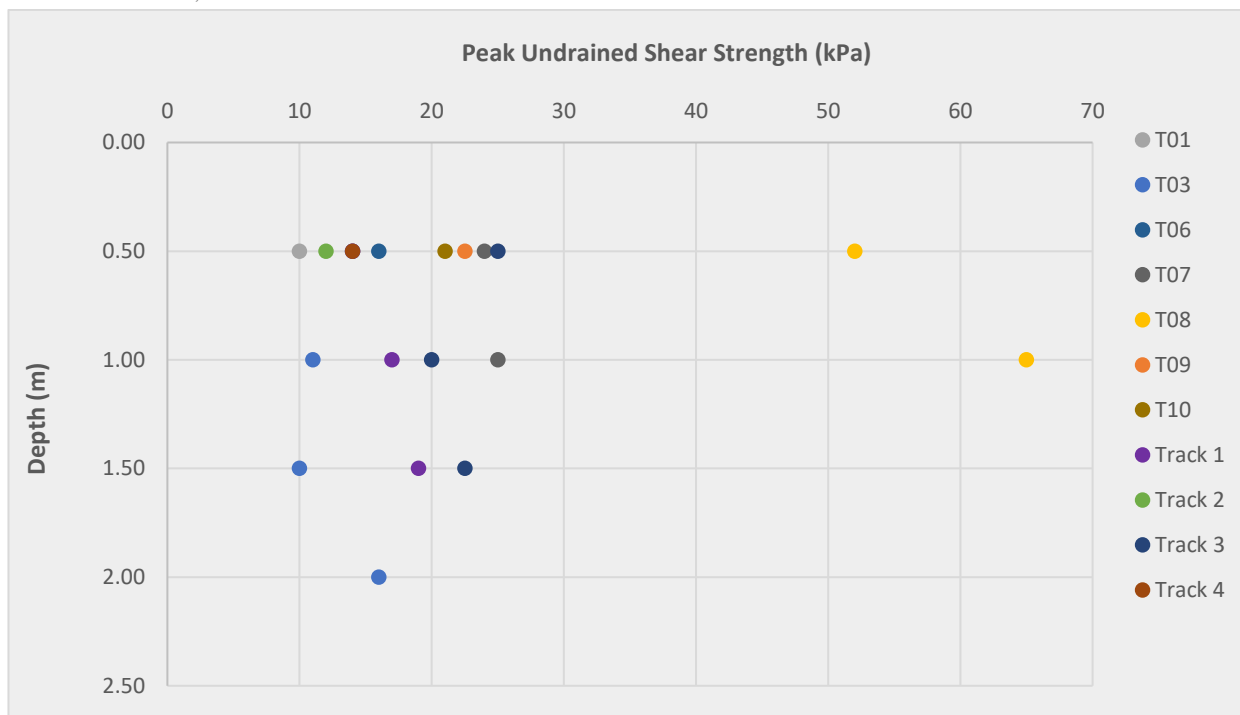
Figure 3.2: Peak Undrained Shear Strength (kPa) against Depth (mbgl) across the areas of key infrastructure at the Proposed Development.

Figure 3.1 depicts the peak undrained shear strength data against depth.

The peak undrained shear strength is seen to be generally medium to high across the test points, from 10 to 65 kPa within the peat deposits with a slight trend showing increasing shear strength with depth. The Site wide average is 21.5 kPa (strength), so a conservative value of 10 kPa is considered appropriate for the Site wide slope analysis.

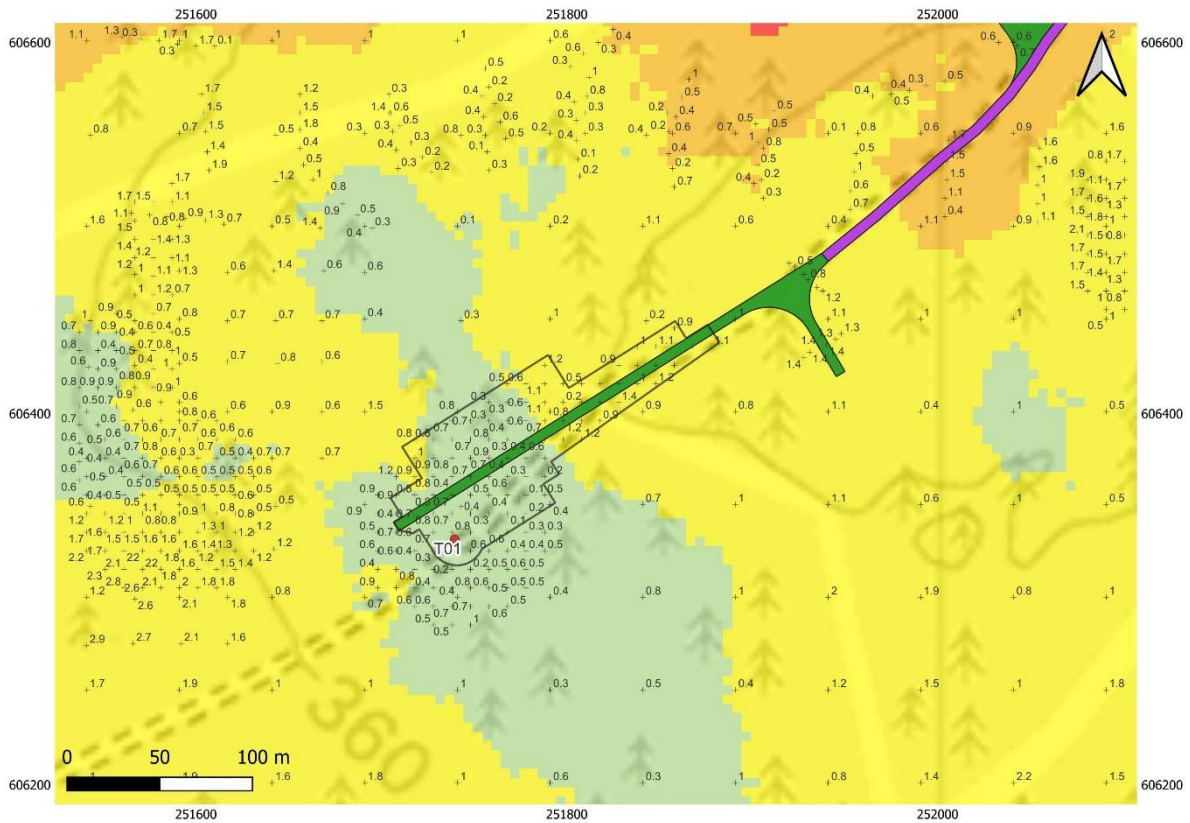
T01 Location – OS Mapping 1:25,000 – 1:1500 Scale

Development Infrastructure		Environmental	Contributory Factors (Probability/Exposure)	Risk Ranking
T01	1	1	Peat Depth (Mean = 0.51m)	3
			Slope Angle (2.5°)	1
			FoS (Min = Cu _{min} > site mean)	1
			Peat cracking / Infiltration	1
			Groundwater Flow	1
			Hydrology	1
			Previous Instability	1
			Land Management	2
				1*(3+2) =5
				Low

Land management factor of '2' due to forestry operations. Drainage outfalls should be designed to avoid discharging to the southwest of the hardstanding towards deeper peat deposits.

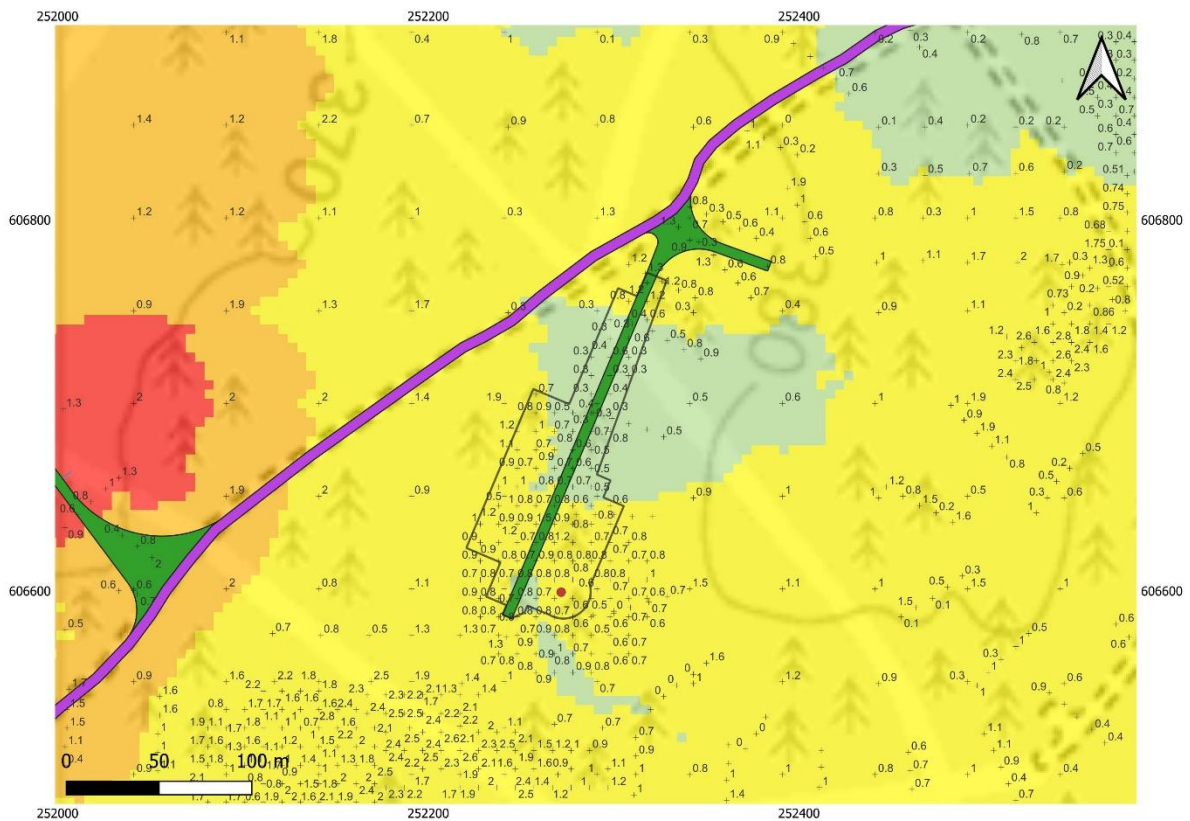
T03 Location – OS Mapping 1:25,000 – 1:1500 Scale

Development Infrastructure		Environmental	Contributory Factors (Probability/Exposure)	Risk Ranking
T03	1	1	Peat Depth (Mean = 0.78m)	3
			Slope Angle (4°)	3
			FoS (Min = Cu _{min} > site mean)	1
			Peat cracking / Infiltration	1
			Groundwater Flow	1
			Hydrology	1
			Previous Instability	1
		Land Management	2	
				1 * (3+3+2) = 8 Low

The slope angle and peat depths on average around the proposed turbine location are conducive to peat sliding. Care should be taken when stockpiling peat during the construction process around this turbine due to the pockets of deep peat and relatively steeper gradients. Land management factor of '2' due to forestry operations. Drainage outfalls should be designed to avoid discharging towards pockets of deep peat found to the northwest and south of the hardstanding.

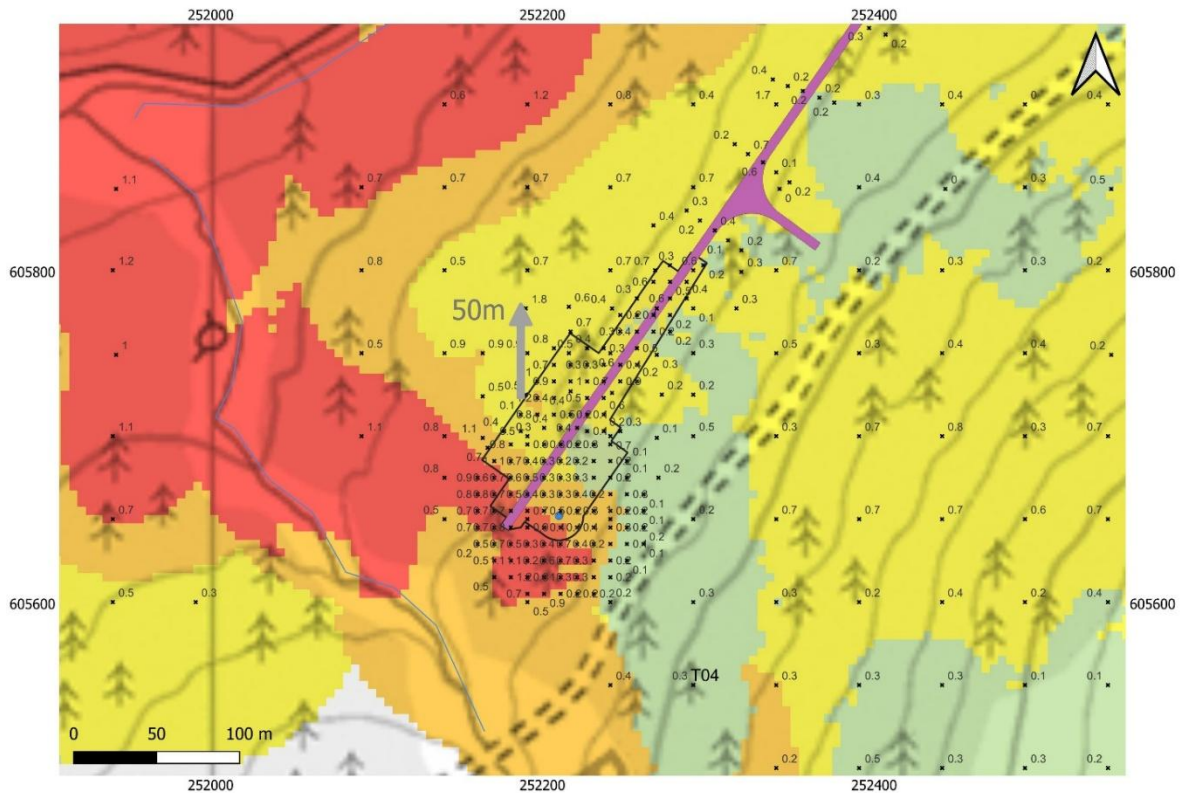
T04 Location – OS Mapping 1:25,000 – 1:1500 Scale

Development Infrastructure		Environmental	Contributory Factors (Probability/Exposure)	Risk Ranking
T04	1	2	Peat Depth (Mean = 1.12m)	5
			Slope Angle (10°)	5
			FoS (Min = Cu _{min} > site mean)	1
			Peat cracking / Infiltration	1
			Groundwater Flow	1
			Hydrology	1
			Previous Instability	1
		Land Management	2	
				2* (5+5+2) =24 High

The slope angle is conducive for peat sliding and peat depths on average around the proposed turbine location are between 1-2.0m. Care should be taken when stockpiling peat around this turbine to avoid steeper gradients. There are also localised deeper peat deposits to the west where special care will need to be taken during the construction process.

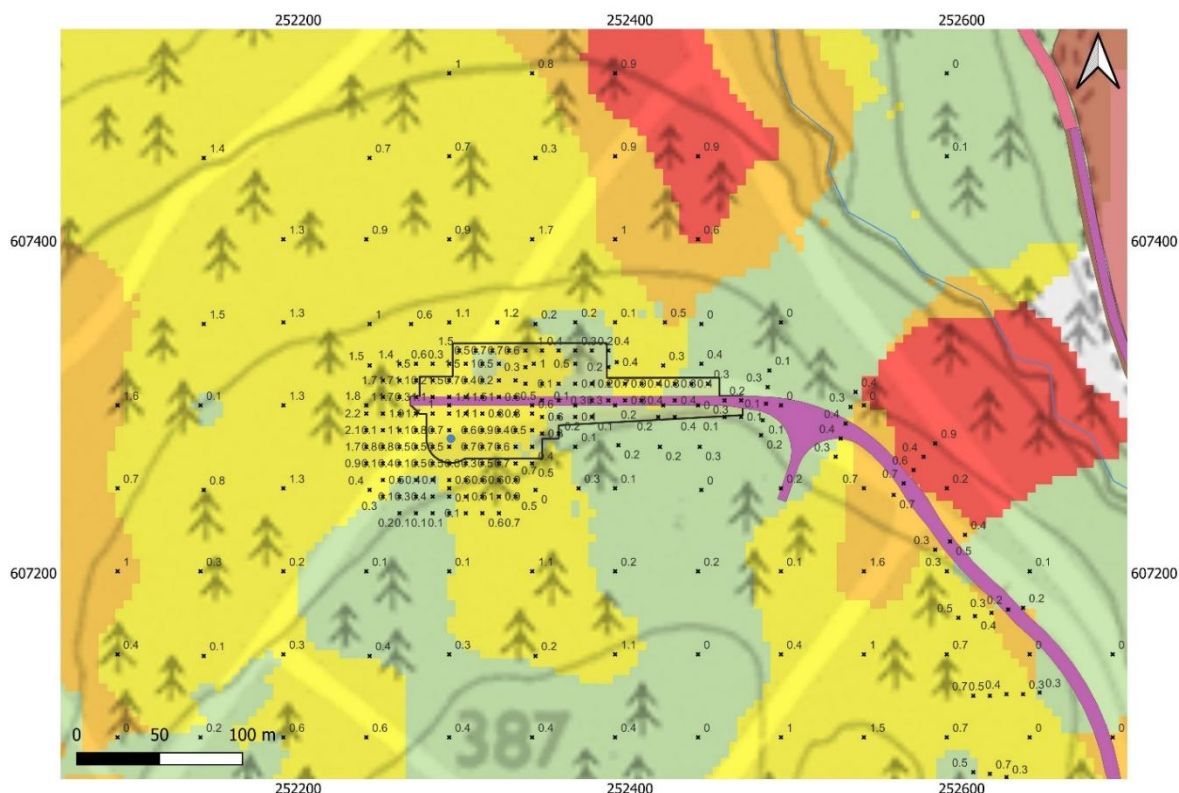
T05 Location – OS Mapping 1:25,000 – 1:1500 Scale

Development Infrastructure		Environmental	Contributory Factors (Probability/Exposure)	Risk Ranking
T05	1	1	Peat Depth (Mean = 0.54m)	3
			Slope Angle (5°)	3
			FoS (Min = Cu _{min} > site mean)	1
			Peat cracking / Infiltration	1
			Groundwater Flow	1
			Hydrology	1
			Previous Instability	1
			Land Management	2
				1 * (3+3+2) = 8 Low

There are localised deeper peat deposits to the north and west where special care will need to be taken during the construction process.

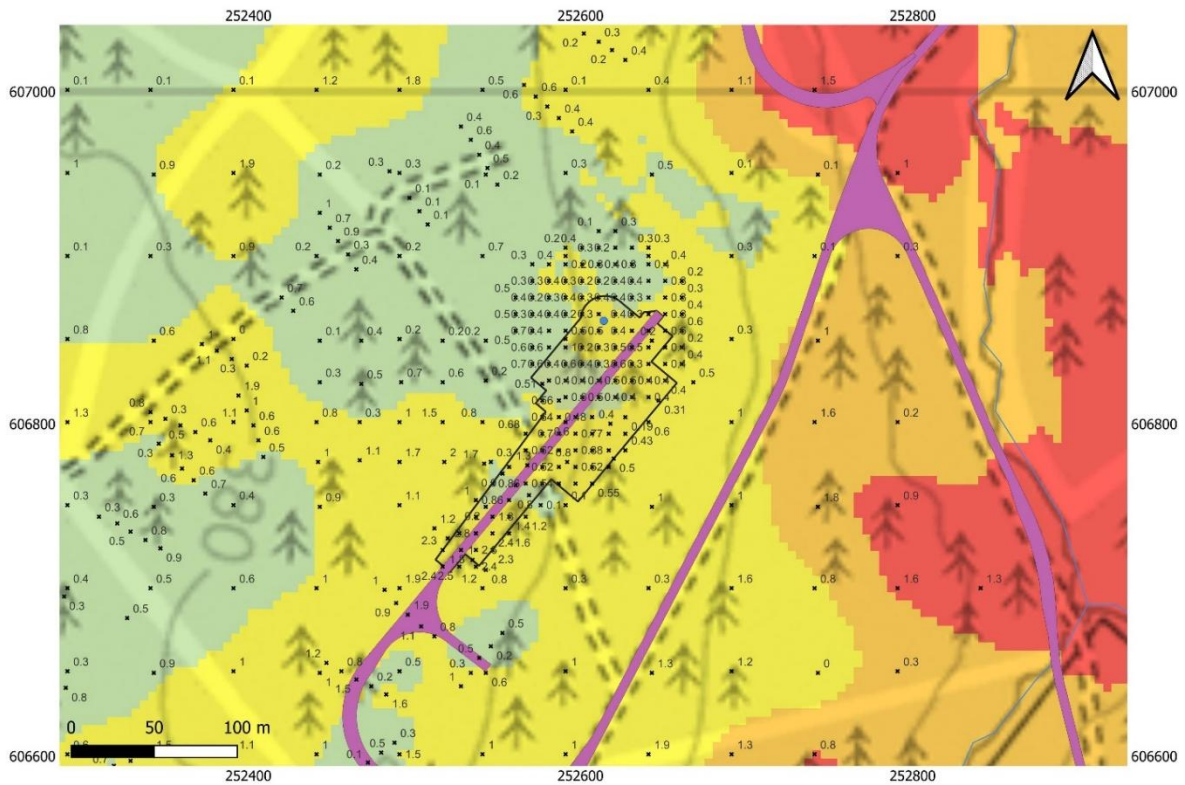
T06 Location – OS Mapping 1:25,000 – 1:1500 Scale

Development Infrastructure		Environmental	Contributory Factors (Probability/Exposure)	Risk Ranking
T06	1	1	Peat Depth (Mean = 0.71m)	3
			Slope Angle (5°)	3
			FoS (Min = Cu _{min} > site mean)	1
			Peat cracking / Infiltration	1
			Groundwater Flow	1
			Hydrology	1
			Previous Instability	1
		Land Management	2	1 * (3+3+2) = 8 Low

There are localised deeper peat deposits in the southwestern areas of the hardstanding where special care will need to be taken during the construction process.

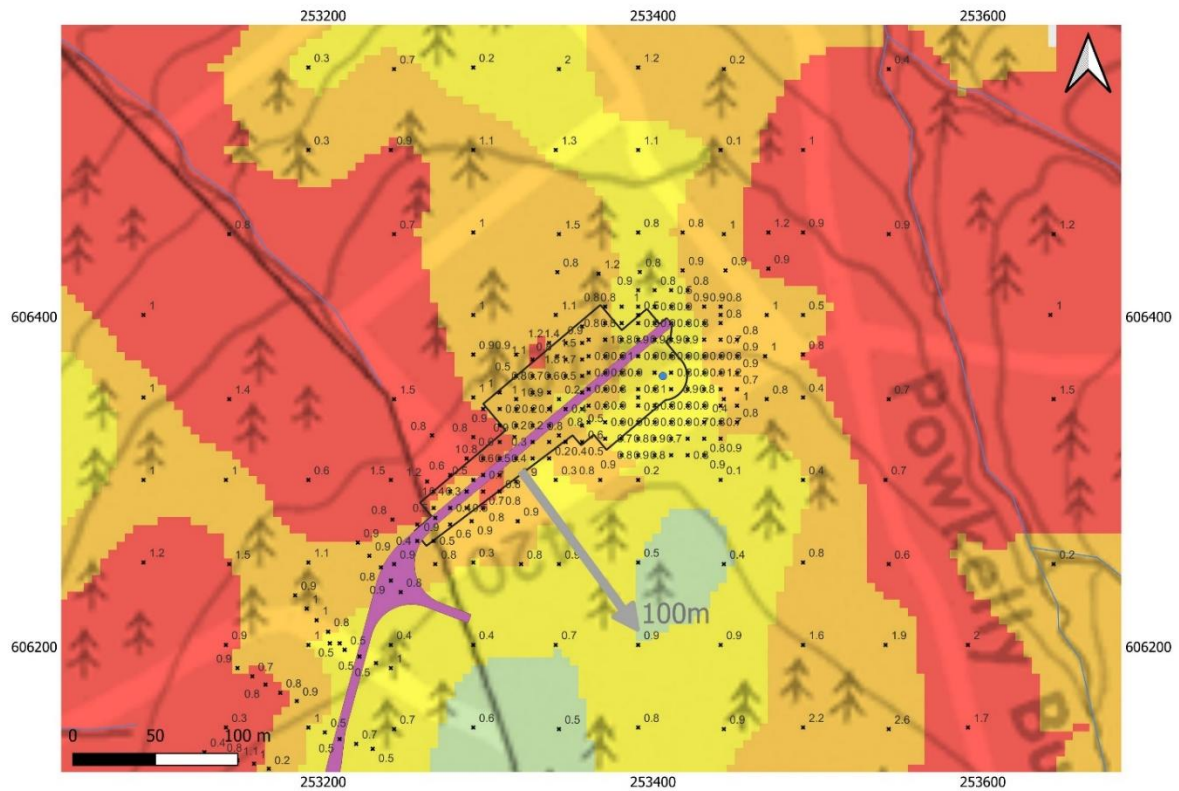
T07 Location – OS Mapping 1:25,000 – 1:1500 Scale

Development Infrastructure		Environmental	Contributory Factors (Probability/Exposure)	Risk Ranking
T07	1	3	Peat Depth (Mean = 0.90m)	3
			Slope Angle (7°)	3
			FoS (Min = Cu _{min} > site mean)	1
			Peat cracking / Infiltration	1
			Groundwater Flow	1
			Hydrology	1
			Previous Instability	1
			Land Management	2
				3 * (3+3+2) = 24 High

Care should be taken when stockpiling peat around this turbine to avoid steeper gradients.

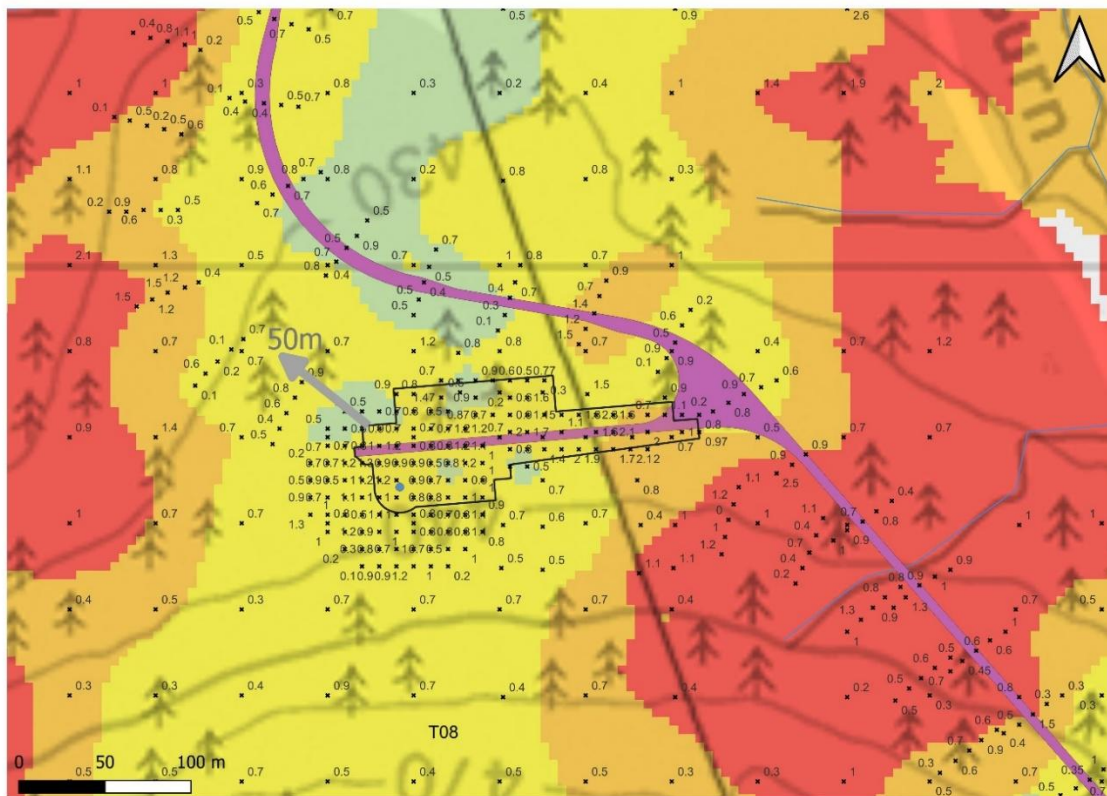
T08 Location – OS Mapping 1:25,000 – 1:1500 Scale

Development Infrastructure		Environmental	Contributory Factors (Probability/Exposure)	Risk Ranking
T08	1	2	Peat Depth (Mean = 1.03m)	5
			Slope Angle (4°)	3
			FoS (Min = Cu _{min} > site mean)	1
			Peat cracking / Infiltration	1
			Groundwater Flow	1
			Hydrology	1
			Previous Instability	1
		Land Management	2	1 * (5+3+2) = 20 High

Care should be taken when stockpiling peat around this turbine to avoid steeper gradients and deeper pockets of peat in the eastern side of the hardstanding area.

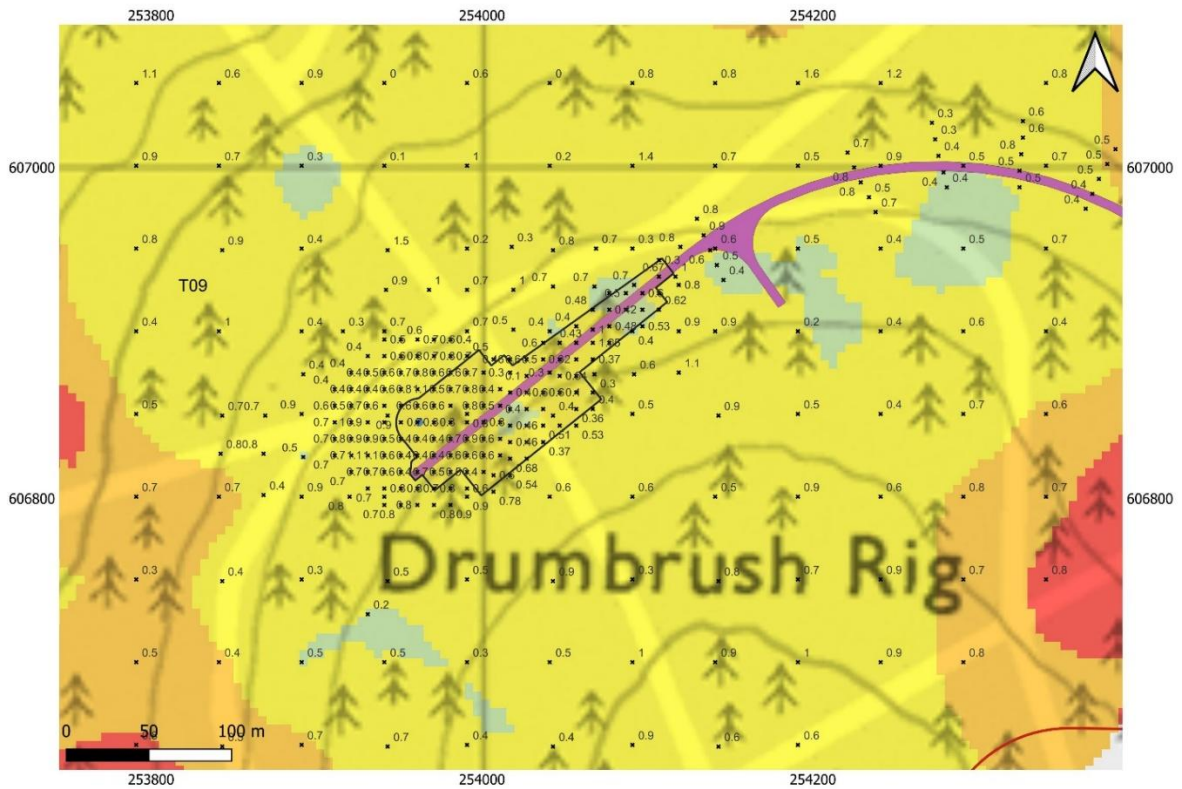
T09 Location – OS Mapping 1:25,000 – 1:1500 Scale

Development Infrastructure		Environmental	Contributory Factors (Probability/Exposure)	Risk Ranking
T09	1	1	Peat Depth (Mean = 0.54m)	3
			Slope Angle (6°)	3
			FoS (Min = Cu_{min} > site mean)	1
			Peat cracking / Infiltration	1
			Groundwater Flow	1
			Hydrology	1
			Previous Instability	1
			Land Management	2
				1 * (3+3+2) 8 Low

Land management factor of '2' due to forestry operations. The slope angle is conducive for peat sliding and peat depths on average around the proposed turbine location are over 0.50m. Care should be taken when stockpiling peat around this turbine to avoid steeper gradients.

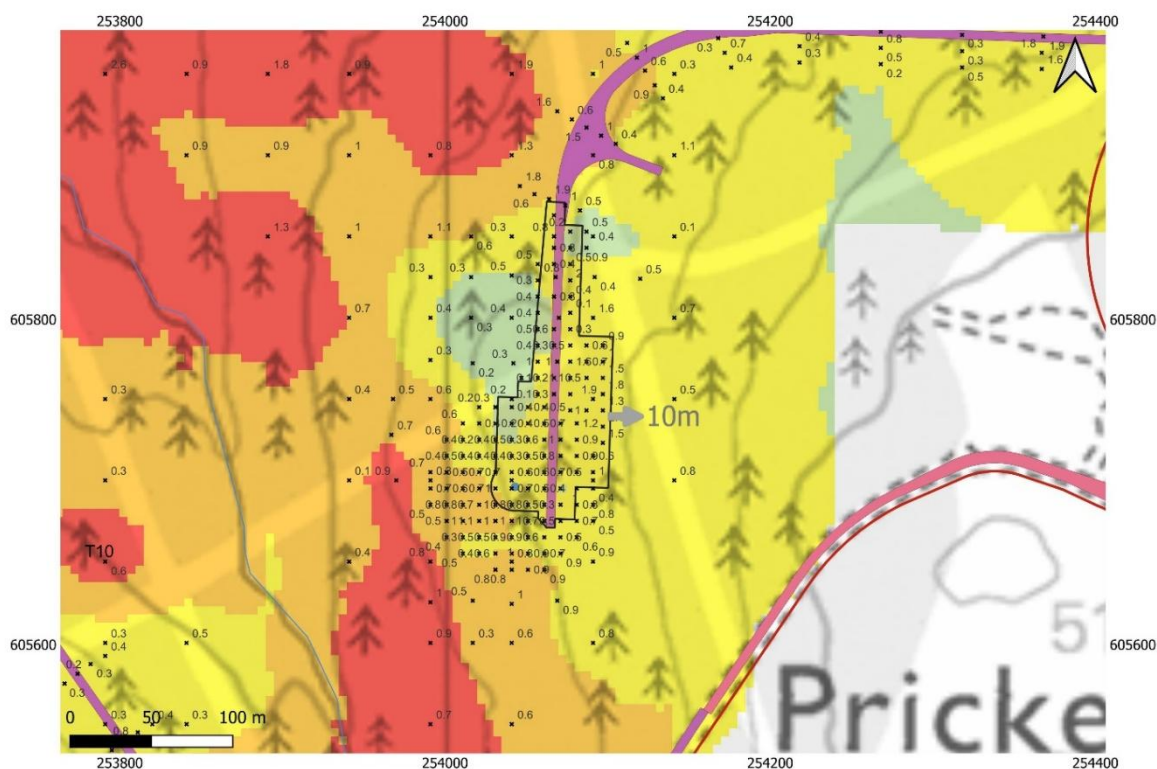
T10 Location – OS Mapping 1:25,000 – 1:1500 Scale

Development Infrastructure		Environmental	Contributory Factors (Probability/Exposure)	Risk Ranking
T10	1	2	Peat Depth (Mean = 0.61m)	3
			Slope Angle (8°)	3
			FoS (Min = Cu _{min} > site mean)	1
			Peat cracking / Infiltration	1
			Groundwater Flow	1
			Hydrology	1
			Previous Instability	1
			Land Management	2
				$2 * (3+3+2) = 16$ Medium

There are localised deeper peat deposits to the north and southwest where special care will need to be taken during the construction process.

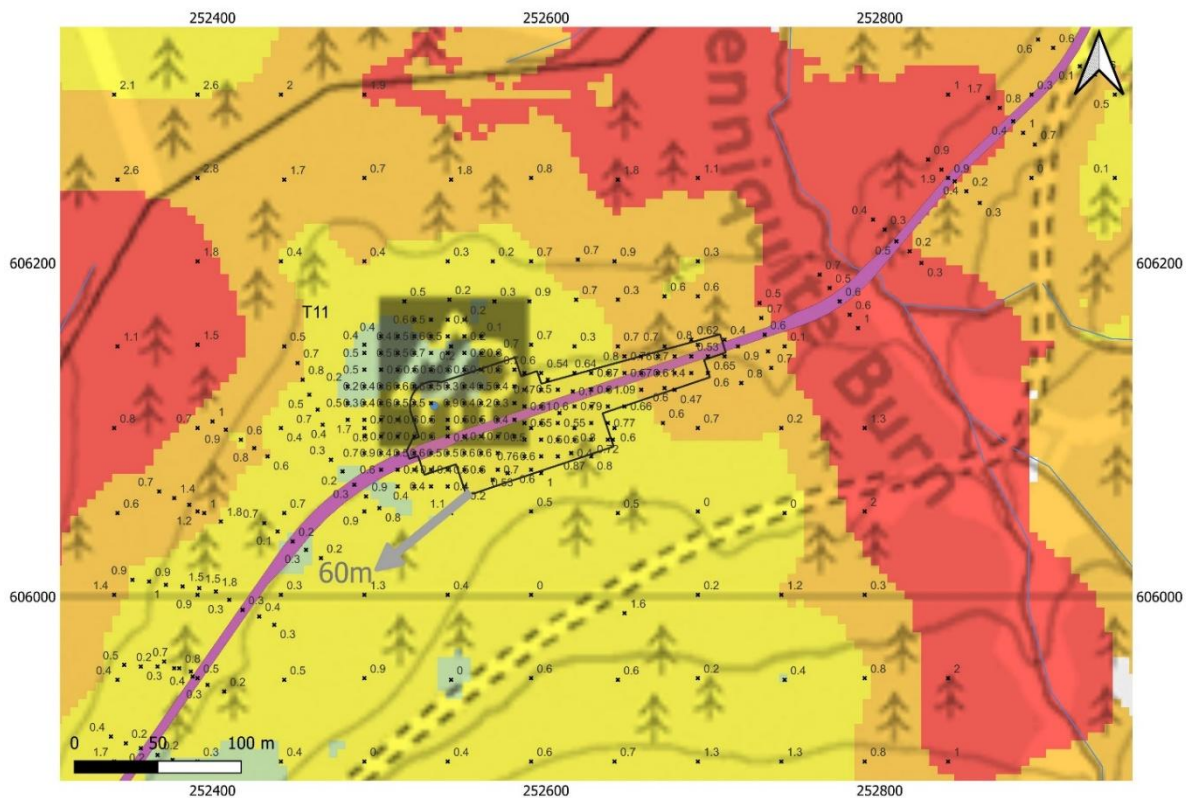
T11 Location – OS Mapping 1:25,000 – 1:1500 Scale

Development Infrastructure		Environmental	Contributory Factors (Probability/Exposure)	Risk Ranking
T11	1	2	Peat Depth (Mean = 0.58m)	3
			Slope Angle (6°)	3
			FoS (Min = Cu _{min} > site mean)	1
			Peat cracking / Infiltration	1
			Groundwater Flow	1
			Hydrology	1
			Previous Instability	1
			Land Management	2
				2 * (3+3+2) = 16 Medium

There are localised deeper peat deposits to the north and west where special care will need to be taken during the construction process.

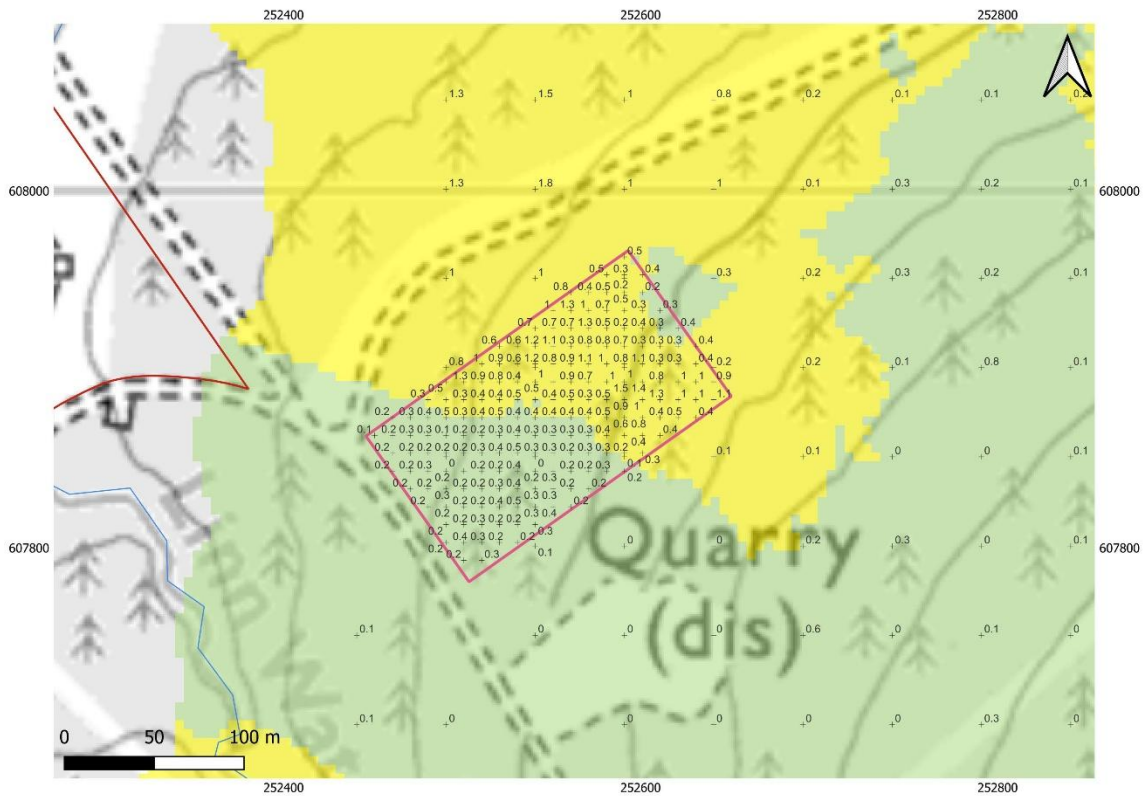
Substation/Battery Storage Location – OS Mapping 1:25,000 – 1:1500 Scale

Development Infrastructure		Environmental	Contributory Factors (Probability/Exposure)	Risk Ranking
Substation Building / Battery Storage Facility	1	1	Peat Depth (Mean = 0.37m)	1
			Slope Angle (7°)	3
			FoS (Min = Cu _{min} > site mean)	1
			Peat cracking / Infiltration	1
			Groundwater Flow	1
			Hydrology	1
			Previous Instability	1
			Land Management	2
				1 * (3+2) = 5 Low

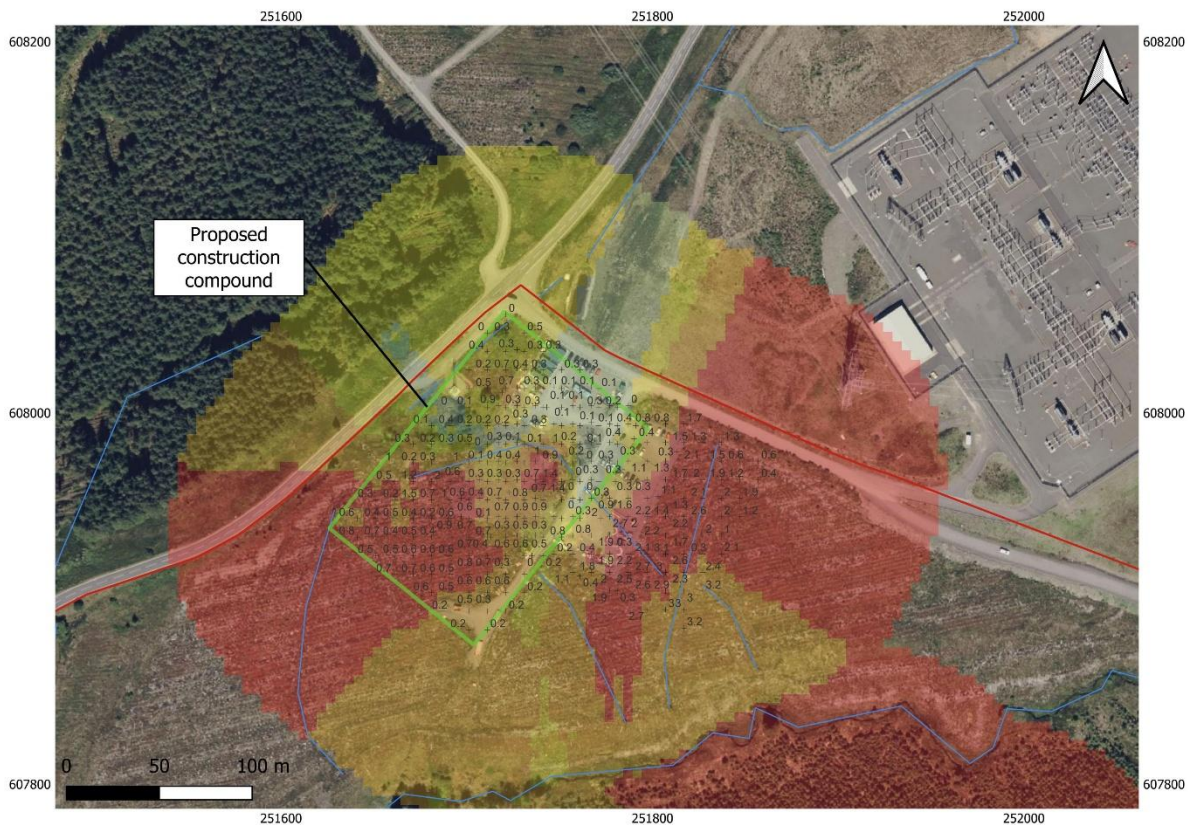
Construction Compound Location – Bing Virtual Earth 1:25,000 – 1:1500 Scale

Development Infrastructure	Environmental	Contributory Factors (Probability/Exposure)	Risk Ranking
Construction Compound	1	2/3*	Peat Depth (Mean = 1.00)	3
			Slope Angle (2.5°)	1
			FoS (Min = Cu _{min} > site mean)	1
			Peat cracking / Infiltration	1
			Groundwater Flow	1
			Hydrology	1
			Previous Instability	1
			Land Management	3
2*(3+2+3) = 16				Medium

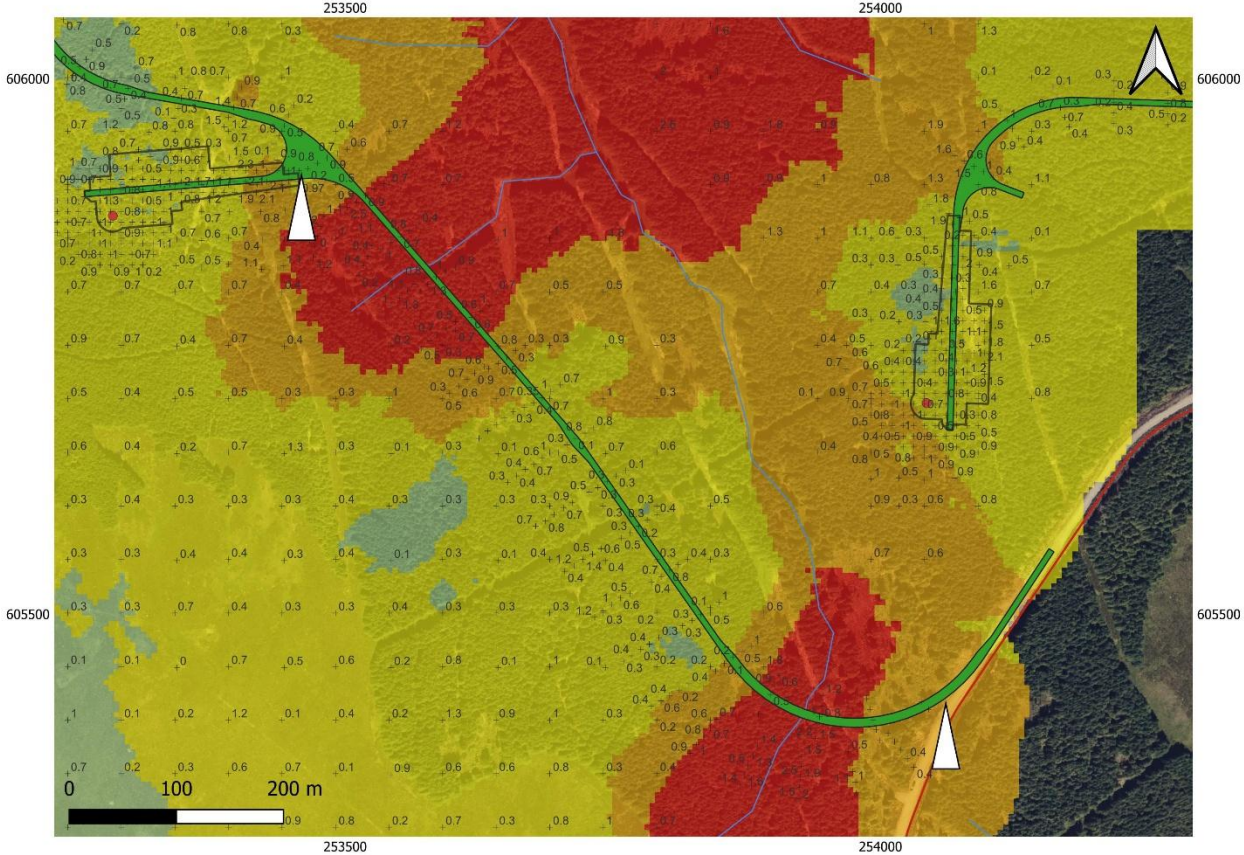
Track Element
<p>Track Section 1: Southwest of Prickenny Hill to T08</p>

<p>Contributors to elevated peat slide risk:</p> <ul style="list-style-type: none"> • Proximity to watercourses/watercrossings • Slope angles (3 – 12 degrees°) • Peat depth – up to 2.2 m <p>Specific Mitigation:</p> <p>The following mitigation is therefore required along this track section in order to reduce the risk to low:</p> <ul style="list-style-type: none"> • Cross track drainage which prevents any ponding or build-up of groundwater pressure within the peat upslope or beneath the access infrastructure. Where possible existing drainage systems should be utilised and maintained; • No stockpiling or surcharging of the peat along areas of medium to high risk on this section • Where detail design proves floating access, track is safe to use, this should be the preferred method of track construction to reduce the impact on peatland by avoiding excavation.

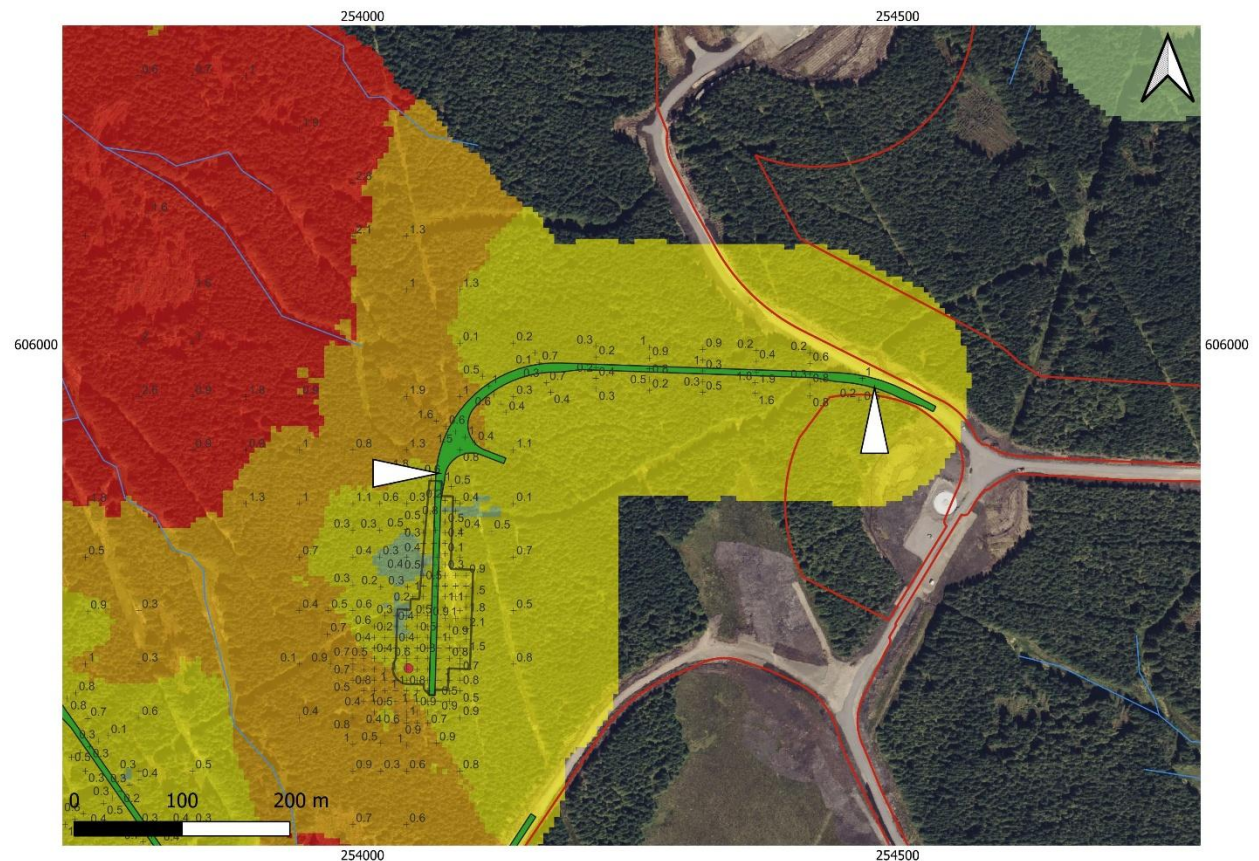
Track Section 2: North of Prickenny Hill to T10

Contributors to elevated peat slide risk:

- Proximity to watercourse to west
- Slope angle – 4 to 10°
- Peat depth - up to 1.9 m

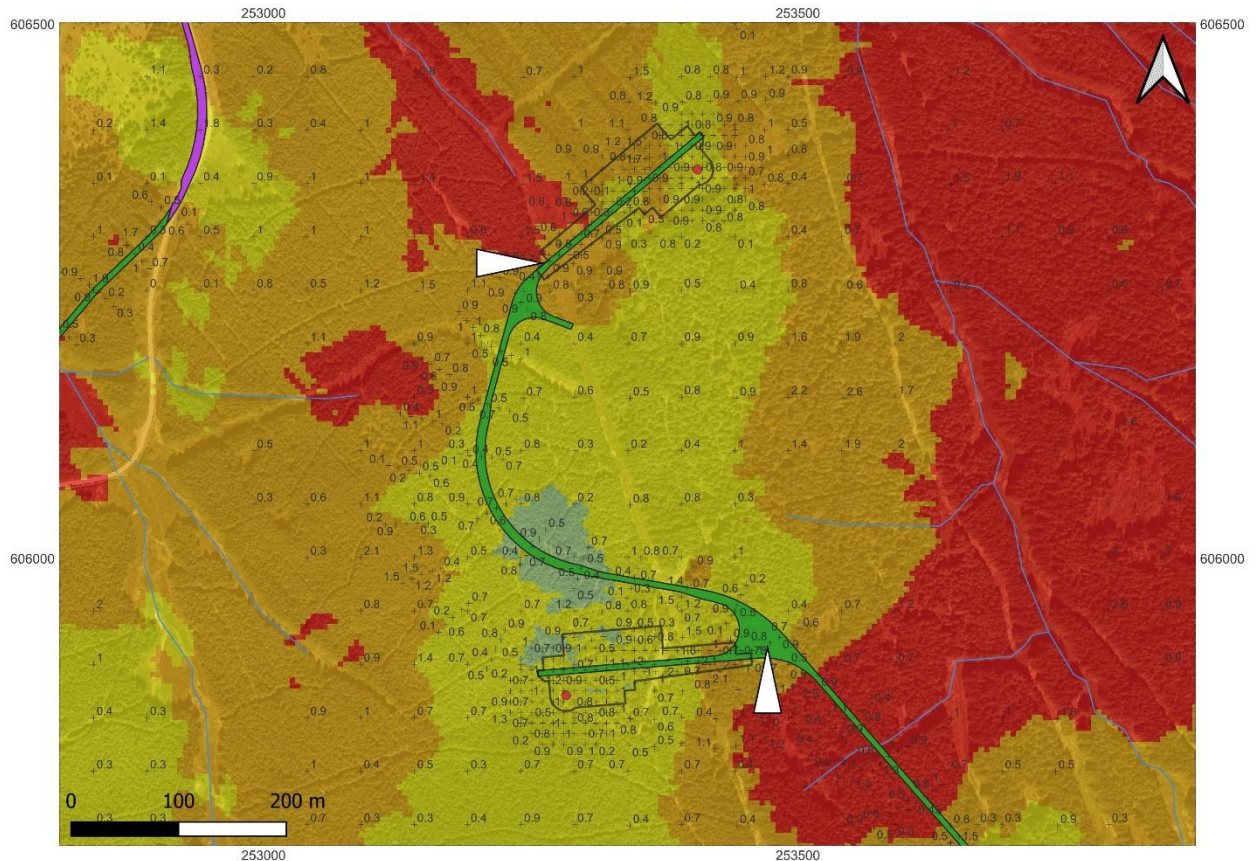
Track Section 3: T08 to T07

Contributors to elevated peat slide risk:

- Proximity to watercourse to west and northwest
- Slope angle – 0 to 8°
- Peat depth - up to 1.5 m.

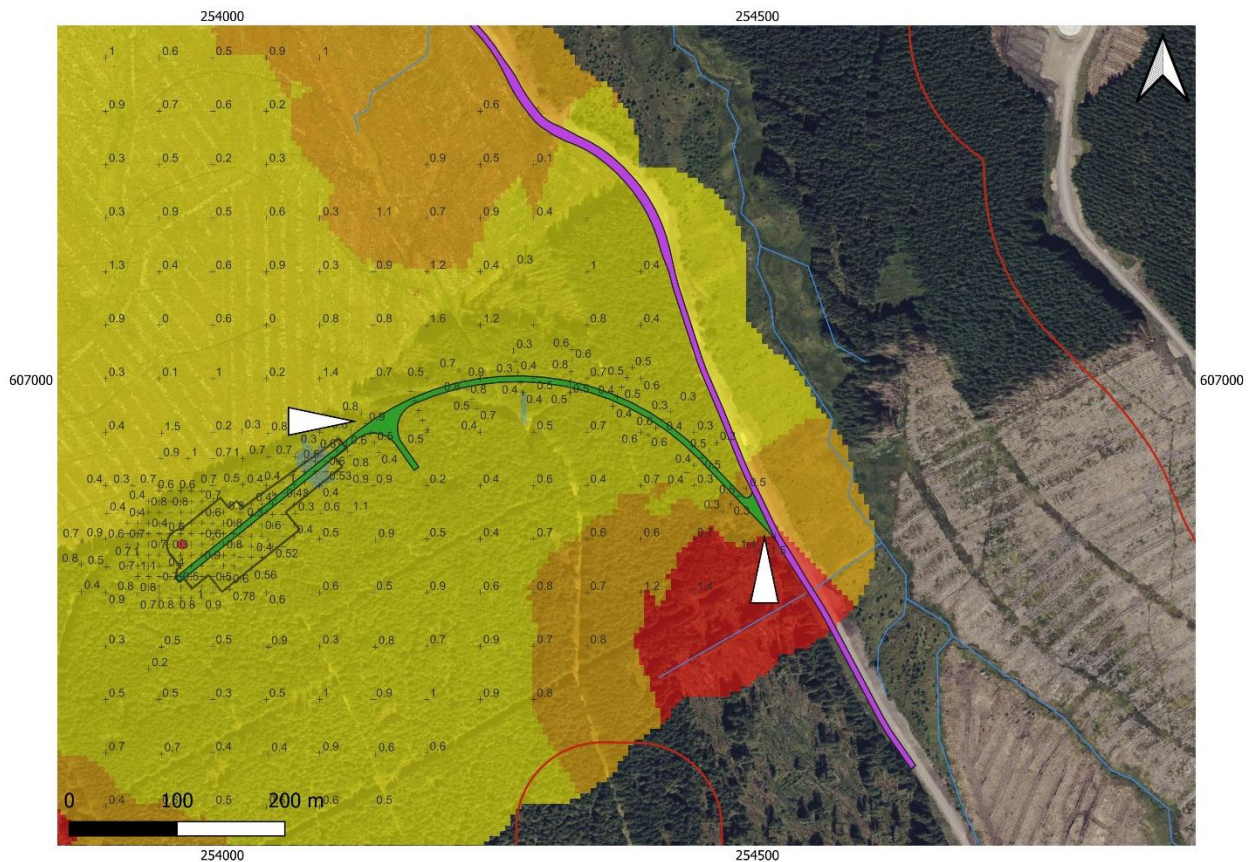
Track Section 4: New track to T09

Contributors to elevated peat slide risk:

- Proximity to watercourse to east
- Slope angle – 7 to 18°

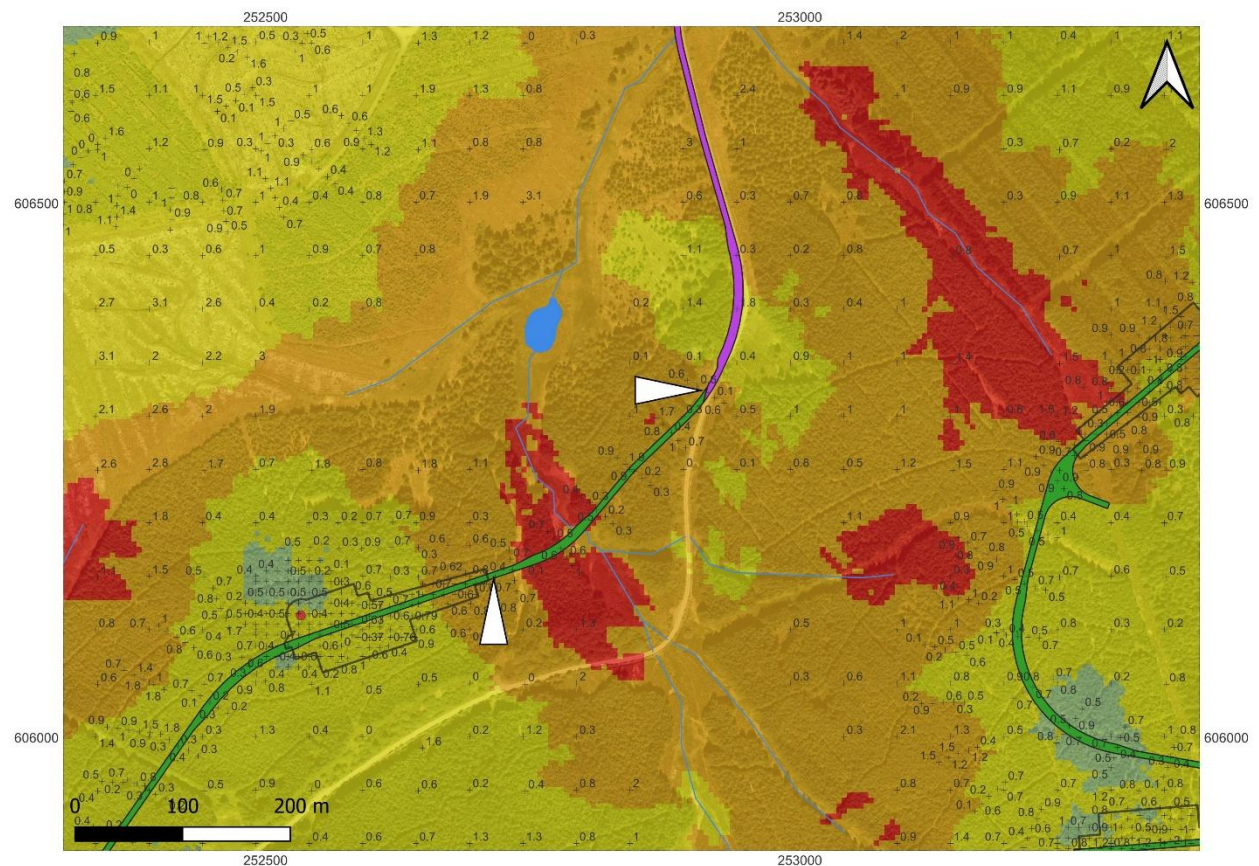
Track Section 5: New track to T11

Contributors to elevated peat slide risk:

- Proximity to watercourses and watercrossing
- Slope angle – 2 to 19°
- Peat depth – Up to 1.9 m
