South Kyle II Wind Farm

FEI Technical Appendix E - Peat Slide Risk Assessment

Vattenfall

June 2026

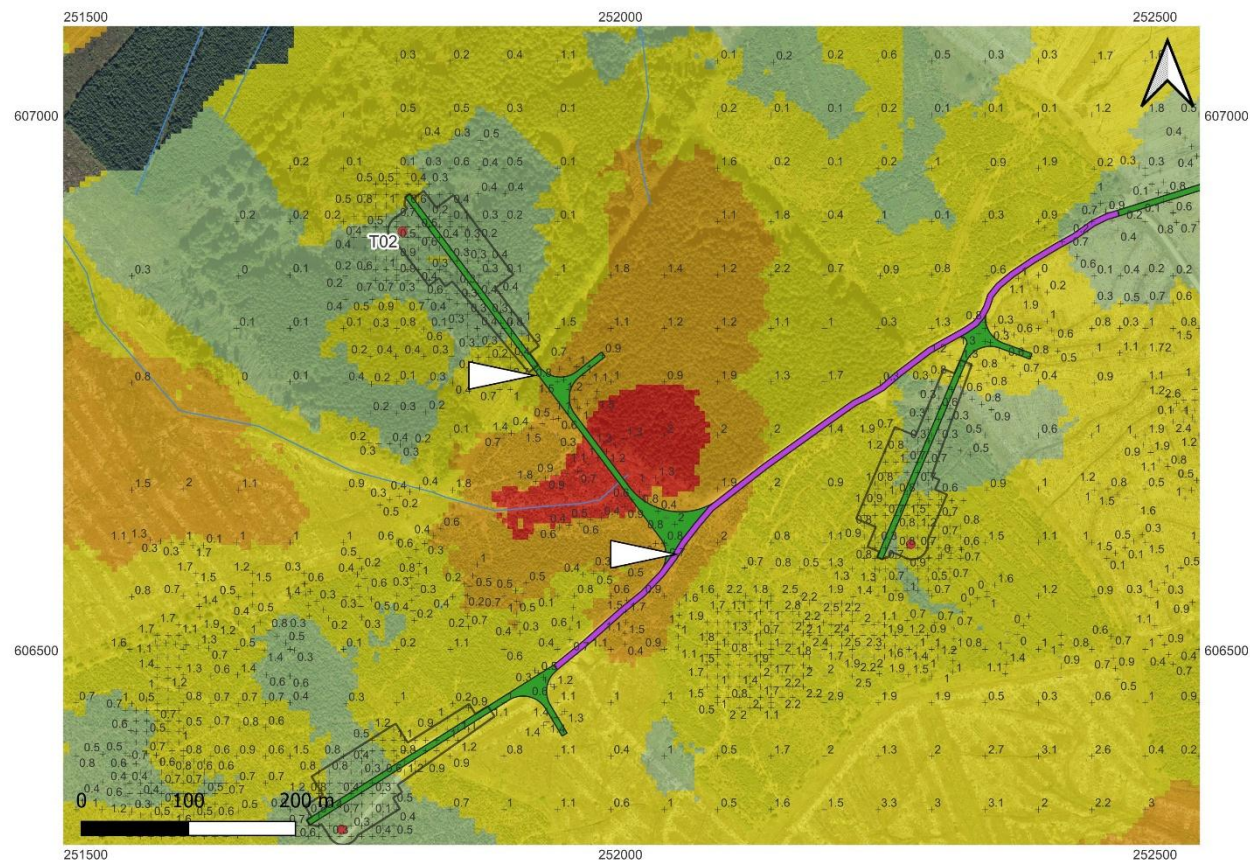
Track Section 7: New track to T02

Contributors to elevated peat slide risk:

- Proximity to watercourse west and watercrossing
- Slope angle – 0 to 6°
- Peat depth – 0.5 – 1.5 m.

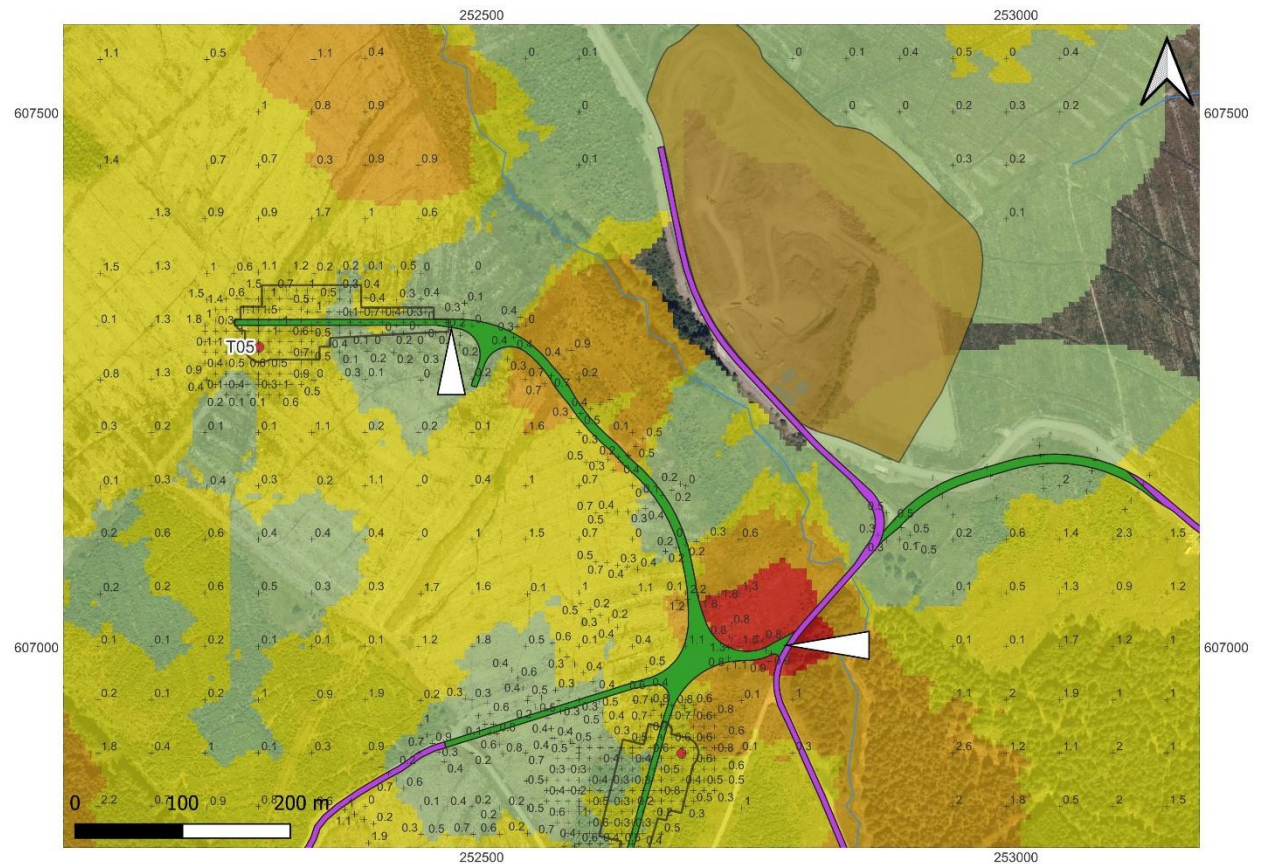
Track Section 8: Northeast of T06 to T05

Contributors to elevated peat slide risk:

- Proximity to watercourse to northeast
- Slope angle – 4 to 18°

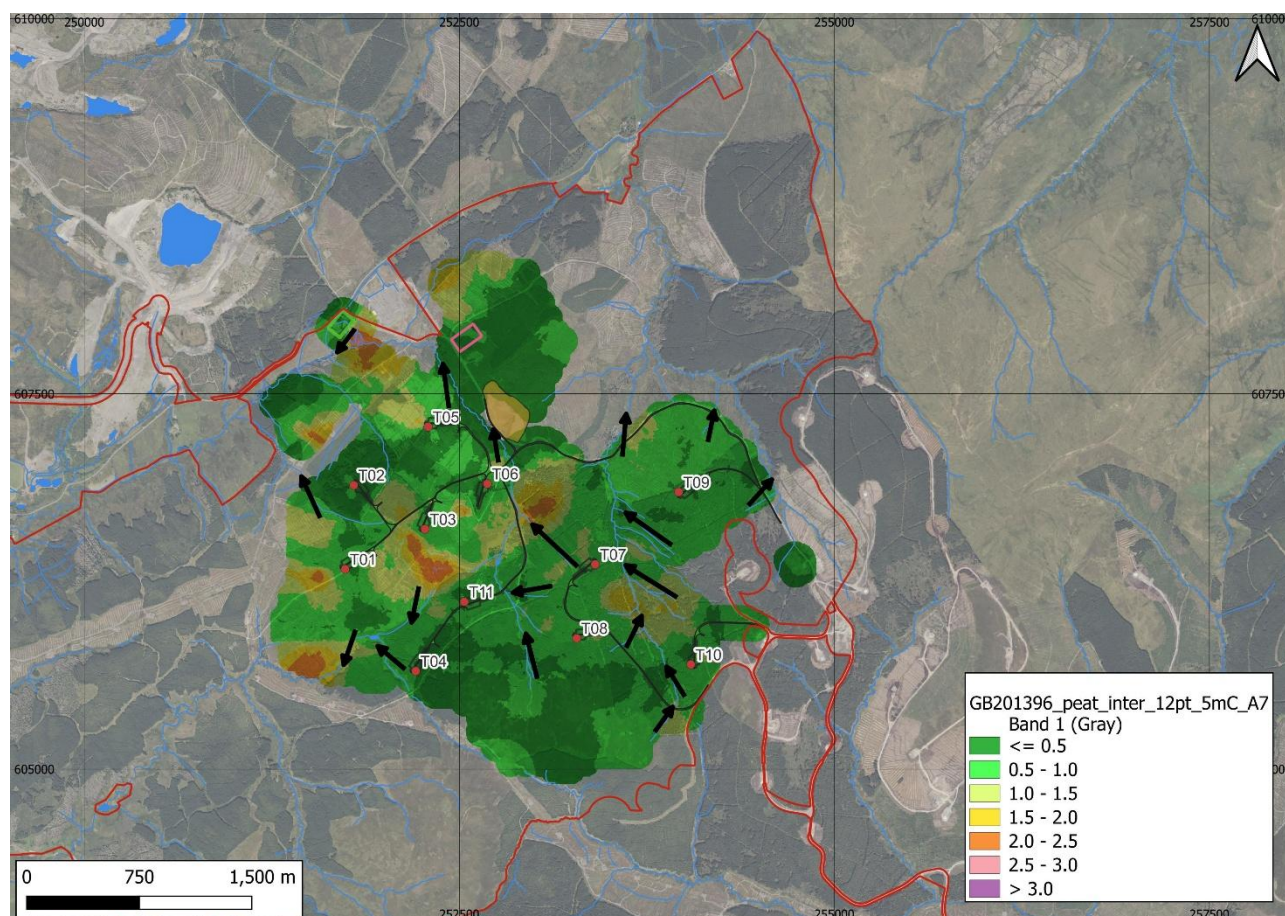
Notwithstanding the point above, this report examines the terrain and the potential evolution of any triggered peat slide event. The determination has been that entrained peat flows would primarily be channelled along the main watercourse's downslope of proposed infrastructure; these locations are highlighted by the black arrows on the Peat Slide Pathways Map in Figure 6.1. The pathways shown indicate the directions where peat flows would travel into main watercourses or waterbodies, they do not indicate risk of instability. The main offsite receptors are the River Dee, Nith and Doon from which the main waterbodies within the Proposed Development merge into.

Figure 6.1: Preliminary peat slide pathways (black arrows) and indicative peat depth.

The risk of run out and significant damage to the wider hydrological environment is deemed low, providing the relevant control measures outlined in his report are implemented at the site.

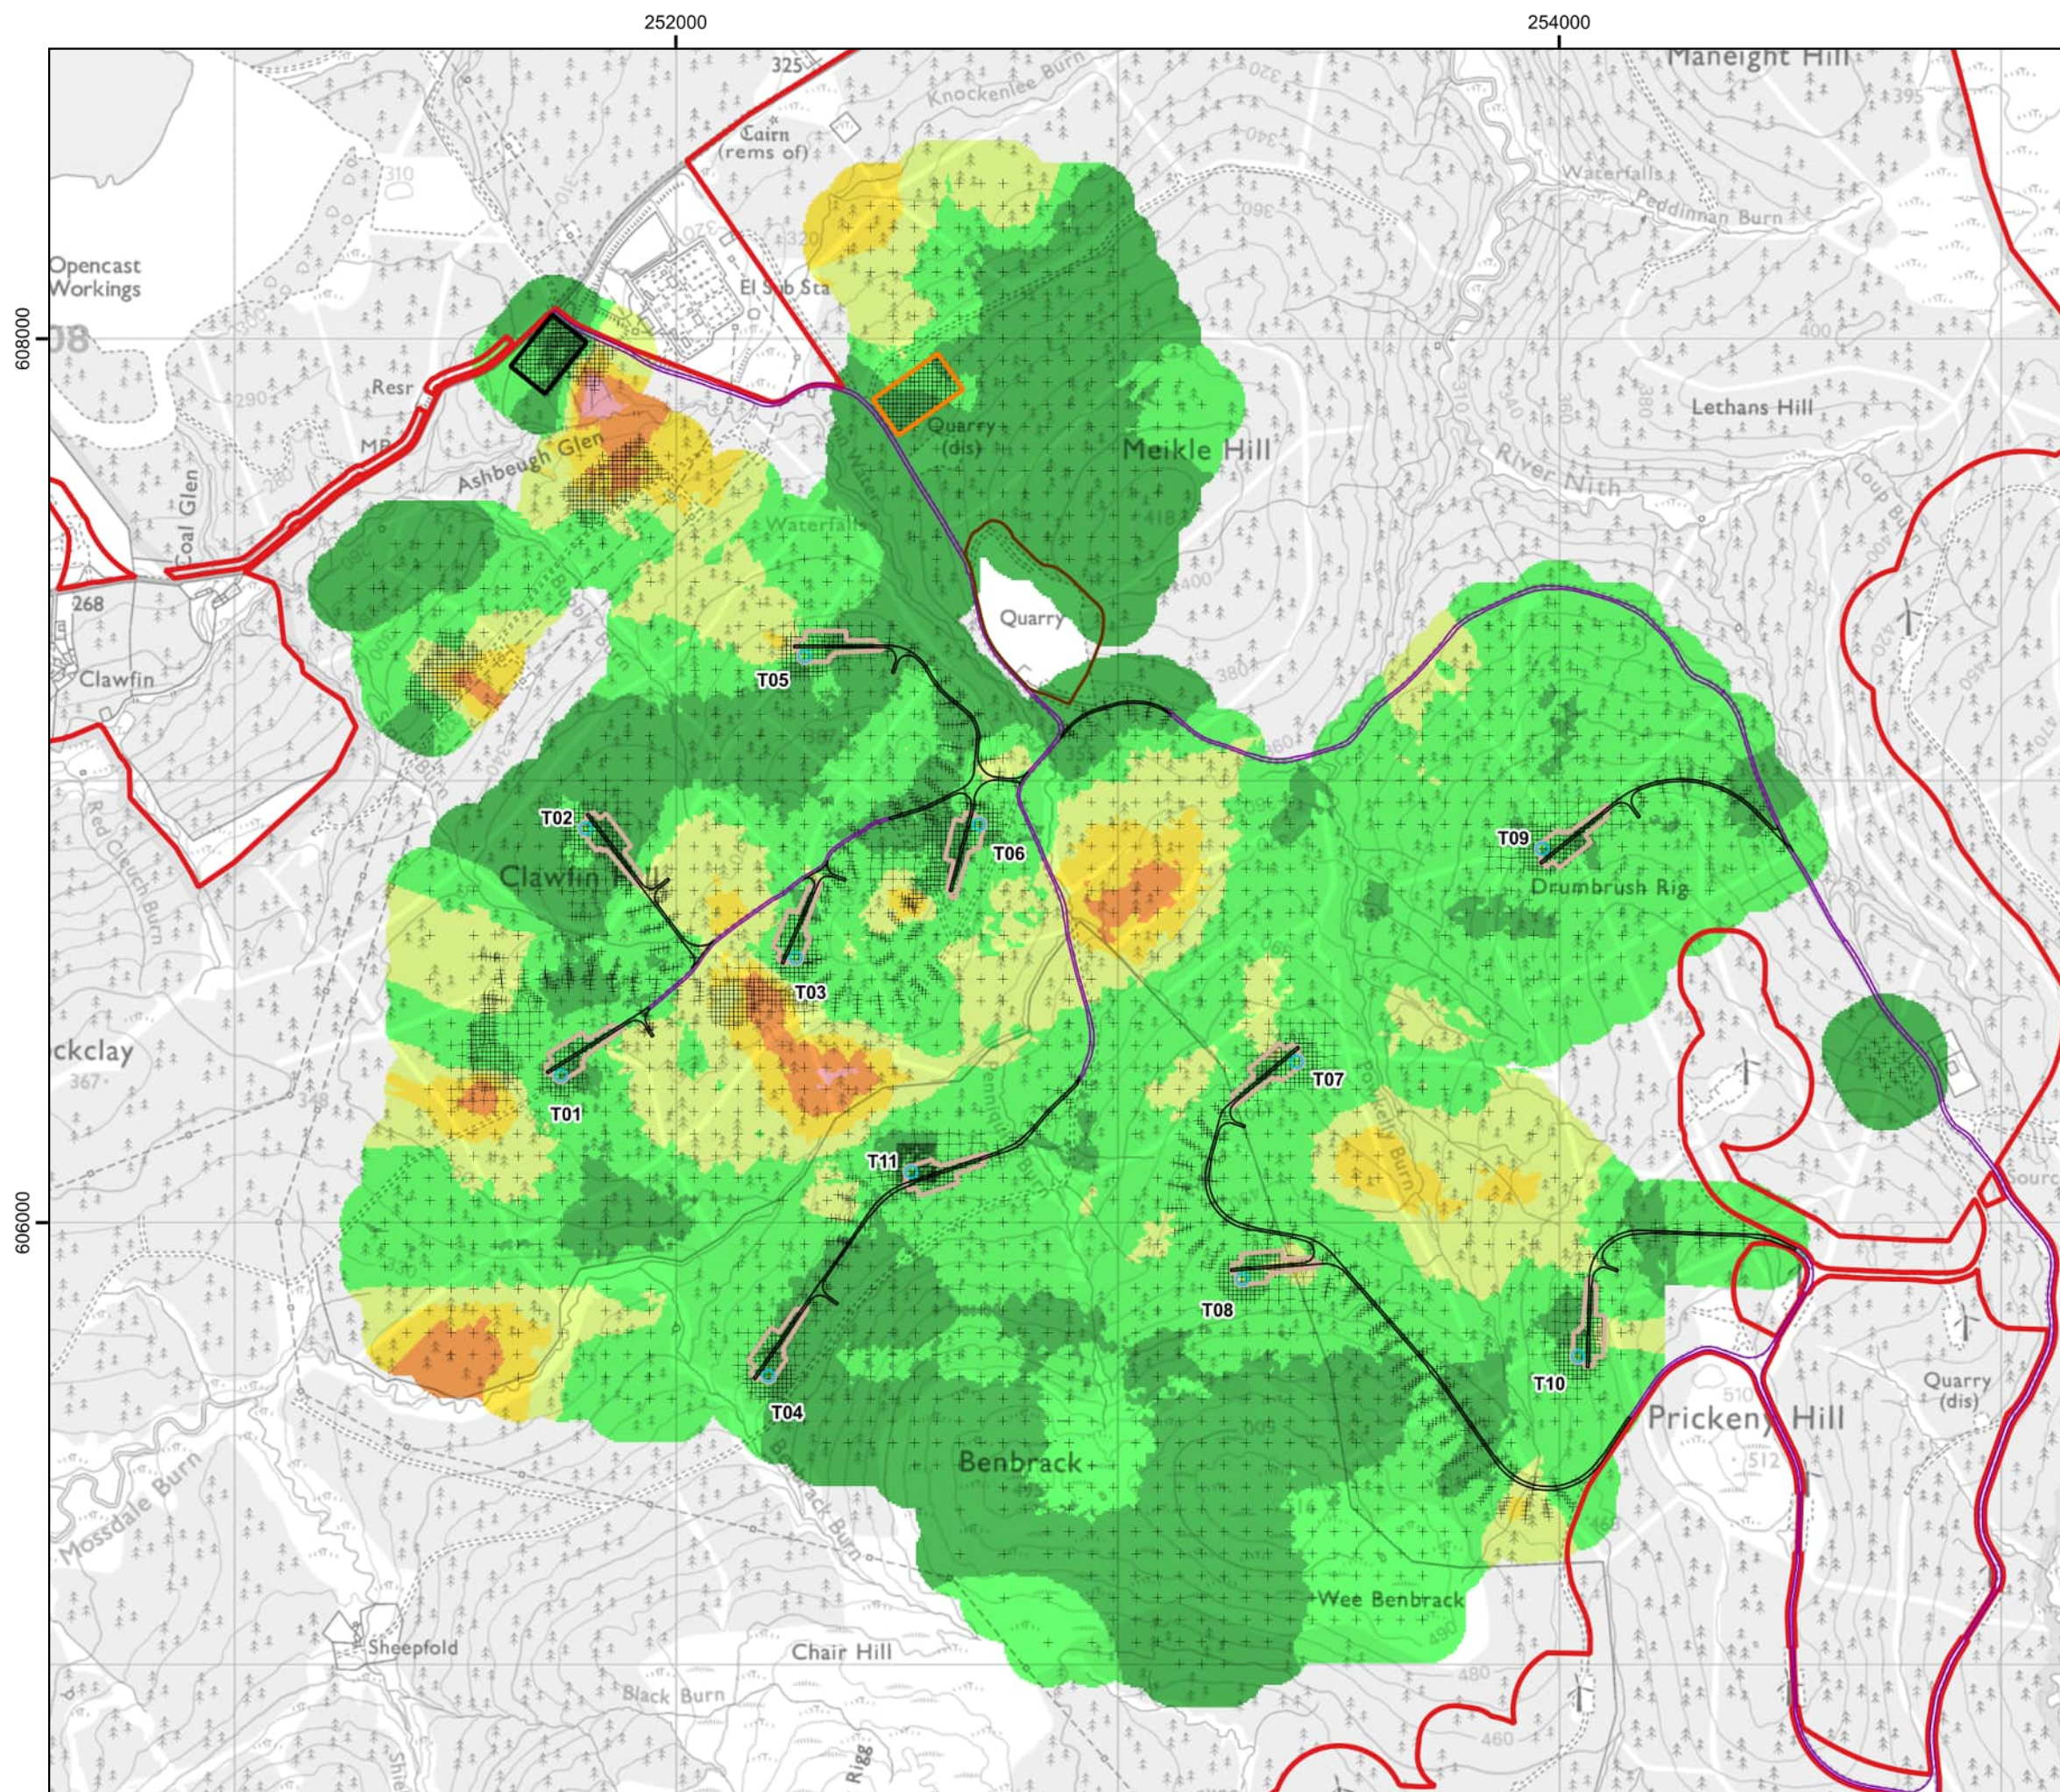
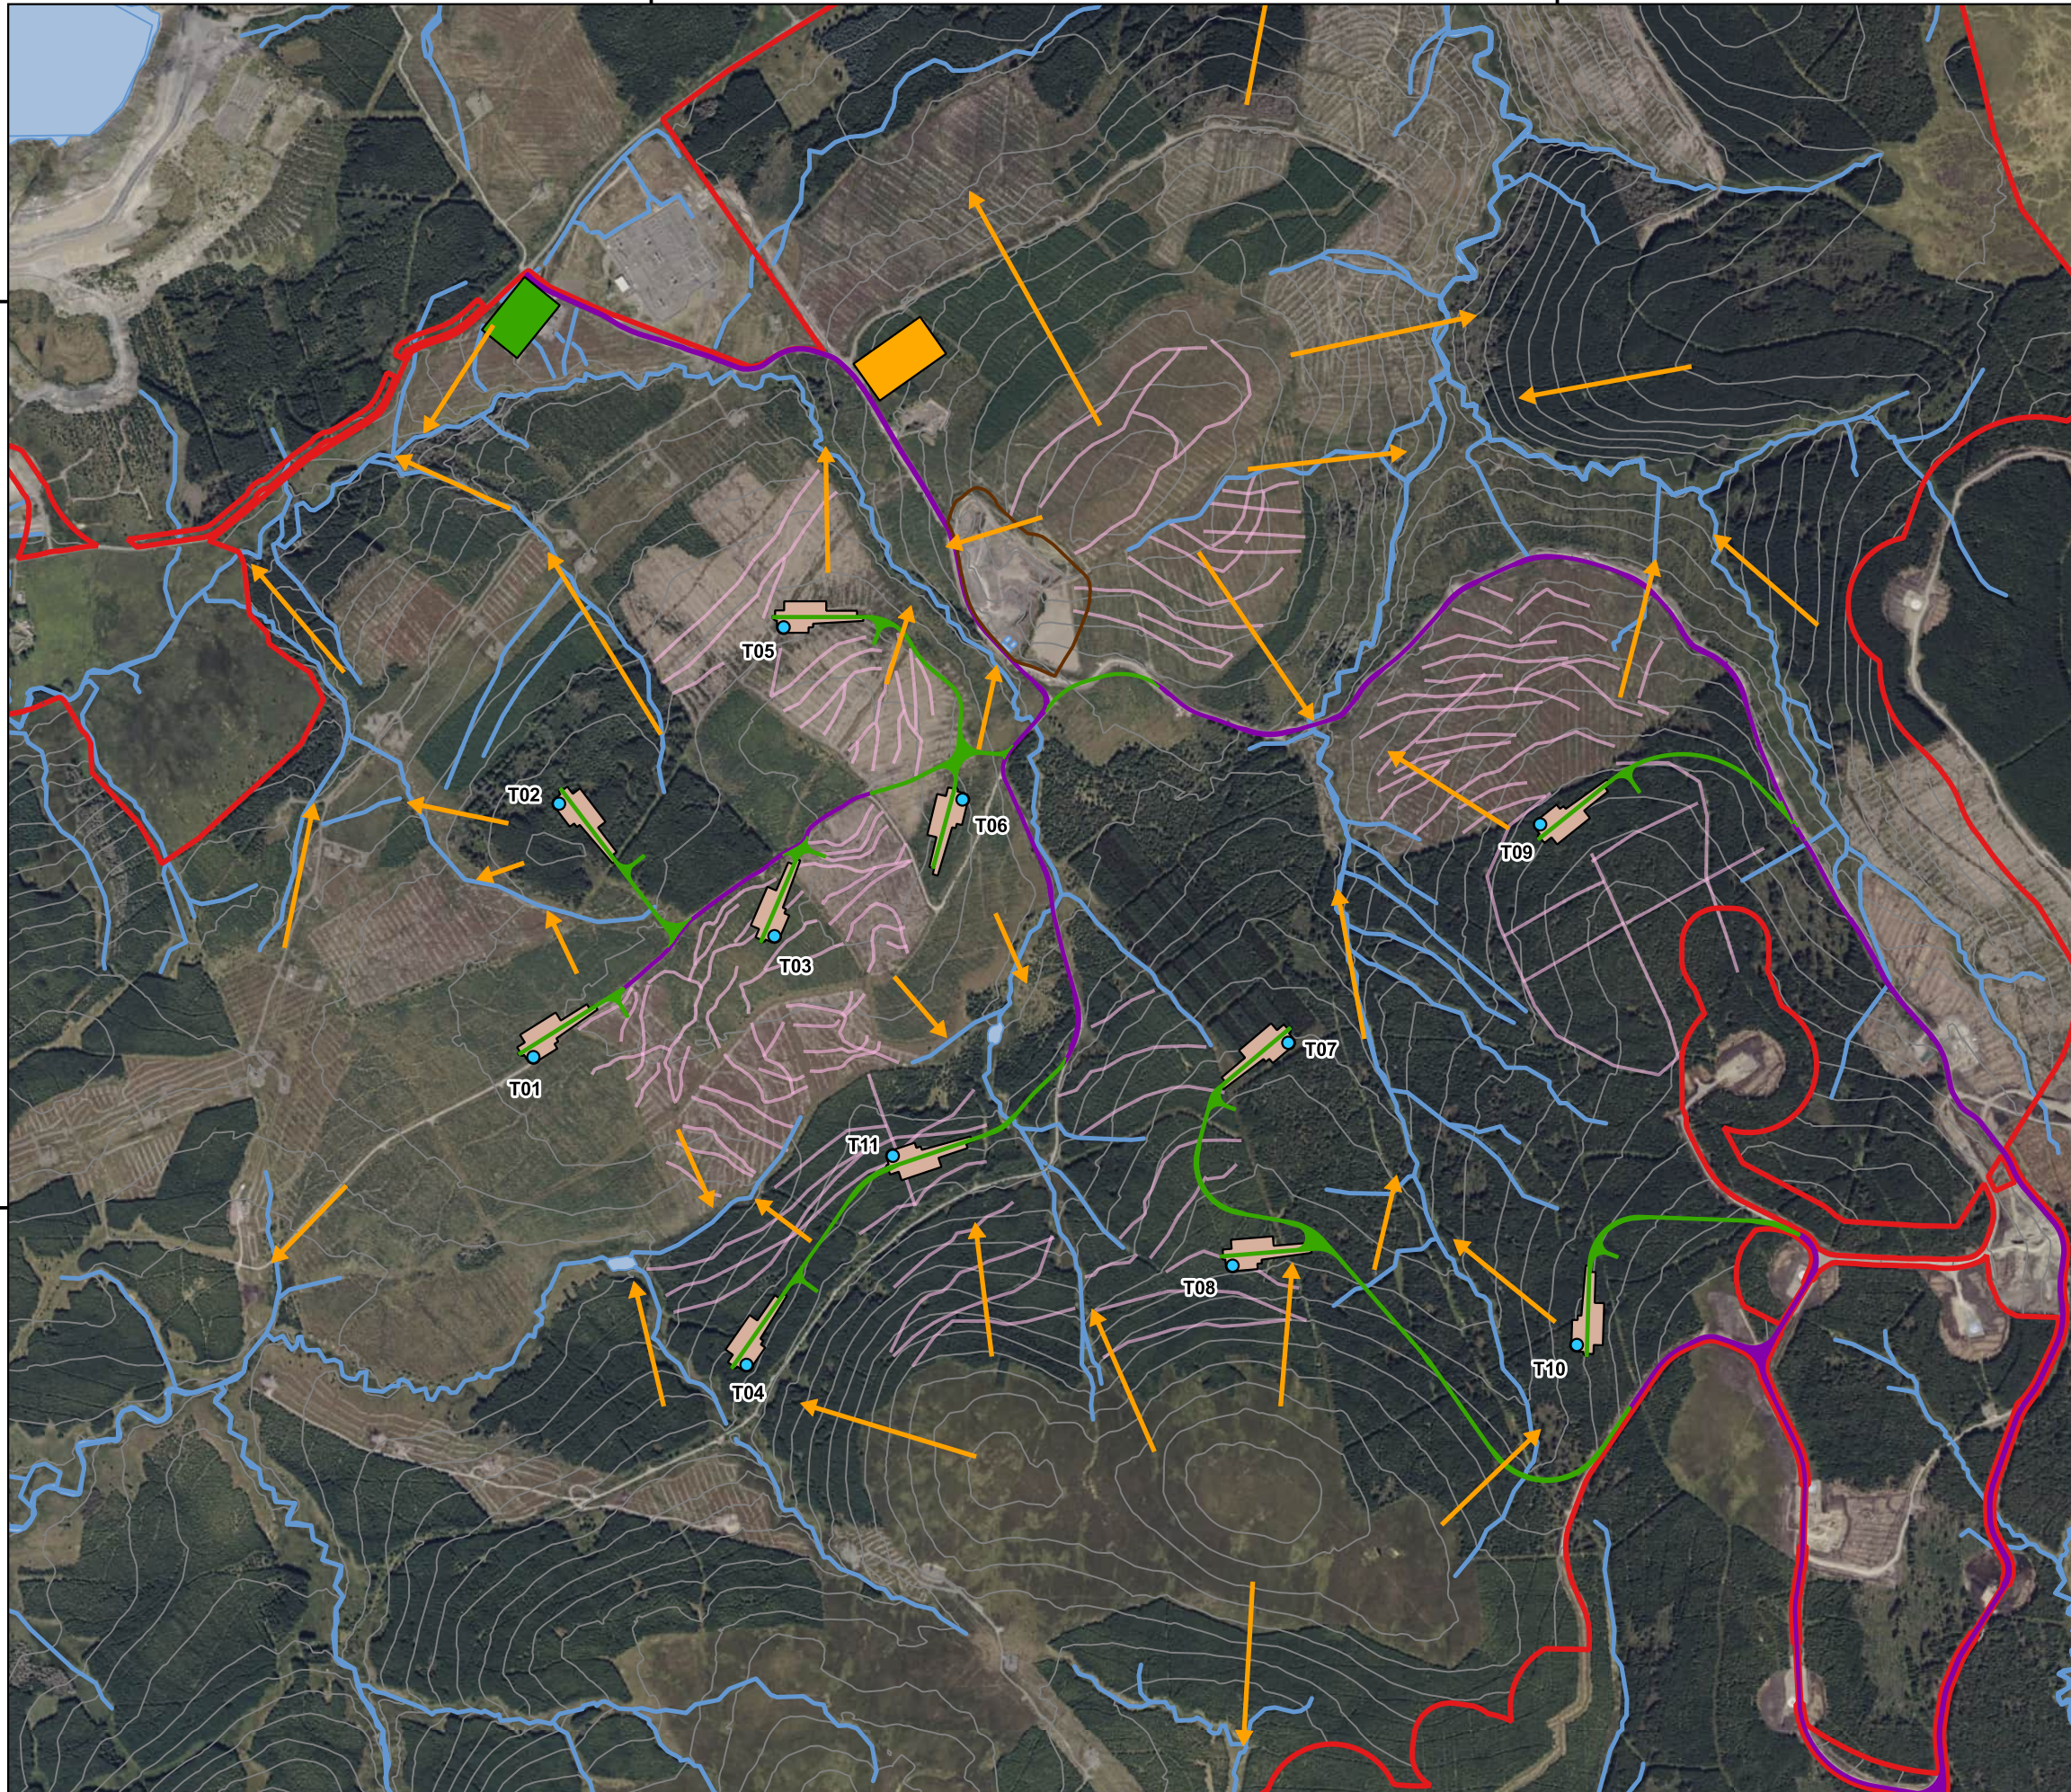
Title:
**FEI Figure A.1: Interpolated
 Peat Depth**

The collected peat probe depths suggest that the majority of the site is covered by significant amounts of peat, with a peat depth average of 0.77m. There are several deep pockets of peat in excess of 3.0m, with a maximum depth of 3.8m. The most extensive areas of deep peat within the Site are found in the broad valley floors southeast of Clawfin Hill (southeast of T03), south of Meikle Hill (east of T06) and west of Benbrack (west of T04). In general, the amended proposed infrastructure avoids the deepest peat deposits across the site.
